Re: George Massey Crossing Project – Use of Existing Immersed Tube Tunnel

As part of a detailed tunnel condition review undertaken by COWI (George Massey Crossing Assessment – Existing Tunnel Condition Assessment Report, December 11 2020), sampling and testing of the precast concrete tunnel sections and cast-in-place

CONDITION ASSESSMENT REPORT - DRAFT

A127810 GMC-rpt-41-ext-cowi-Condition Assessment-Rev0C-11-Dec-2020

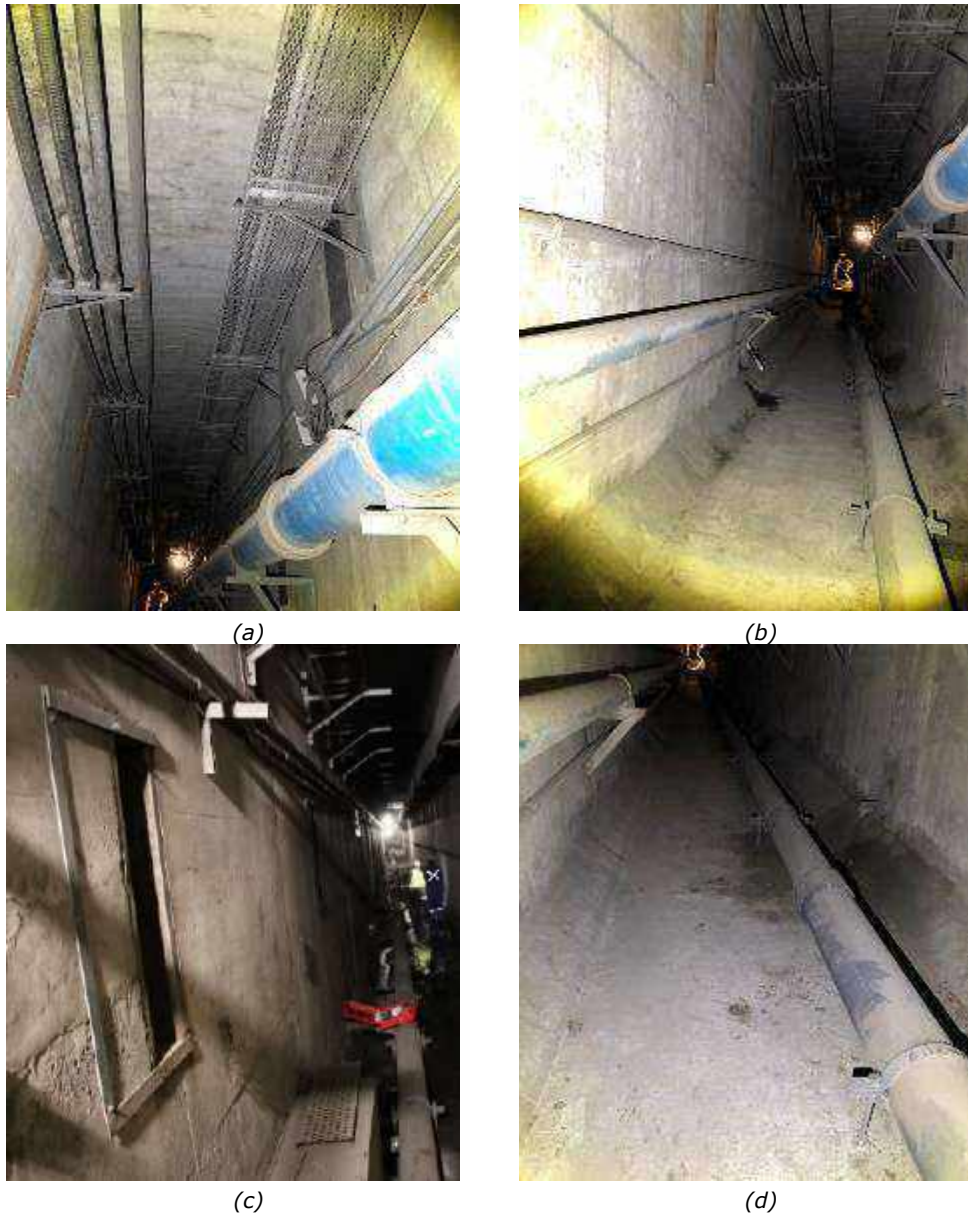
Figure 3-5: Photos of the typical condition of (a) soffit, (b) outer wall, (c) intermediate wall, and (d) floor of the air duct tubes during summer inspection 2020. Dark spots on chamfer and bottom slab seen in (b) and (d) are from water seeping from drainpipes.

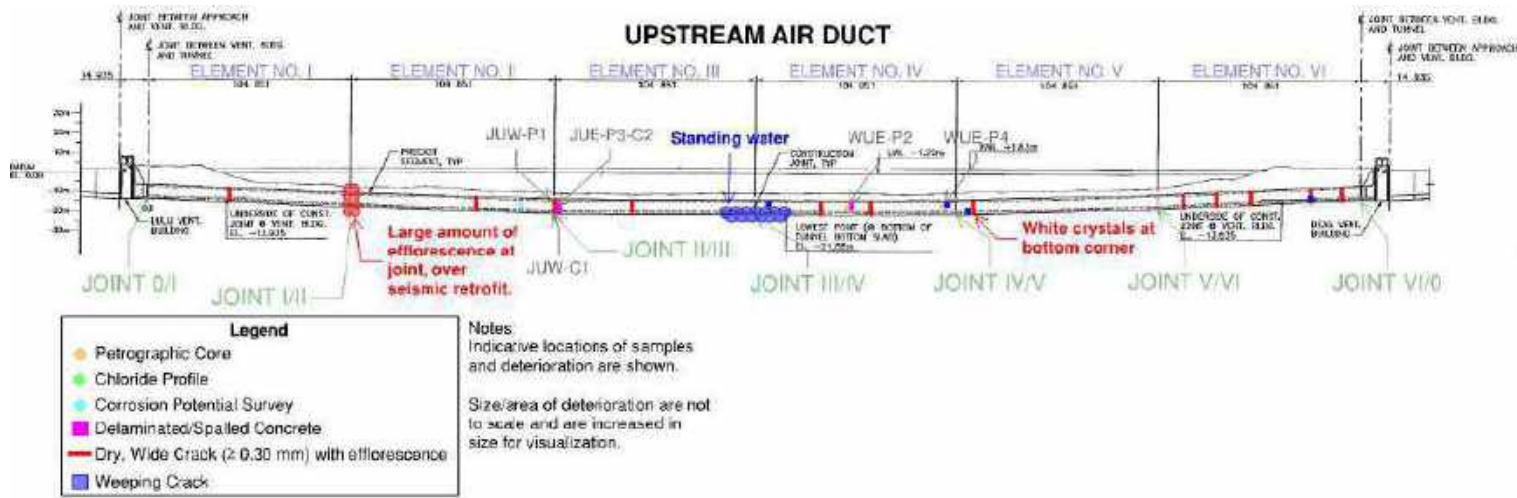
Figure 3-6: Schematic of approximate locations of observed deterioration at the Outer (East) Wall of the Upstream Air Duct Tube during summer inspection 2020.

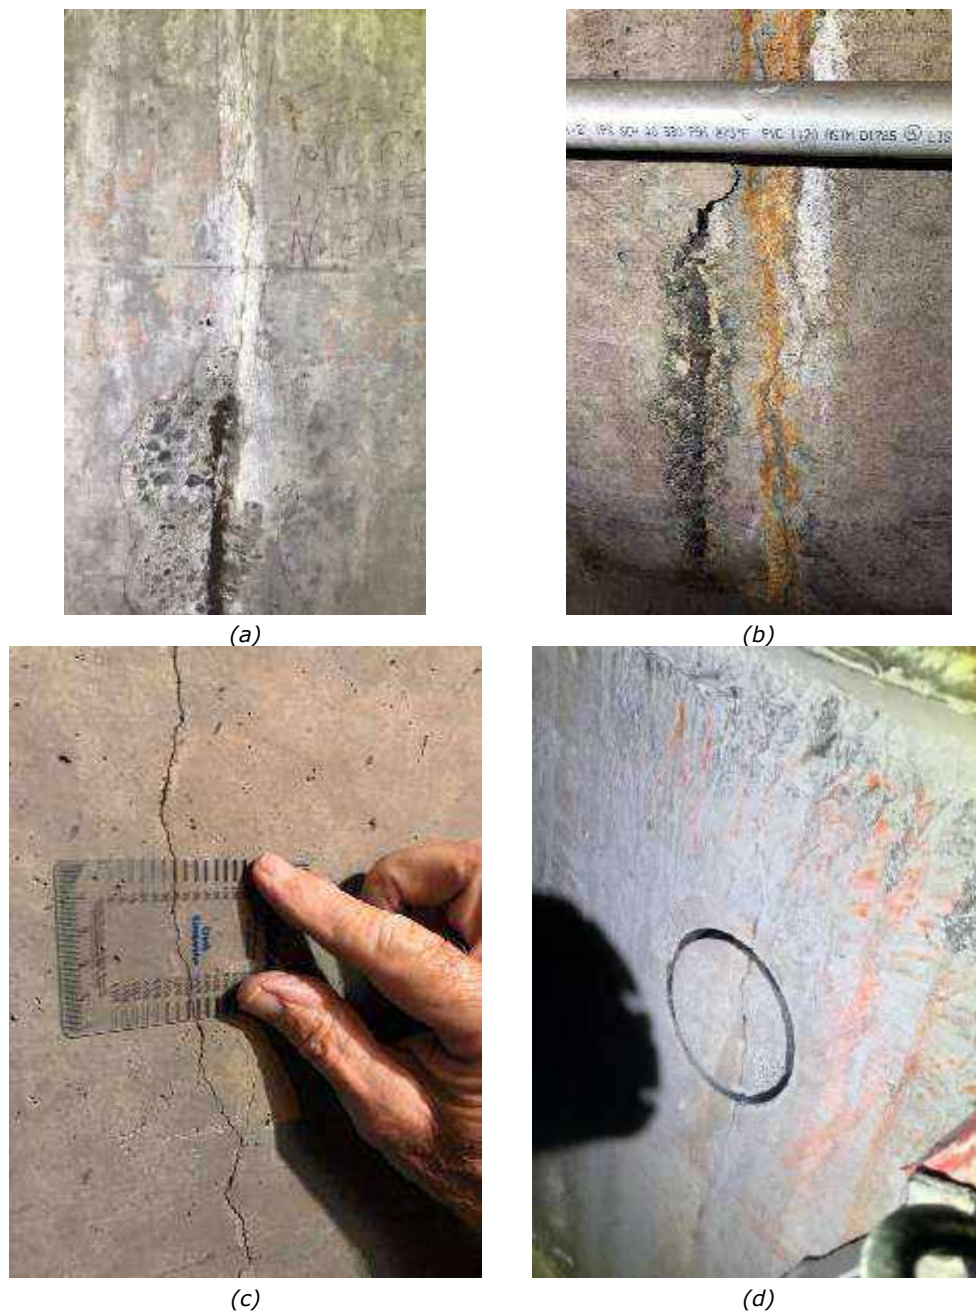
Figure 3-7: Transverse cracks observed in the outer walls of the air duct tubes, including (a) a dry crack with efflorescence and spalling at a location with ~35 mm cover (Downstream Air Duct, Element III, Door 17/18, powder samples collected), (b) a dry crack with efflorescence and corrosion staining (Downstream Air Duct, Element IV, Door 23/34), (c) a dry crack without staining (Downstream Air Duct, Element IV Door 20), (d) a dry crack without staining after core drilling (Upstream Air Duct, Joint II/III, Core JUE-P3-C2 collected, coring slurry seen on concrete surface).

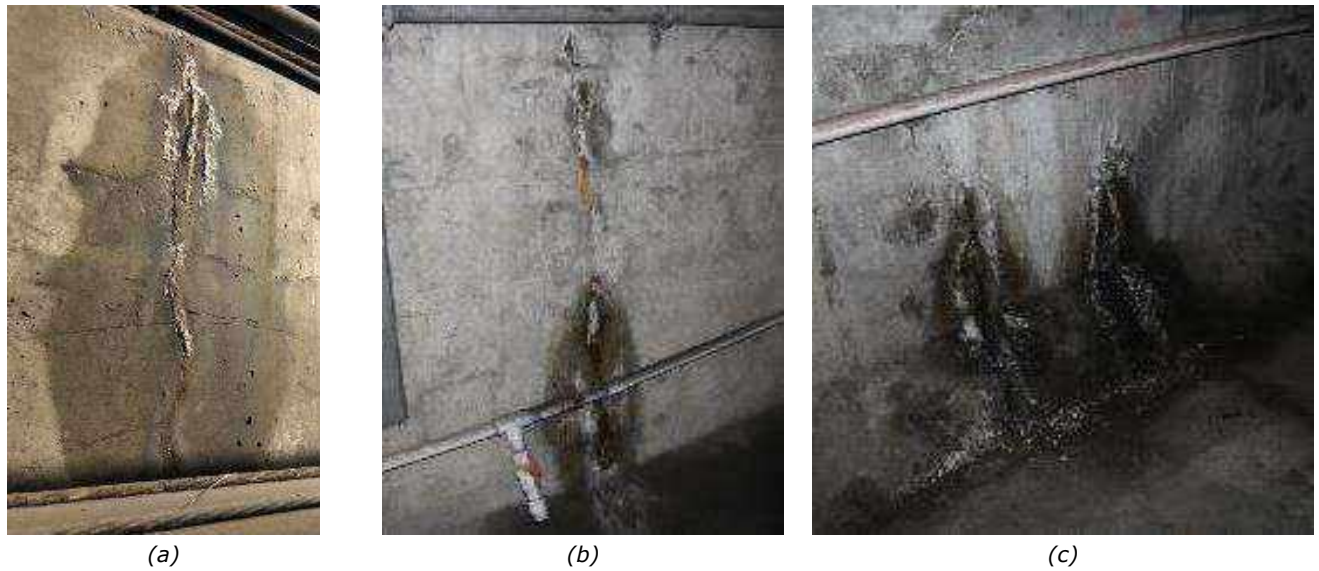
Figure 3-8: Examples of weeping transverse cracks observed at (a) Upstream Air Duct, Element IV, Door 24, (b) Downstream Air Duct, Element V, Door 25, and (c) Downstream Air Duct, Element VI, Door 33.

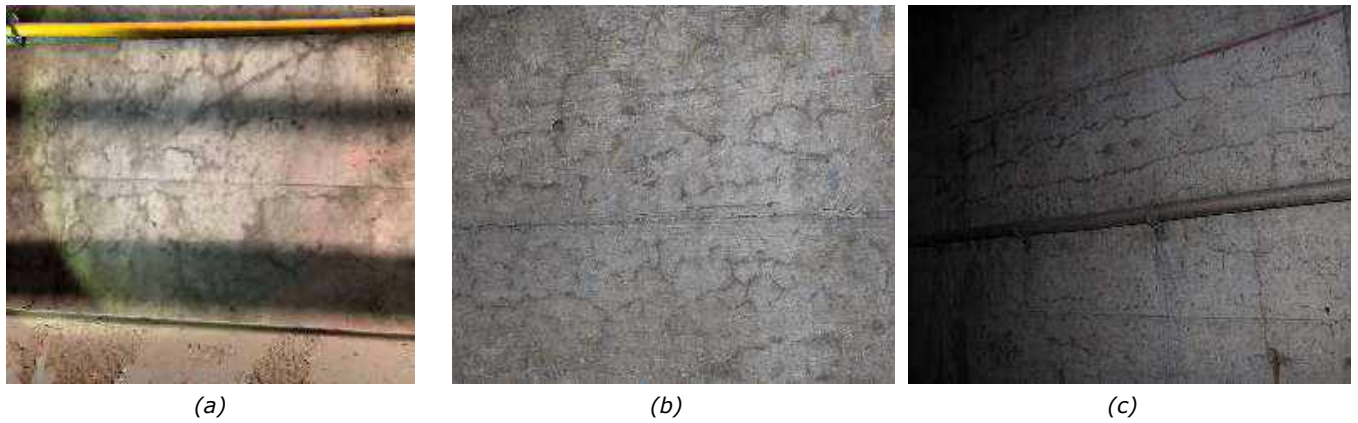
Figure 3-9: Examples of observed map cracking on outer walls of the air duct tube including at (a) Upstream Air Duct, Element IV, Door 24 (core WUE-P4 taken at this location), (b) Downstream Air Duct, Element II, Door 14, and (c) Downstream Air Duct, Element IV, Door 24.

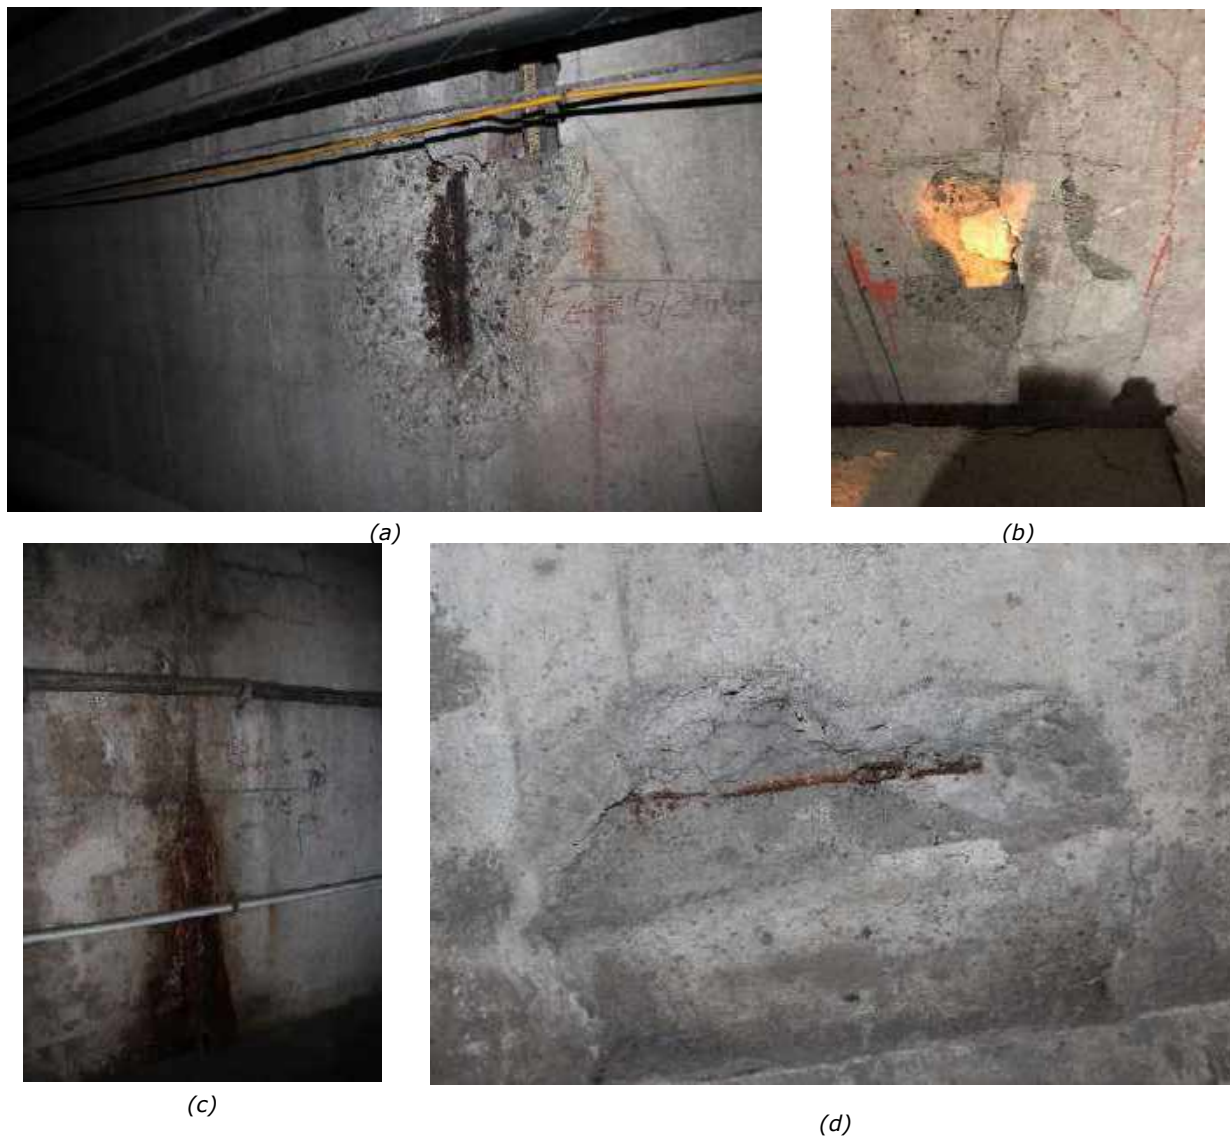
Figure 3-10: Examples of visual signs of reinforcement corrosion including (a) spalling and corrosion staining (Upstream Air Duct, Element IV, Door 22, Outer wall), (b) cracking, delamination and spalling (Downstream Air Duct, Element III, Door 17, Outer wall), (c) corrosion stains on concrete surface (Downstream Air Duct, Element V, Door 29, Outer wall), and (d) spall and exposed reinforcement (Downstream Air Duct, Element II, Intermediate wall).

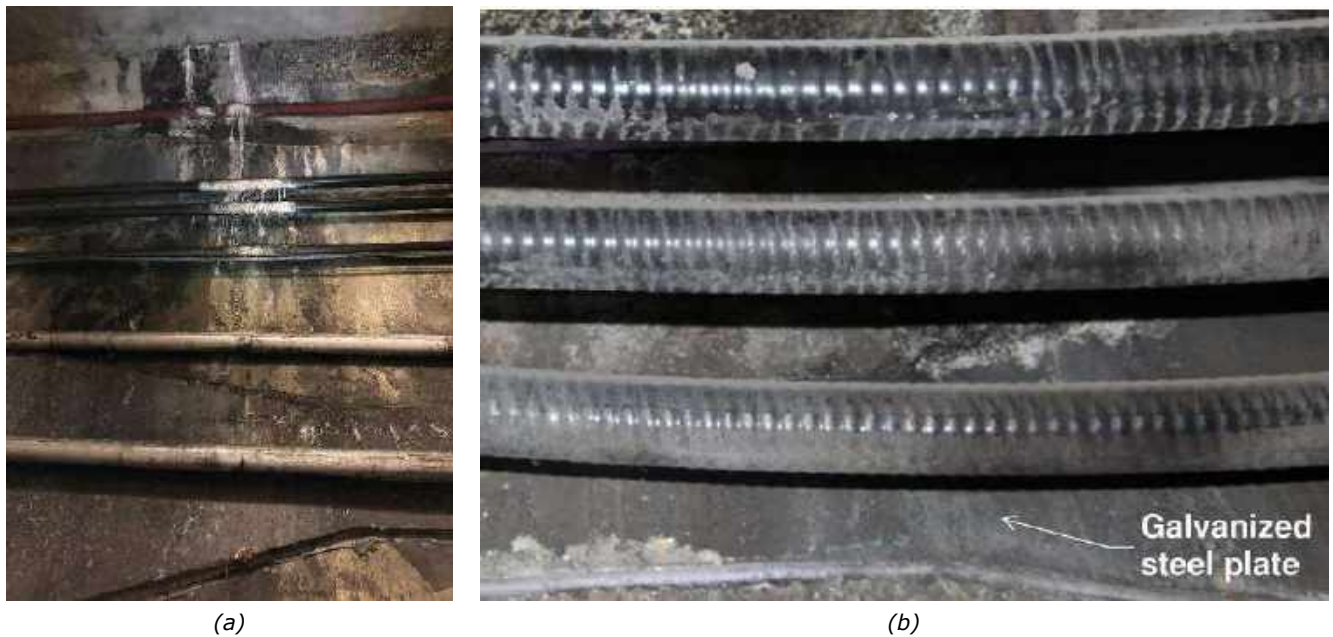
Figure 3-12: Efflorescence in the outer wall joints at (a) Upstream Air Duct, Joint I/II and (b) Downstream Air Duct, Joint IV/V.

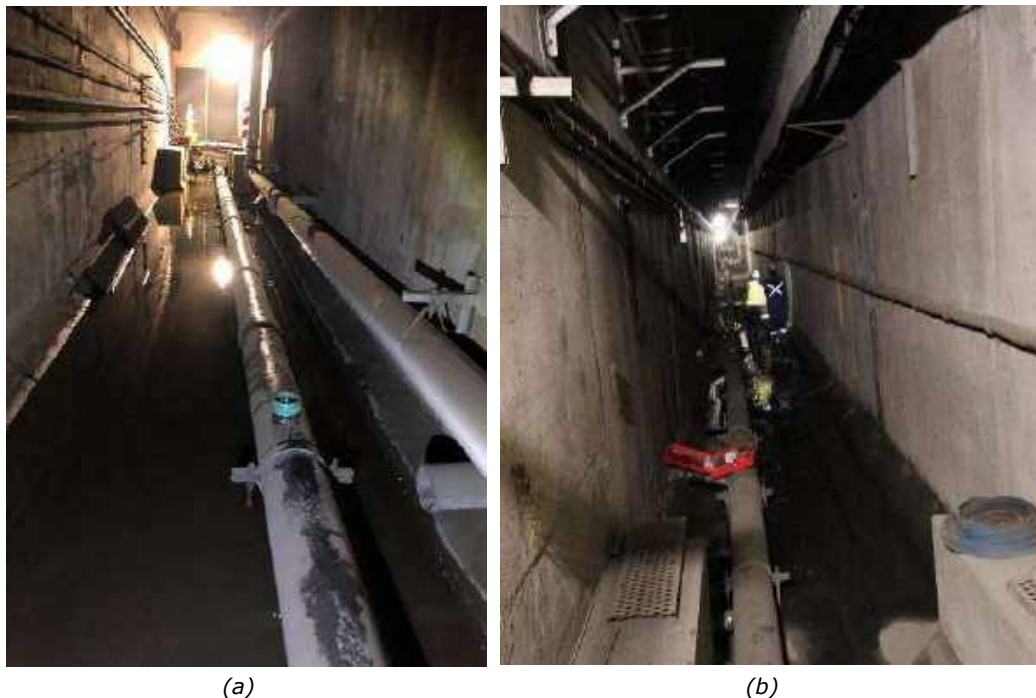
Figure 3-13: Water collection in the air duct tubes: (a) Upstream Air Duct, (b) Downstream Air Duct.

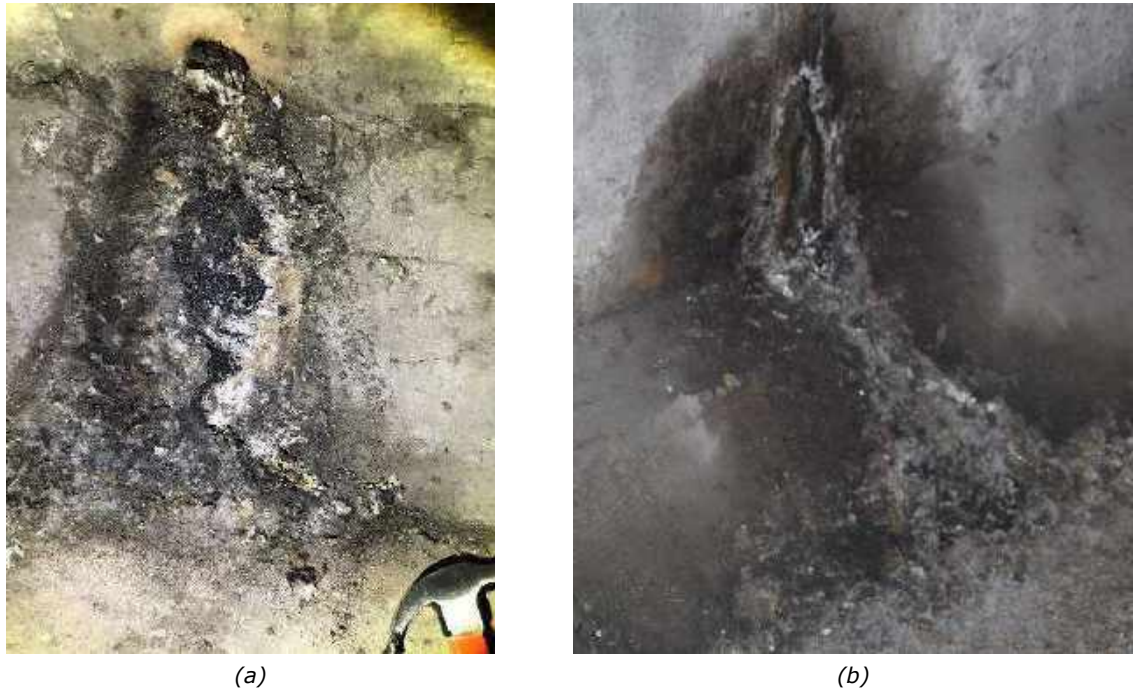
Figure 3-14: Examples of drainpipes in the outer wall of air ducts with leaking water and crystal deposits: (a) Downstream Air Duct, Element 1, Door 6/7, (b) Downstream Air Duct, Element I, Door 5/6.

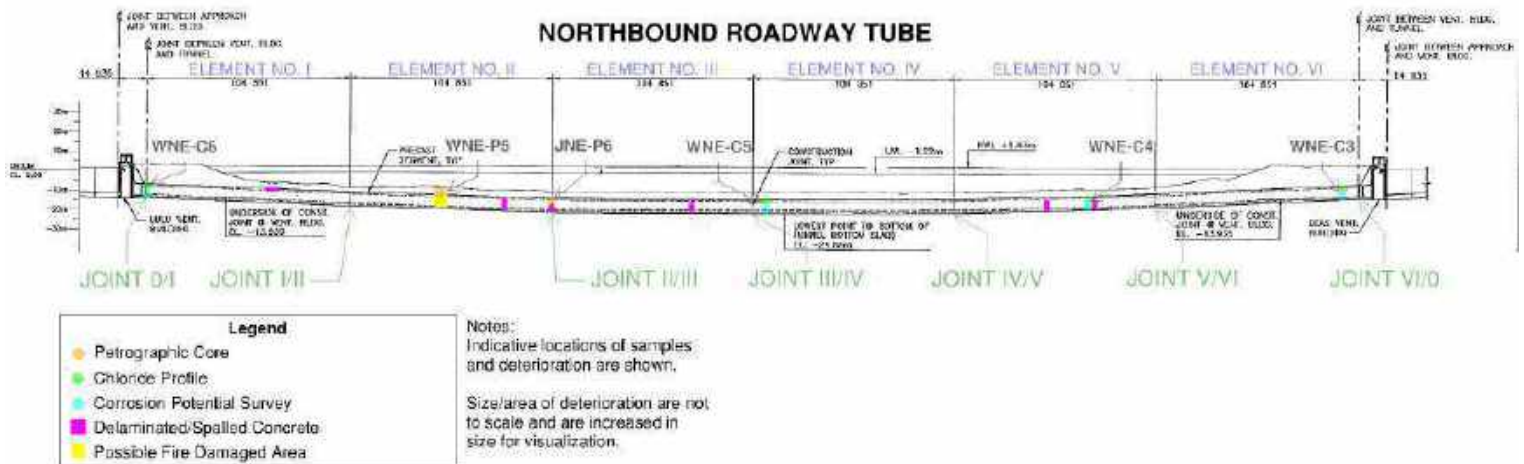
Figure 3-17: Overview of the approximate locations of ongoing deterioration in the Northbound Roadway Tube.

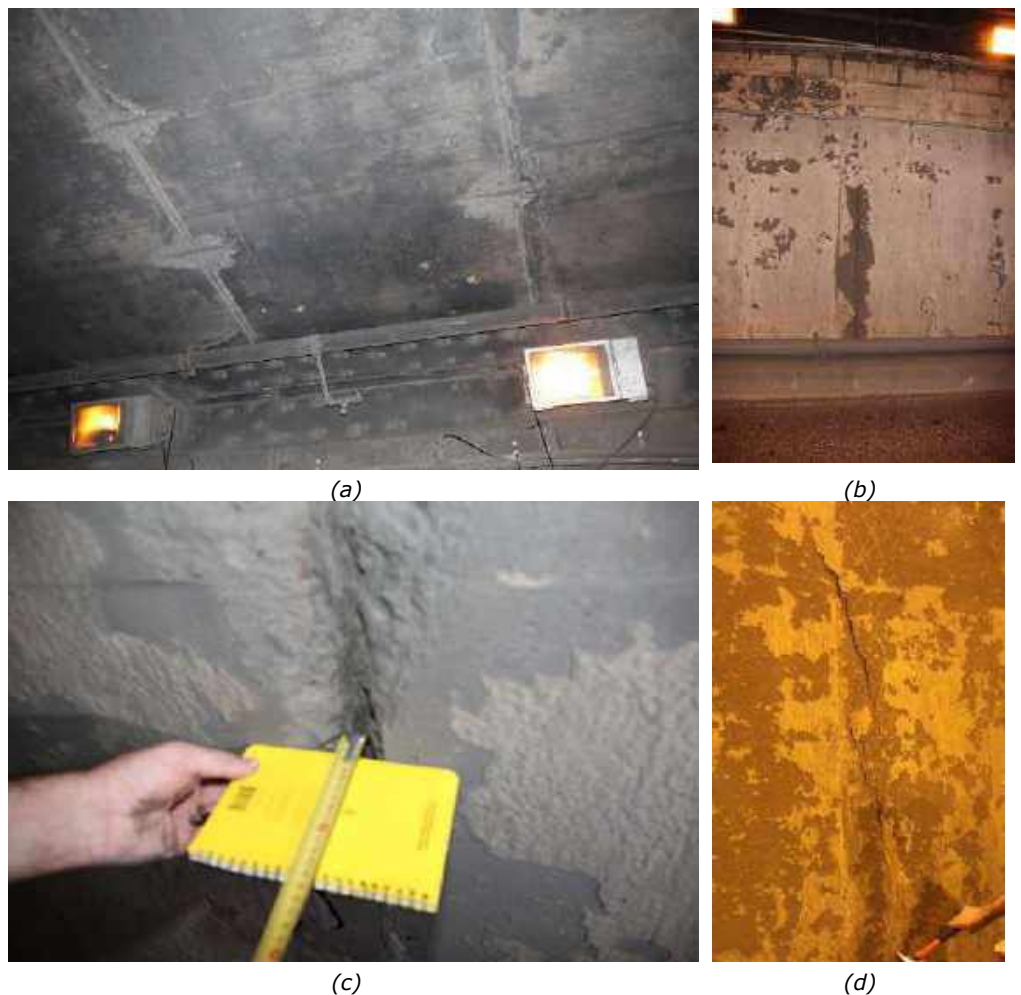
Note that corrosion-induced spalling of concrete was observed from the soffit of the Northbound Roadway Tube, which presents a potential safety concern for the travelling public (the spalling concrete can fall into traffic). This should be addressed, and a Detailed Condition Inspection should be completed to assess whether additional areas of the soffit are delaminated or otherwise at risk for spalling.

Figure 3-18: *Examples of visual signs of reinforcement corrosion including delamination and/or spalling at (a) the soffit in Element I, Door 7/8 showing spalling at the transverse construction joints, (b) the central wall in Element V north of Door 28, (c) the central wall in Element II, South of Door 13, and (d) the central wall in Element III north of Door 18.*

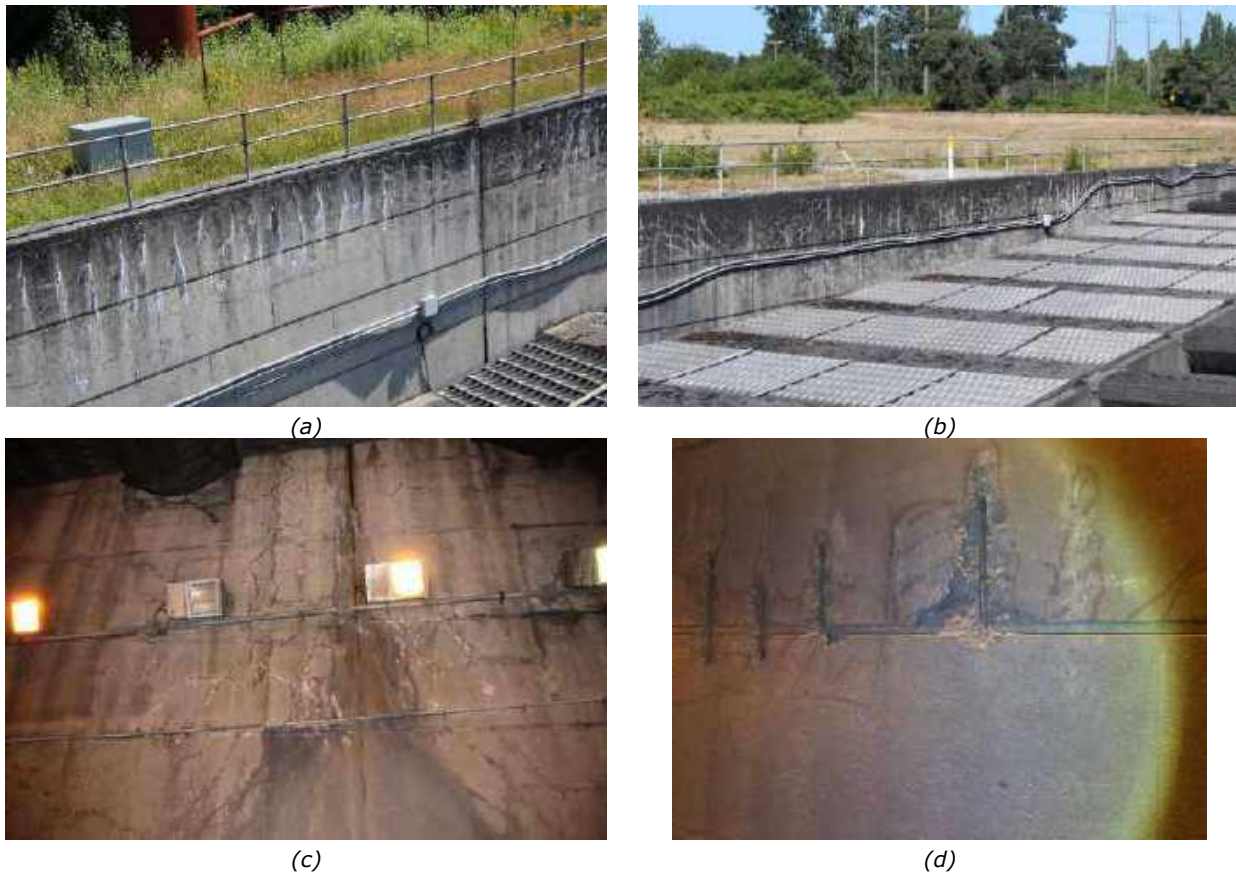
Figure 4-2: Signs of deterioration on the approach ramps include AAR at the upper portions of the retaining walls at (a) the Southern (Deas) Approach Ramp, and (b) Northern (Lulu) Approach Ramp, (c) map cracking with efflorescence and corrosion staining from a joint in the Southern (Deas) Approach Ramp (Element A1, Door 37) and (d) delamination, spalling and corroding reinforcement in the Southern (Deas) Approach Ramp (Element A8, Door 38).

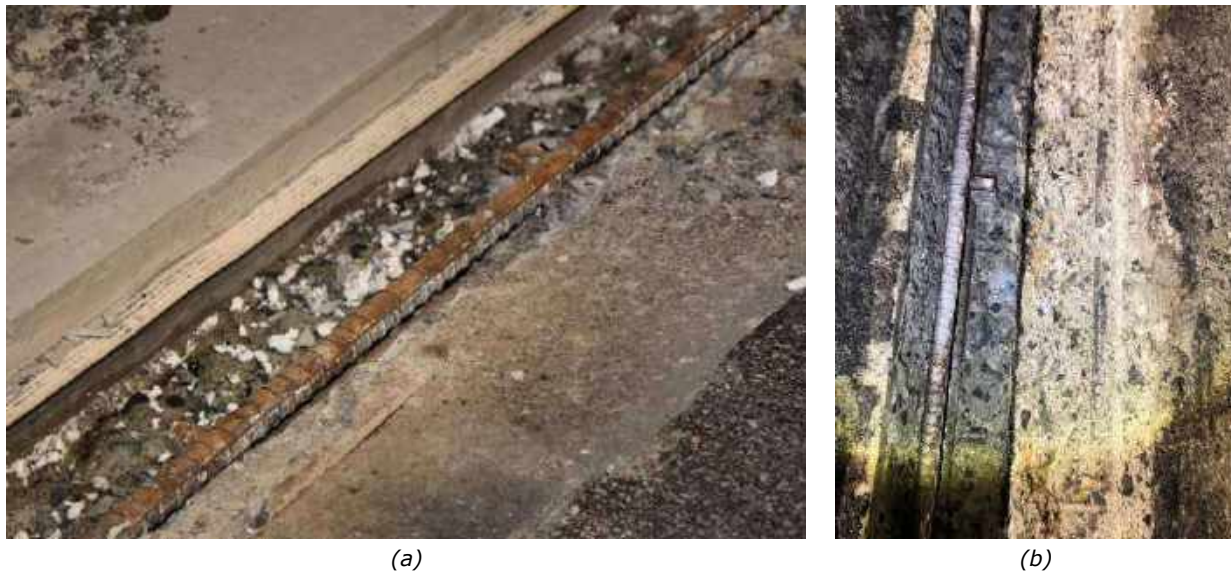
Figure 4-3: Representative examples of reinforcement exposed in the base slab of the Southern Approach Ramp at locations of ongoing rehabilitation of the movement joints.

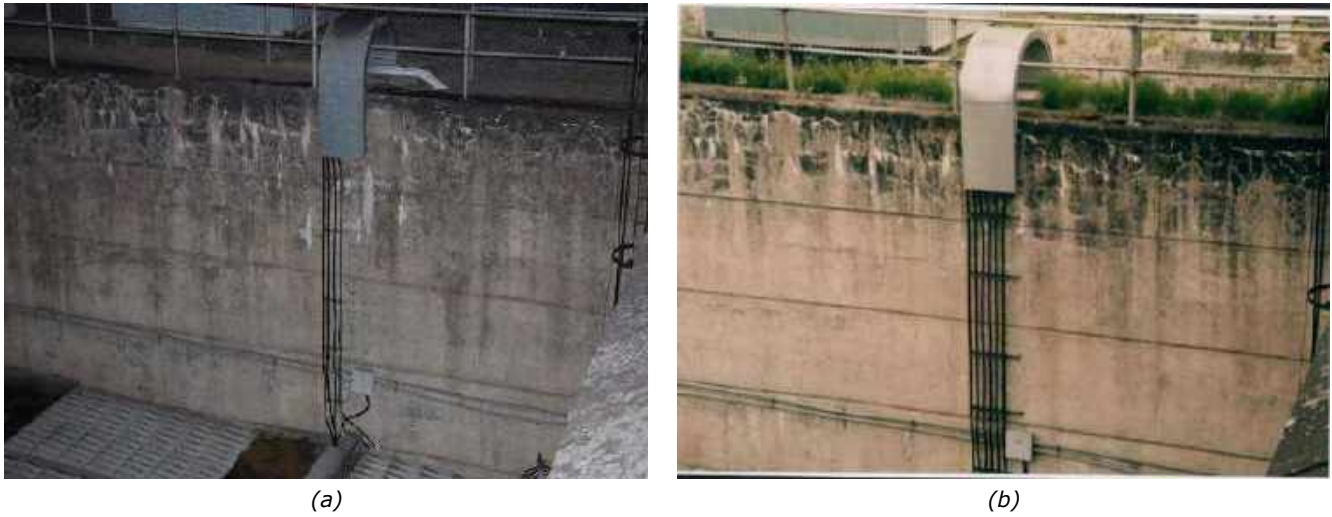
Figure 4-6: Comparison of photo 32 from [1] with (a) showing the condition during the current inspection and (b) the condition during the 2000 inspection – Northern (Lulu) Approach, Element A1, West wall.

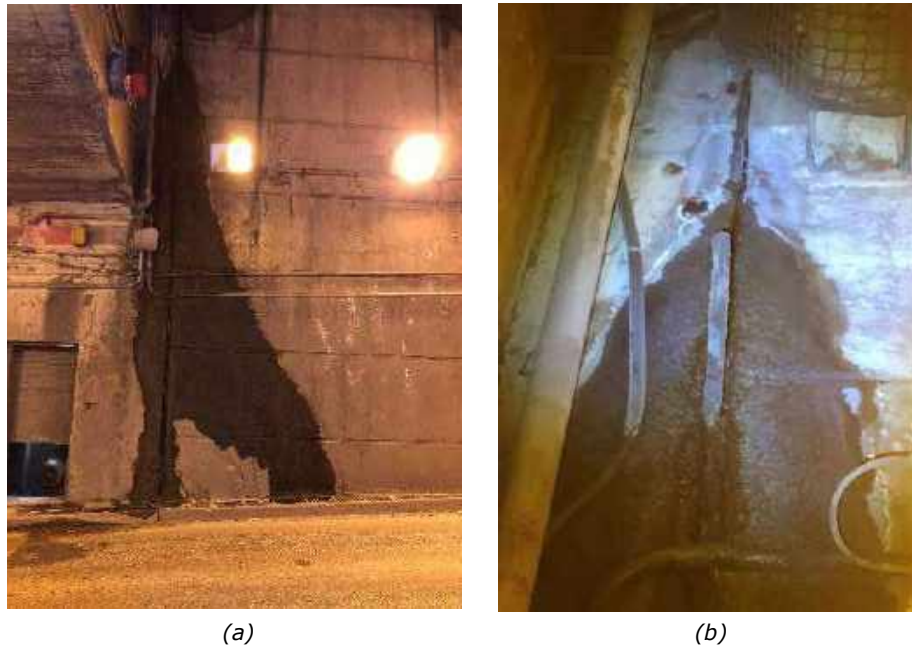
Figure 4-7: Joint leakage at site of damage to the joint seal, with (a) providing an overview and (b) showing the area of joint seal pulled out and broken.

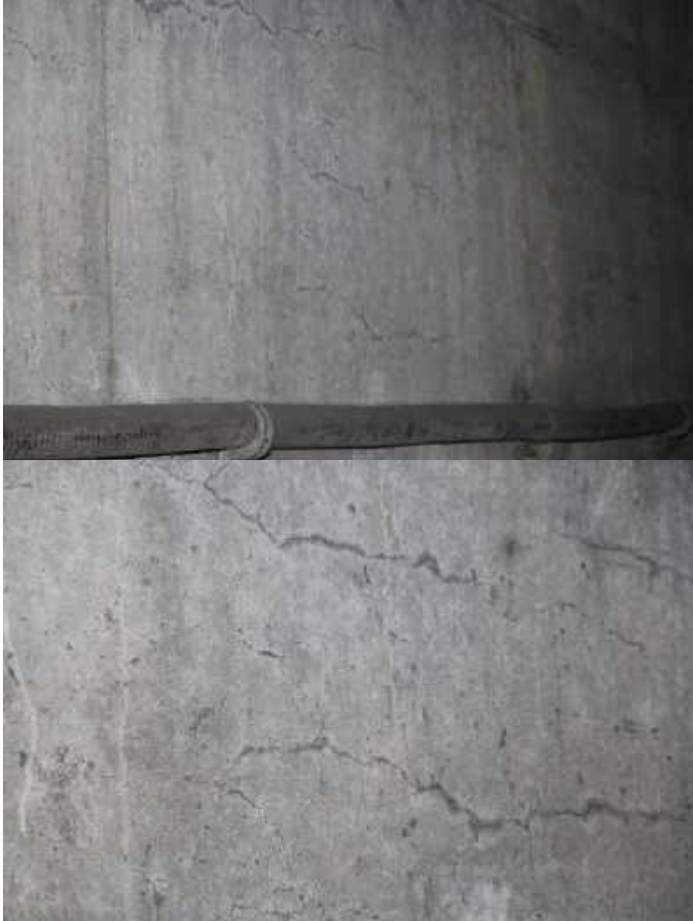
Obs. No.	Location (Area, Element/Joint ID, Wall ID)		Observation Notes	Photos
DS-6	Joint I/II	Outer (West) wall	Sign of delamination

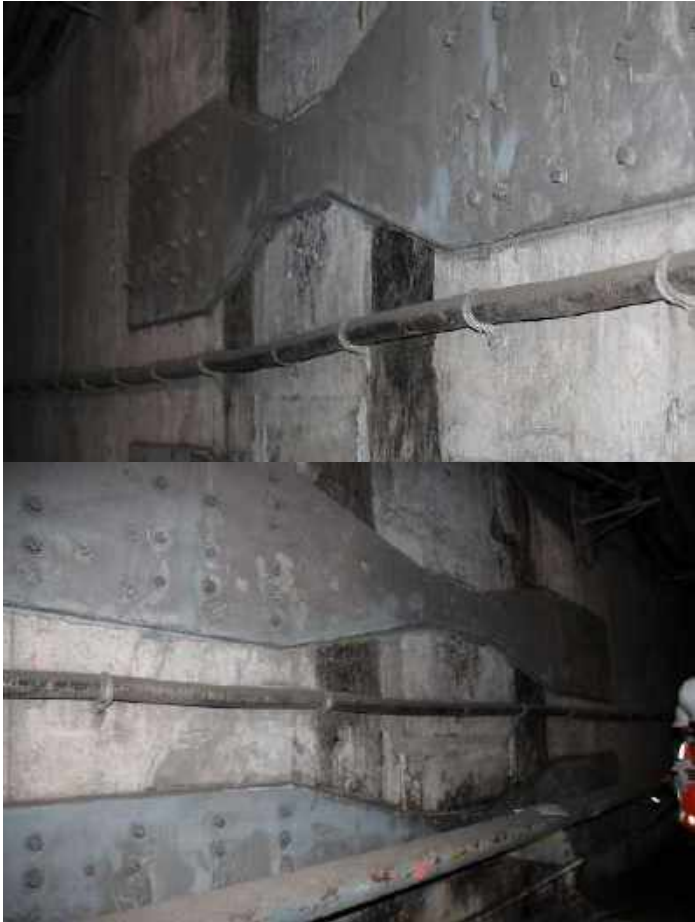
Obs. No.	Location (Area, Element/Joint ID, Wall ID)		Observation Notes	Photos
DS-13	Element III, Door 17	Outer (West) wall	Small area of delamination with large cracks

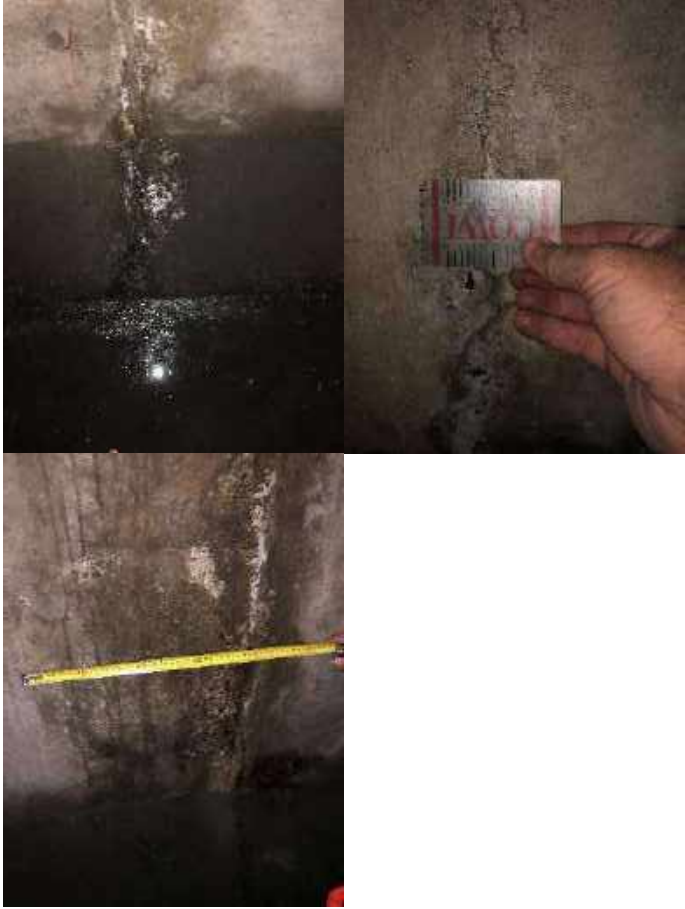
Obs. No.	Location (Area, Element/Joint ID, Wall ID)		Observation Notes	Photos
DS-25	Element IV, Door 23/24	Outer (West) wall	Rust deposit high on west wall. Spot of low cover nearby

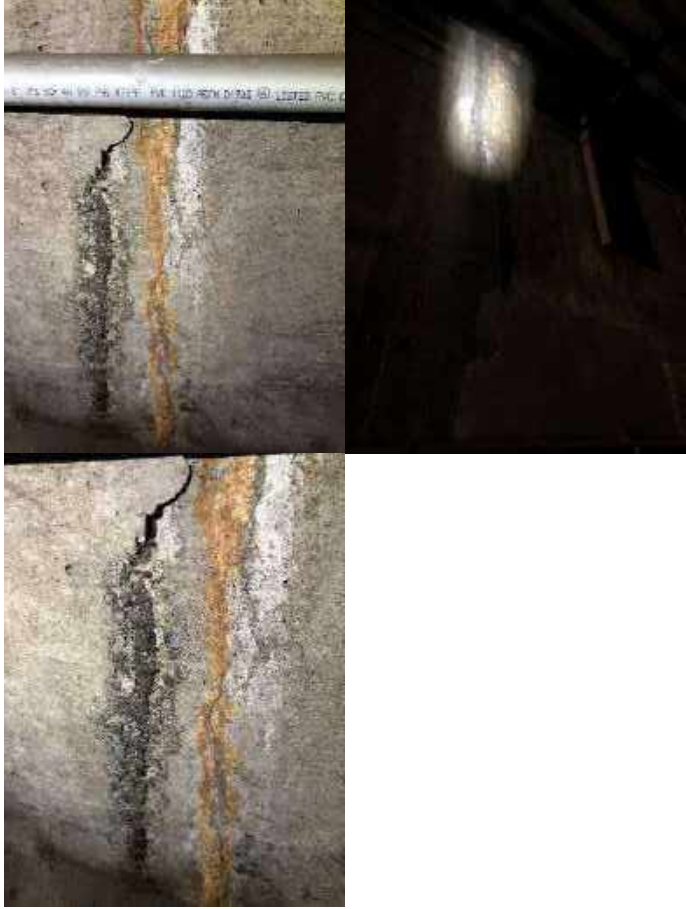
DS-26	Element IV, Door 23/24	Corner of soffit and outer (west) wall	Corrosion staining, dry

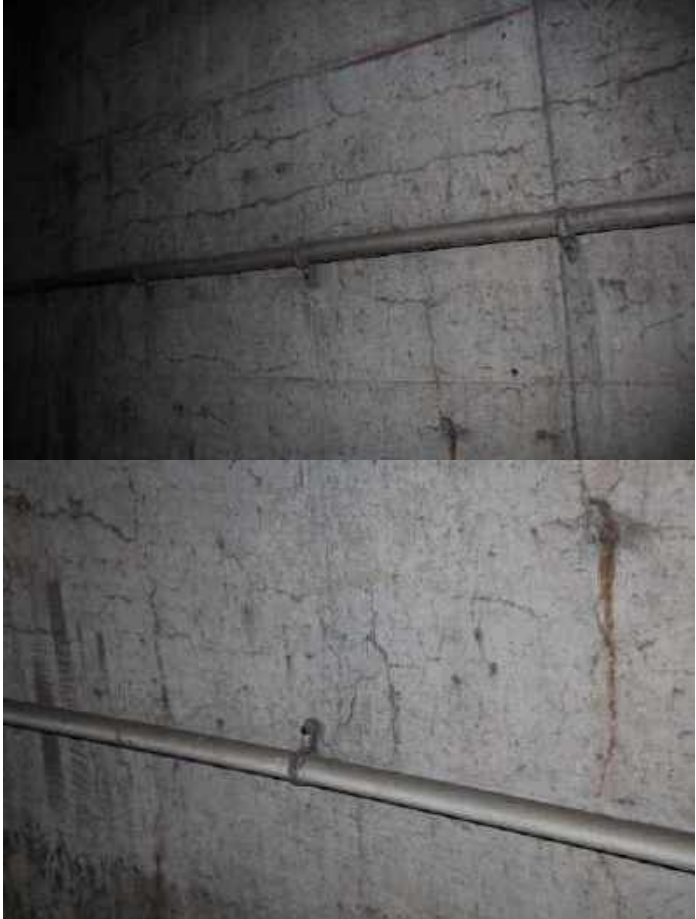
Obs. No.	Location (Area, Element/Joint ID, Wall ID)		Observation Notes	Photos
DS-28	Element IV, Door 24	Outer (West) wall	Small spall

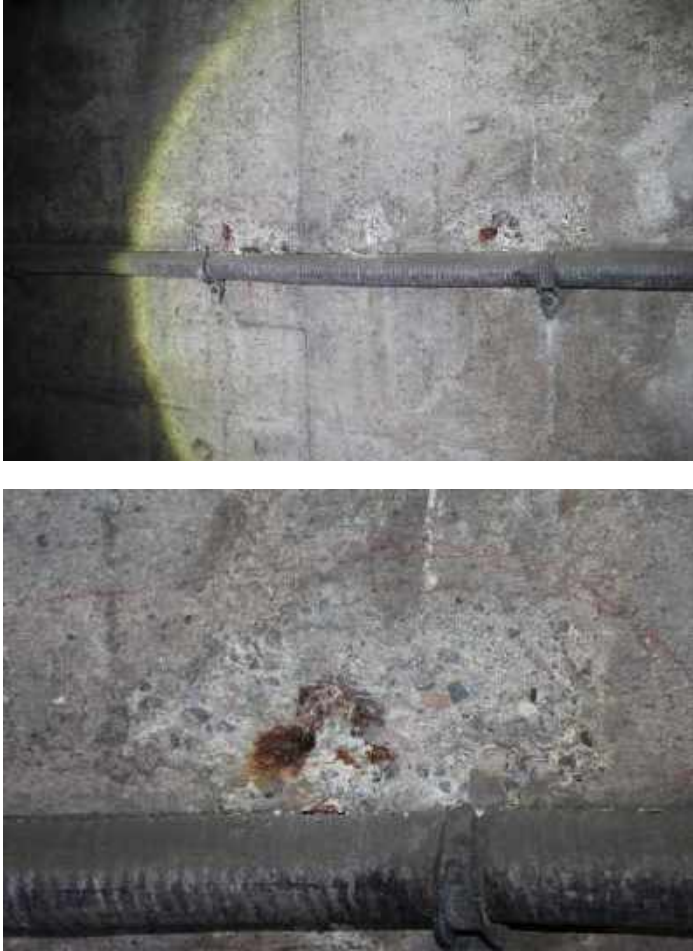
DS-29	Element IV, Door 24, near Joint IV/V	Outer (West) wall	Transverse crack with efflorescence, corrosion staining and weeping near bottom corner of wall.

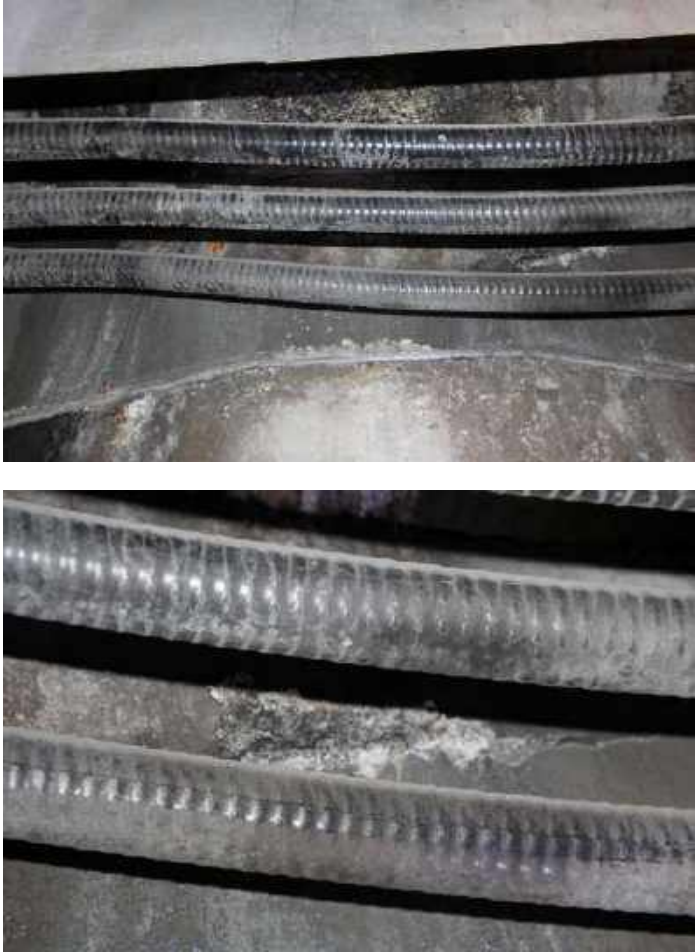
Obs. No.	Location (Area, Element/Joint ID, Wall ID)		Observation Notes	Photos
DS-31	Element V, Door 29	Outer (West) wall	Corrosion staining, spall, exposed rebar

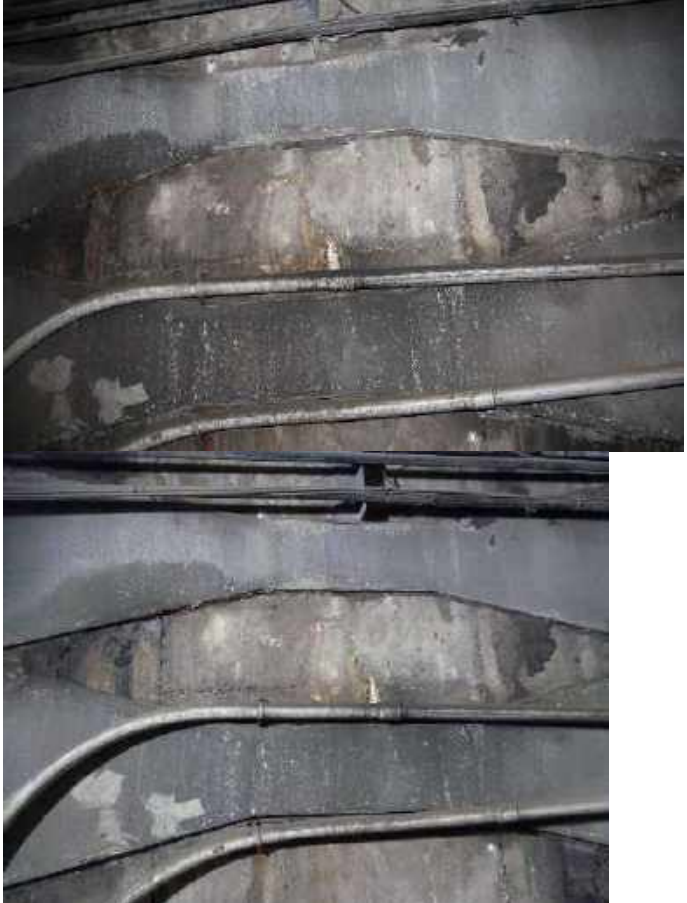
US-8	Element IV, Door 22	Outer (East) wall	Spall and exposed rebar. Possible indication of AAR with rim around coarse aggregates and gel Core WUE-P2 collected here
------	---------------------	-------------------	---

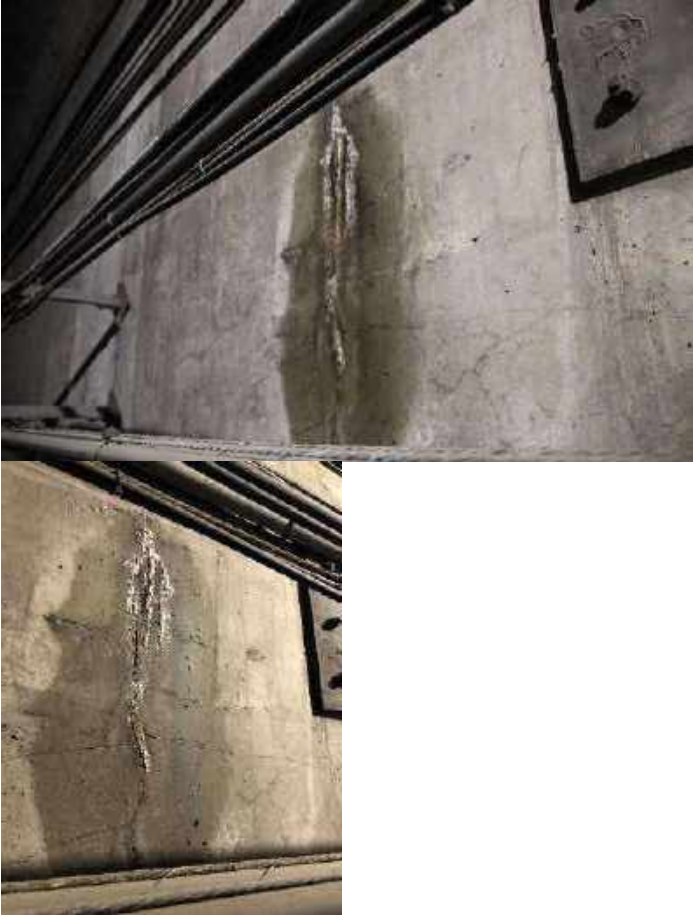
Obs No.	Location (Area, Element/Joint ID, Wall ID)		Observation Notes	Photos
US-11	Element V	Outer (East) wall	Fine cracks

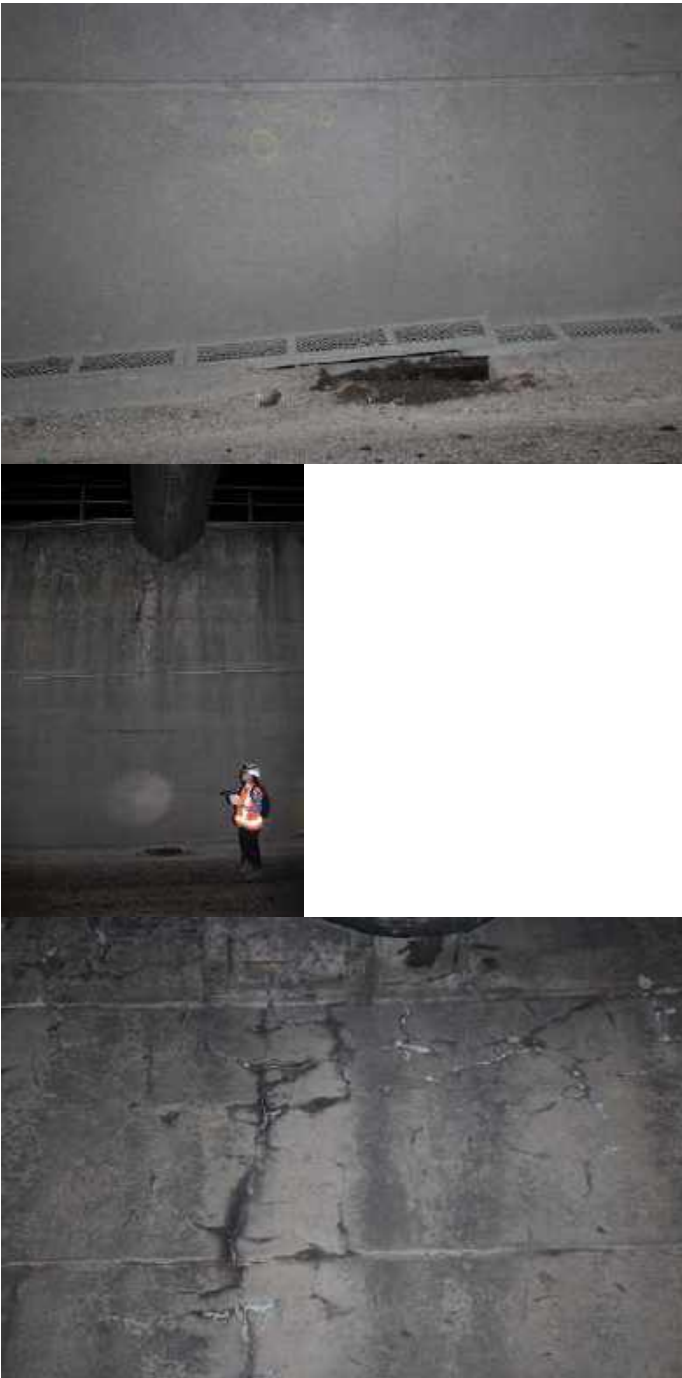
Obs. No.	Location (Area, Element/Joint ID, Wall ID)		Observation Notes	Photos
SA-6	Element A8, Door 38	East wall, roadway level	Delamination and spalling

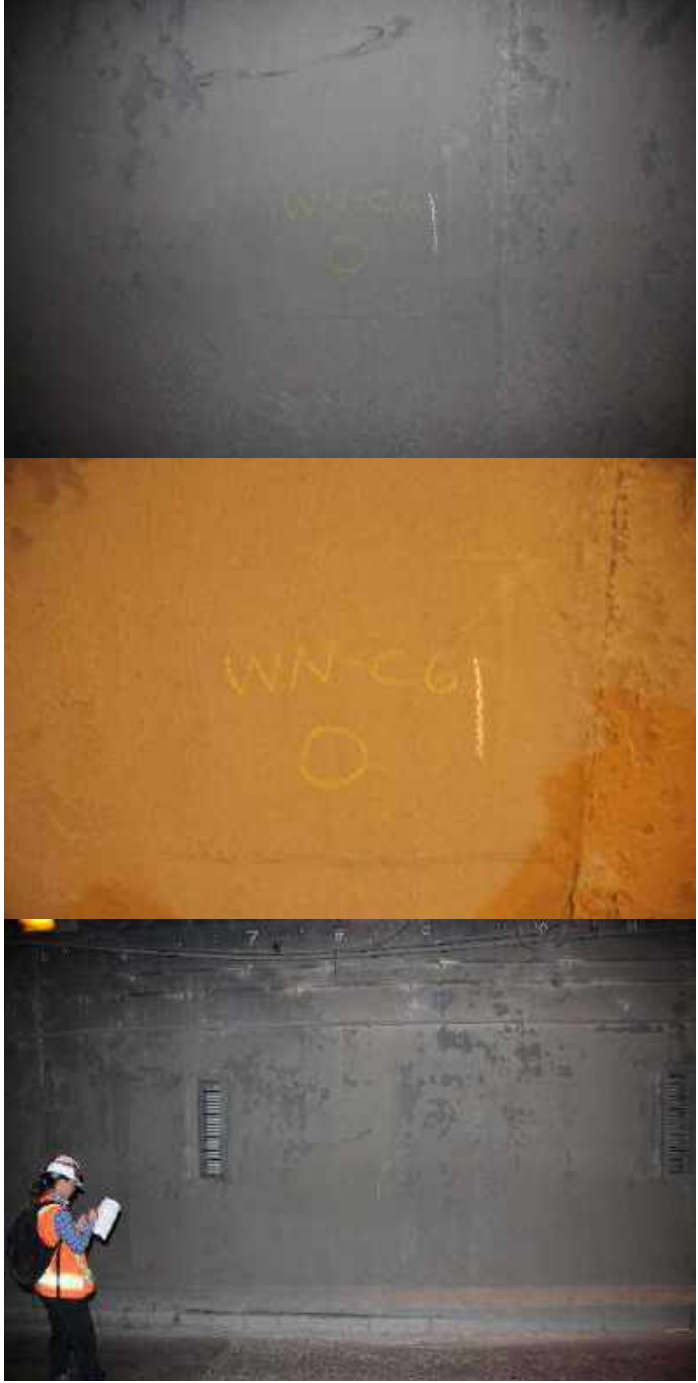
Obs. No.	Location (Element/Joint ID, Wall ID)		Observation Notes	Photos
NB-2	Element I, Door 7/8	Soffit	Spall on ceiling toward east side

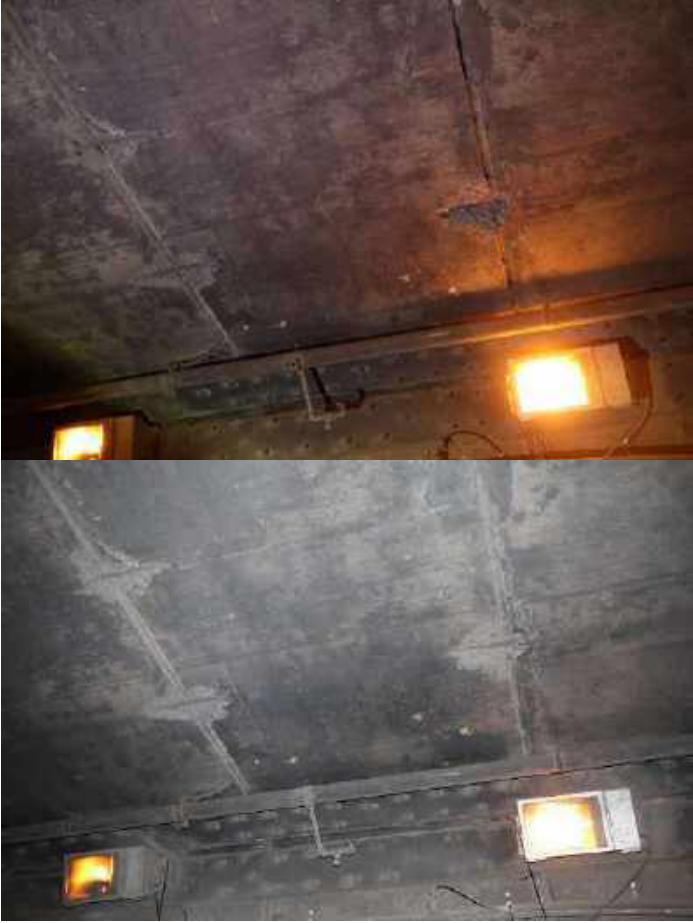
NB-3	Element II, Door 12	East wall	Seemed to be affected by fire in the past Core WNE-P5 location.
