Re: George Massey Crossing Project – Use of Existing Immersed Tube Tunnel

As part of a detailed tunnel condition review undertaken by COWI (George Massey Crossing Assessment – Existing Tunnel Condition Assessment Report, December 11 2020), sampling and testing of the precast concrete tunnel sections and cast-in-place

CONDITION ASSESSMENT REPORT - DRAFT

A127810 GMC-rpt-41-ext-cowi-Condition Assessment-Rev0C-11-Dec-2020

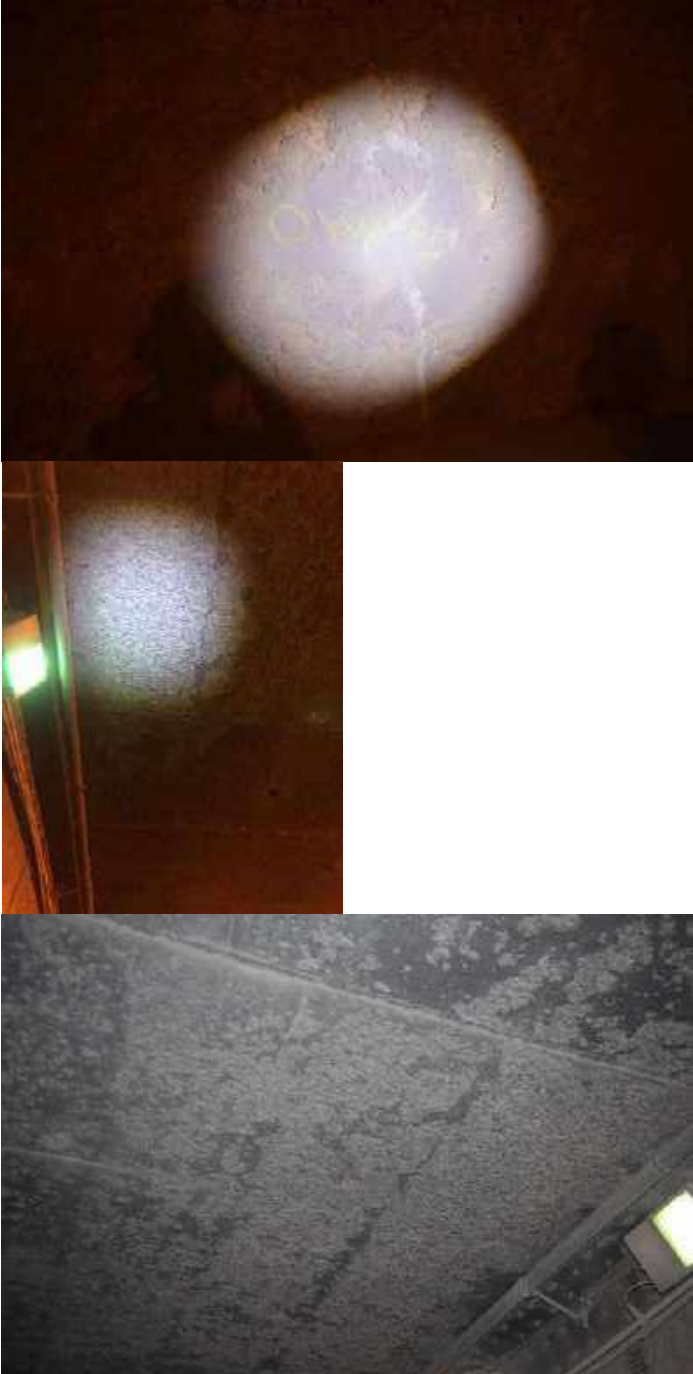
Obs. No.	Location (Element/Joint ID, Wall ID)		Observation Notes	Photos
NB-4	Element II, South of Door 13	West wall	Spall and exposed rebar Low cover, ~30 mm

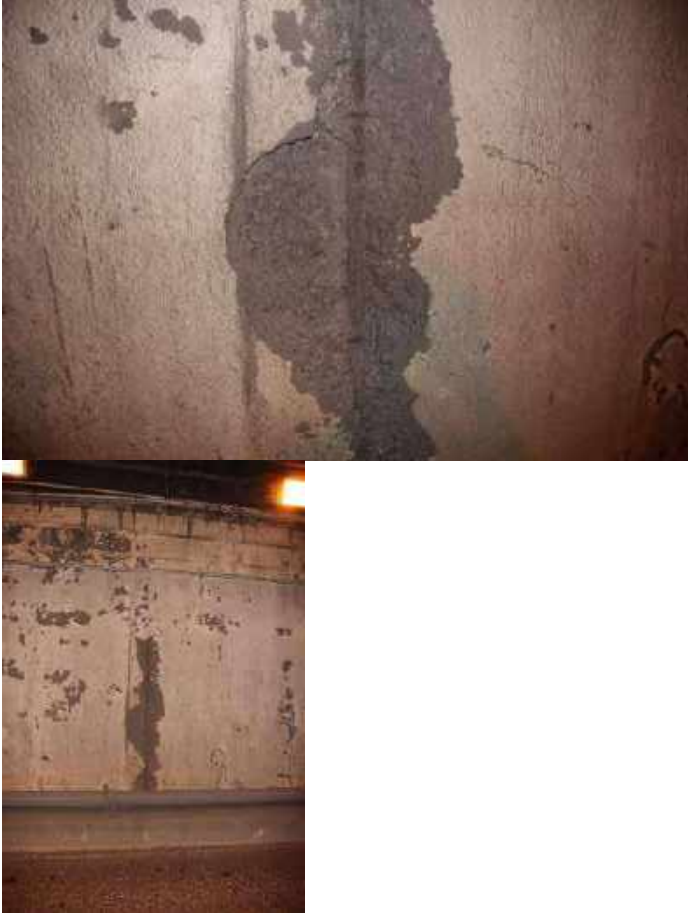
NB-11	Element V, North of Door 28	West wall	Core WNW-C4 location adjacent to spall/exposed vertical rebar.

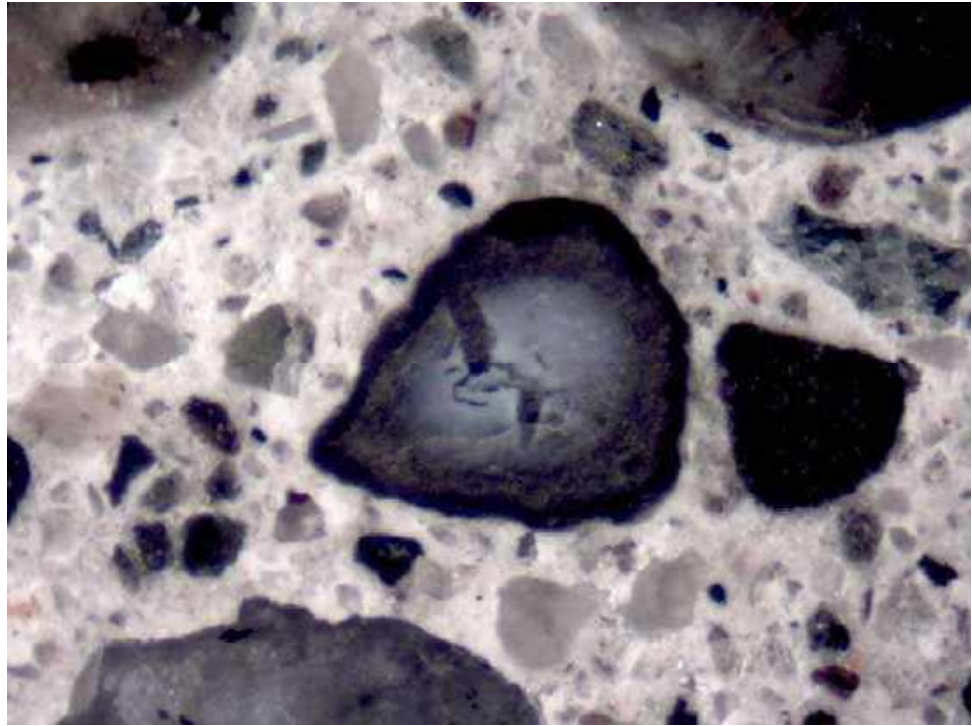
6a. Plane-polarized light view showing a series of cracks in the paste, some associated with ASR gel. Mag. 50x, fov 3 mm.

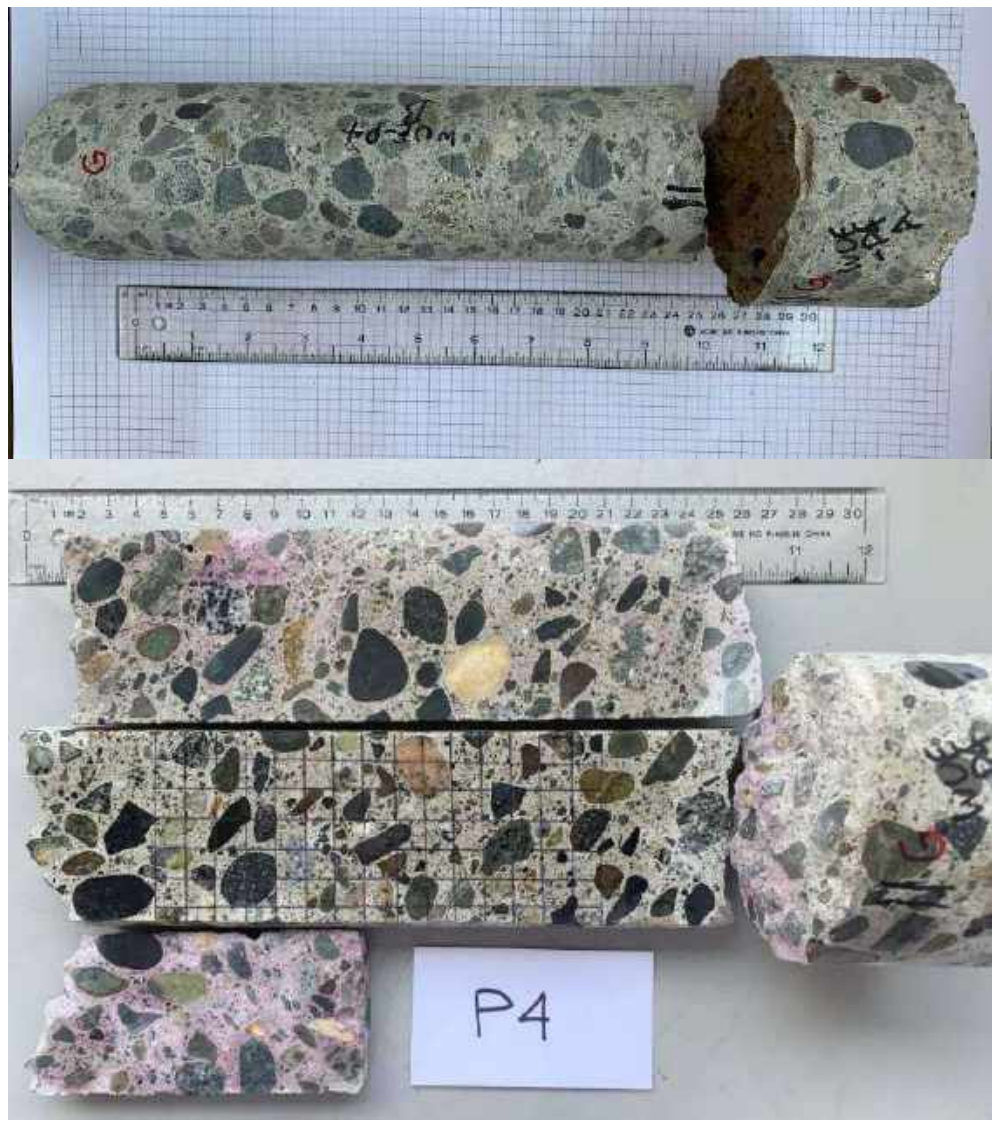
2. Detail of the polished sample, illustrating an ASR-affected volcanic aggregate particle with a reaction rim, an ASR gel-filled crack extending from the aggregate into the adjacent paste (arrows). Magnification 10x, field of view is 8.7 mm across.

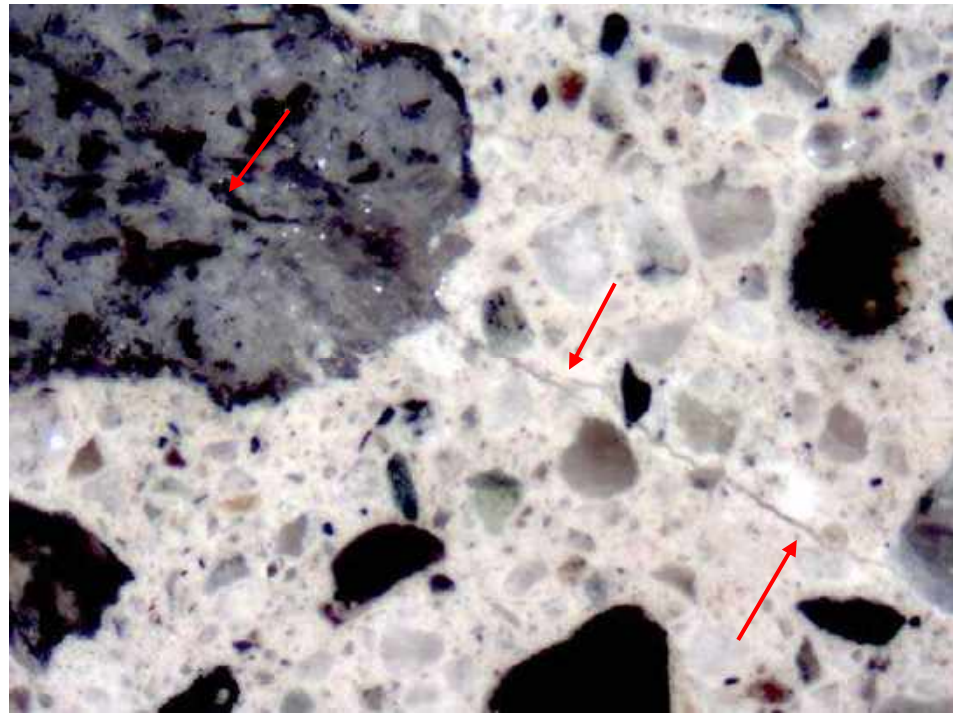
3a. Reaction rim on siliceous aggregate particle at lower right of view; ASR gel-filled void indicated with arrow. Mag. 10x, FOV of view is 8.7 mm.
3b. Debonded aggregate particle, with some ASR gel in resulting crack. Mag. 10x, fov = 8.7 mm.
