Re: George Massey Crossing Project – Use of Existing Immersed Tube Tunnel

As part of a detailed tunnel condition review undertaken by COWI (George Massey Crossing Assessment – Existing Tunnel Condition Assessment Report, December 11 2020), sampling and testing of the precast concrete tunnel sections and cast-in-place

CONDITION ASSESSMENT REPORT - DRAFT

A127810 GMC-rpt-41-ext-cowi-Condition Assessment-Rev0C-11-Dec-2020

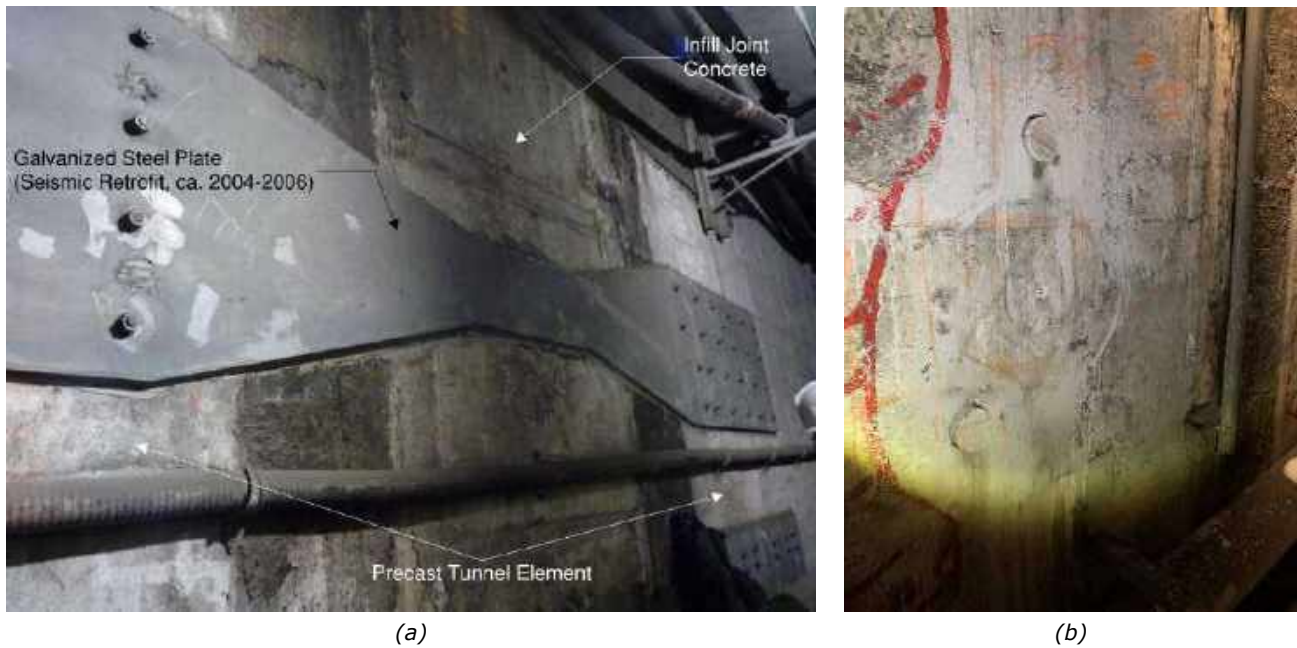
Figure 3-11 shows a typical infill joint. Galvanized steel plates located at the joints in the outer walls were observed to be free from corrosion.

Figure 3-11: Joints between individual immersed tunnel elements as seen in the air duct tubes including at (a) the outer wall (Downstream Air Duct, Joint II/III, Outer wall) and (b) the intermediate wall (Upstream Air Duct, Joint II/III, Intermediate wall).

Typically, the intermediate wall joint concrete was intact; however, the infill concrete at Joint II/III shown in Figure 3-11(b) was found to have delamination in

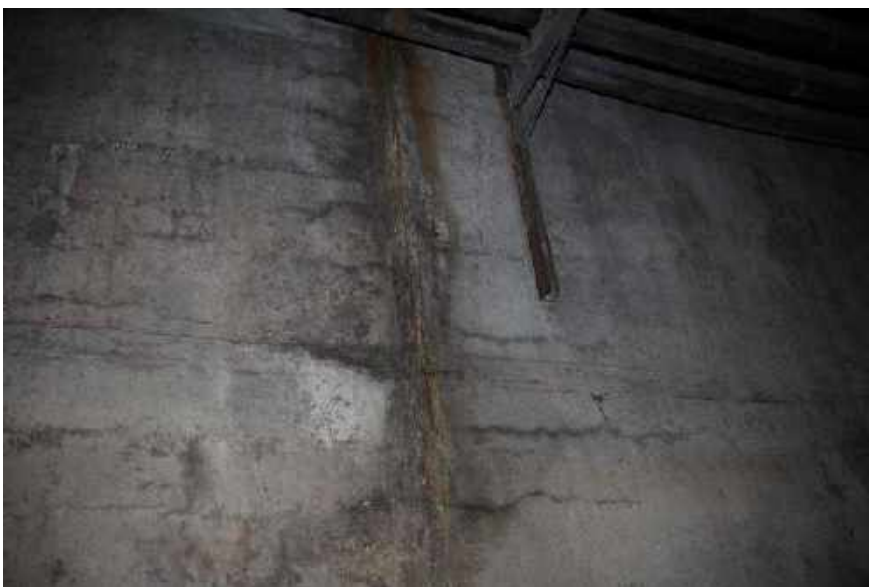
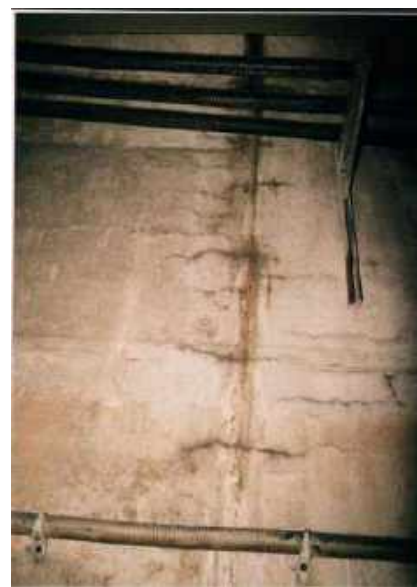
Comparative photographs were taken from similar areas of photographs included in the 2000/2001 inspection [1]. Figure 3-15 shows that a series of horizontal cracks in the outer wall of the Downstream Air Duct in Element V near Door 29 have undergone limited change from 2000 to 2020; however, additional signs of corrosion staining near the vertical joint are observed.

Figure 3-15: Comparison photos from area on outer wall in Downstream Air Duct, Element V, Door 29 with (a) showing the condition during the current inspection and (b) the condition during the 2000 inspection [1].

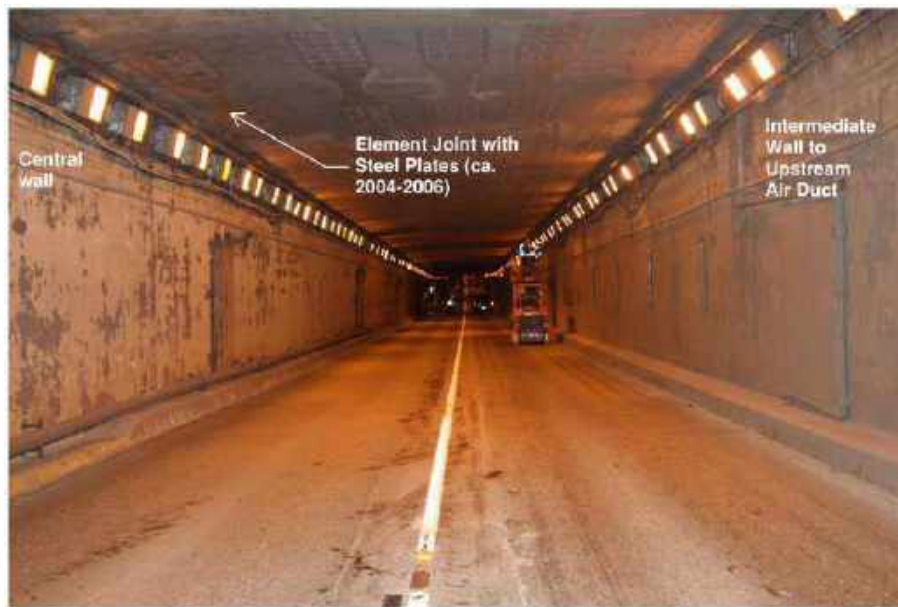
Figure 3-16 illustrates the typical condition of the soffit, central wall between the Northbound and Southbound Roadway Tubes, wall between the Northbound Roadway and Upstream Air Duct tubes, and the roadway surface of the Northbound Roadway Tube. A yellowish surface coating or paint was present on both the central and intermediate wall, which is partially peeling/chipping and the walls and emergency doors were covered by a built-up layer of soot/dirt (both not present in the air duct tubes) that hindered the visibility of cracks and other indication of deterioration.

Figure 3-16: Overview of the Northbound Roadway Tube at Joint V/VI, looking north.

Figure 3-16 includes a typical infill joint as observed in the Northbound Roadway Tunnel. Galvanized steel plates were located at the soffit of the top slab and were observed to be free from corrosion on visible surfaces. Leaks or weeps were not observed at infill joints and no signs of past leakage were noted.

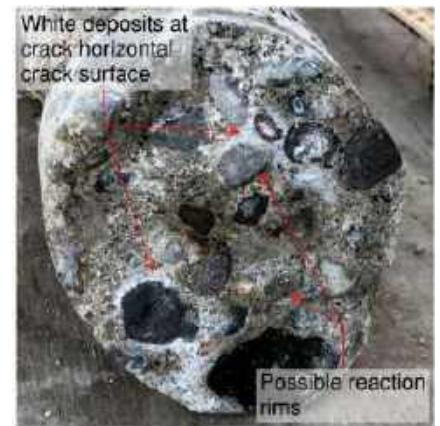
Core NAE-P7, collected from the same location in the Northern (Lulu) Approach as the core "A5" reported in [1], was found to contain numerous ASR-related features through visual inspection and petrographic analysis. Figure 4-4 shows core NAE-P7 with signs of AAR observed including white gel deposits on horizontal cracks encountered by the core and reaction rims around aggregates. Petrographic analysis of the core confirms the presence of ASR gel filling air void, cracks in aggregate and paste, and at the interface between the two. It is noted that the extensive cracking observed along the top of the retaining walls (see Figure 4-2) may not be exclusively caused by ASR and freeze-thaw cycling of the non-air-entrained concrete is probably a major contributing factor.

Figure 4-4 Surface of a horizontal crack in Core NAE-P7 from Northern (Lulu) Approach Ramp

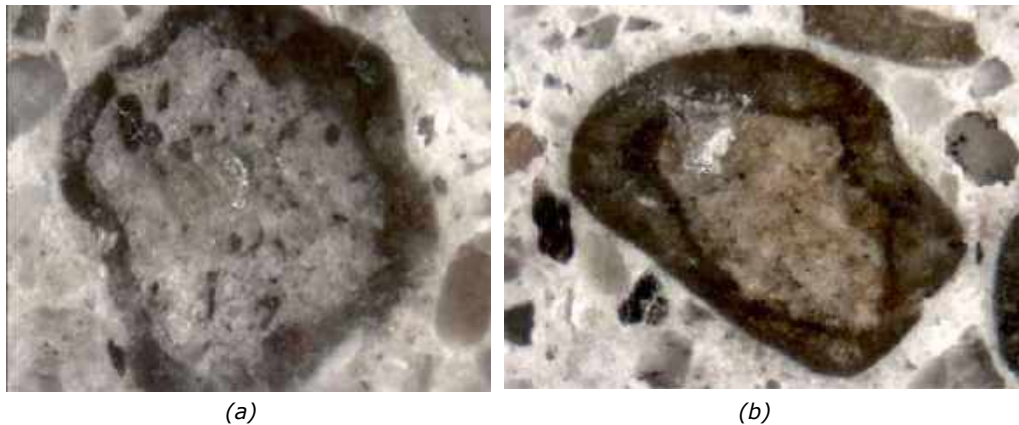
Core SAE-C8, collected near the roadway level of the Southern (Deas) Approach, was taken as an example of the approach ramp concrete without outward signs of ASR induced deterioration or other visible cracking. Petrographic analysis reports similar signs of ASR are observed throughout the sample. A further observation of interest from this core is shown in Figure 4-5. At two locations, ASR gel was found to have formed on the surface of the sample between polishing of the surface (completed on a Friday) and determination of the damage rating index (completed on the following Tuesday). This observation may indicate ASR is still active in this core.

Figure 4-5: Photos showing ASR gel that formed on aggregates with reaction rims in the laboratory subsequent surface polishing of the surface: (a) 38x mag., field of view approx. 3 mm, (b) 25x mag., field of view approx. 4 mm.

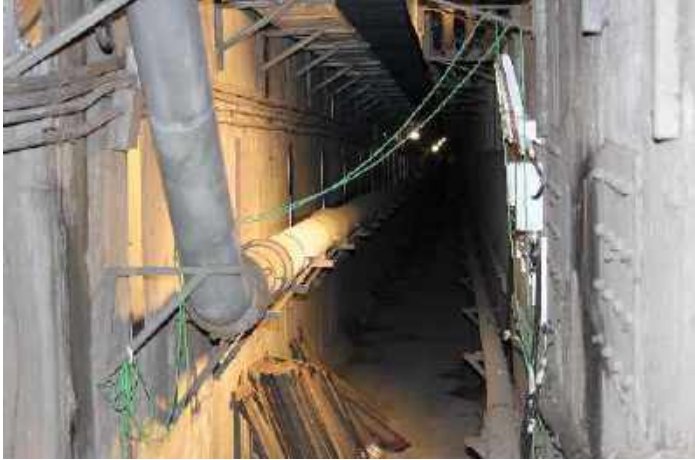
Obs. No.	Location (Area, Element/Joint ID, Wall ID)		Observation Notes	Photos
DS-1	Element I, Door 5	Overview	North end of downstream airduct, looking south

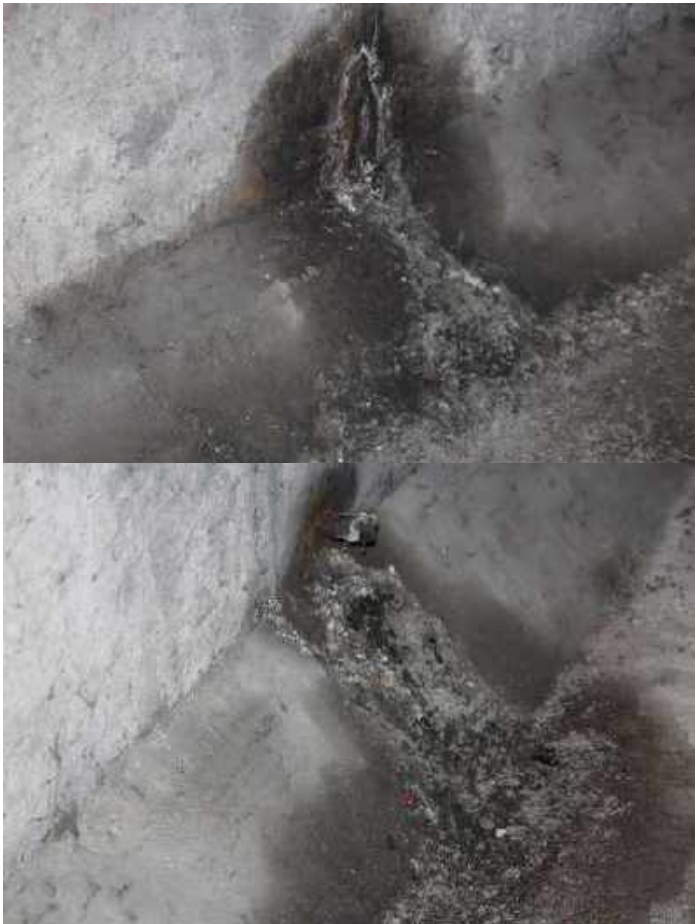
DS-2	Element I, Door 5/6	Outer (West) Wall	Similar location as in photo #11 of 2000 inspection. Moisture and salt crystallization at bottom of the wall, adjacent to a pipe protruding from outer wall

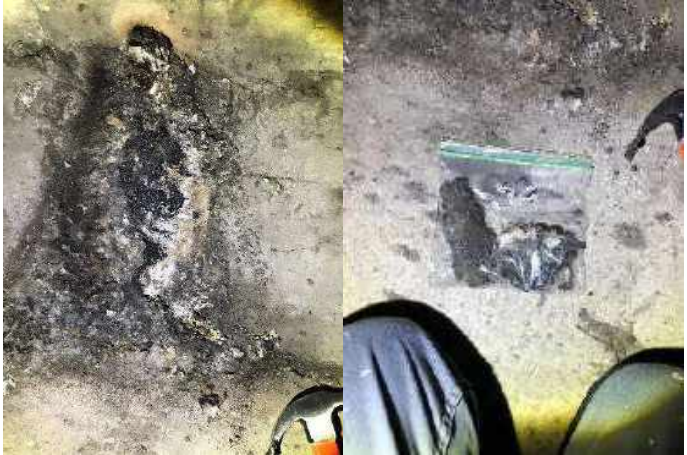
Obs. No.	Location (Area, Element/Joint ID, Wall ID)		Observation Notes	Photos
DS-3	Element I, Door 6/7	Outer (West) wall	Similar location as in photo #11 of 2000 inspection. Pipe protruding from outer wall. Moisture and crystalline deposits. Sample taken (S3)

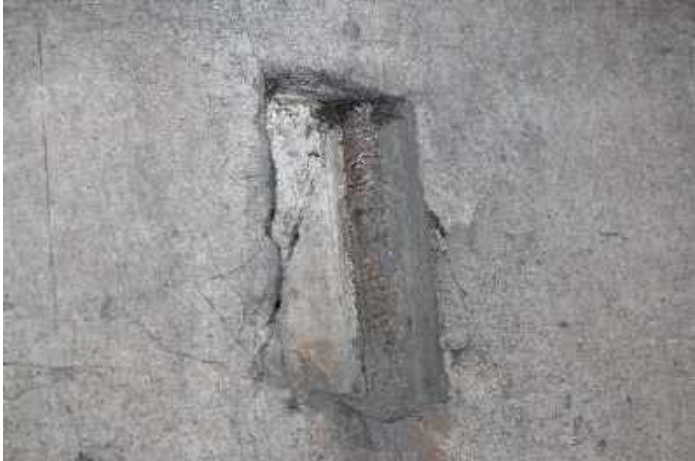
DS-4	Element I	Inner (East) wall	Similar location as photos 5 and 6 in 2000 inspection. Exposed rebar but not concerning.

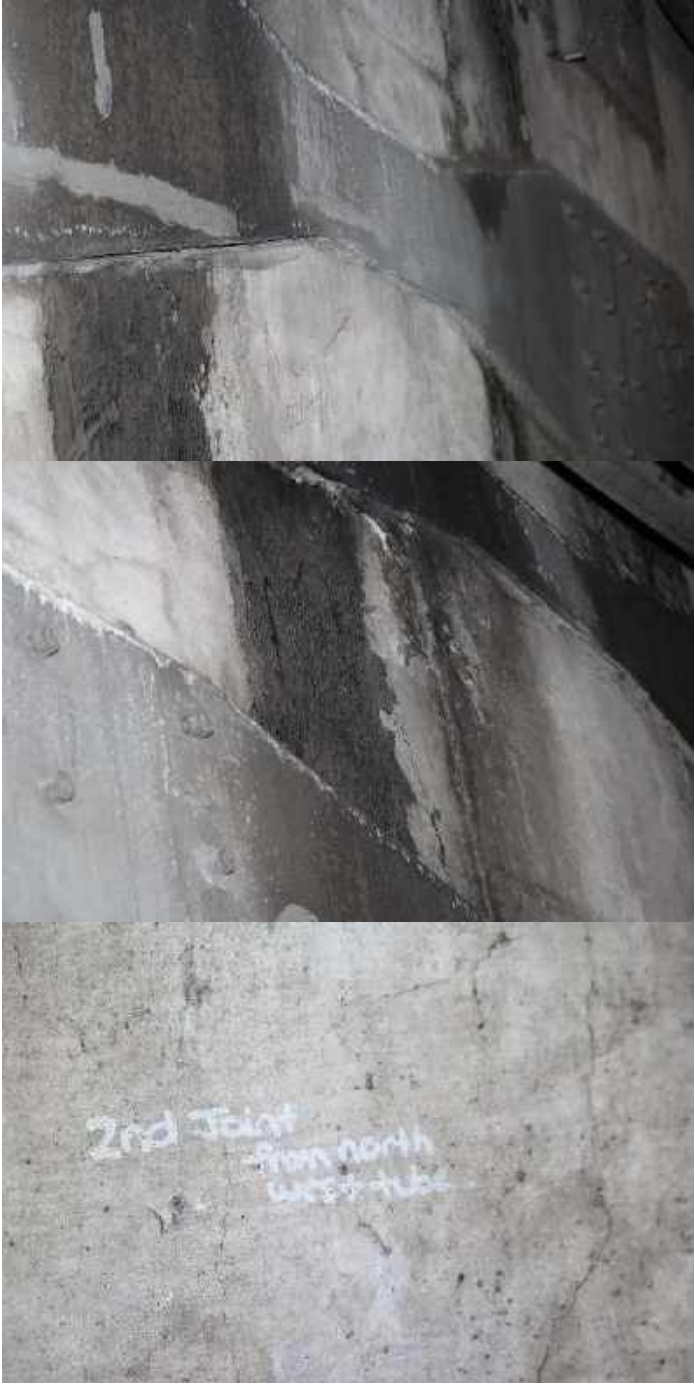
Obs. No.	Location (Area, Element/Joint ID, Wall ID)		Observation Notes	Photos
DS-6	Joint I/II	Outer (West) wall	Sign of delamination

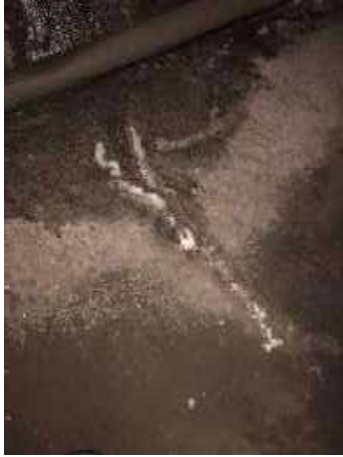
Obs. No.	Location (Area, Element/Joint ID, Wall ID)		Observation Notes	Photos
DS-7	Joint I/II	Corner of Outer (West) wall and floor	White crystals collected on floor, possibly chlorides

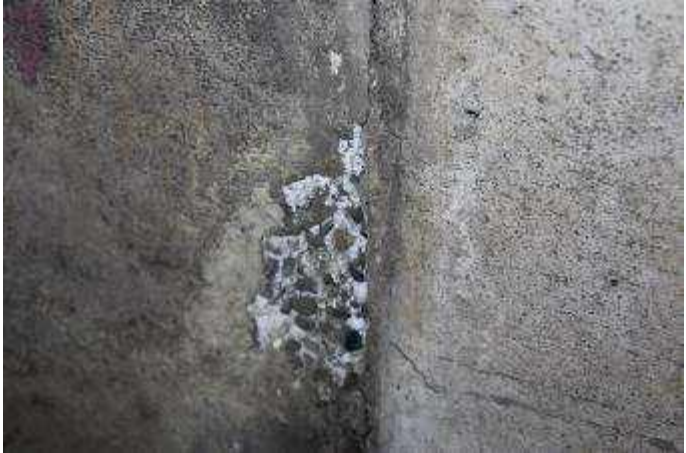
DS-8	Element II, Door 12/13	Inner (East) wall	White efflorescence at surface spall

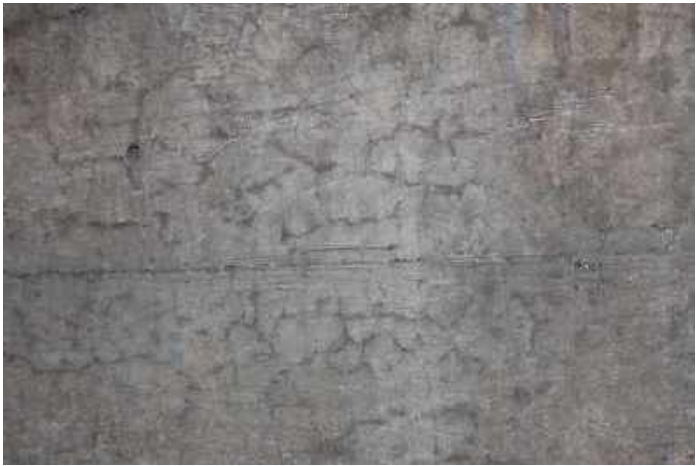
DS-10	Element II, Door 14	Outer (West) wall	Map cracking

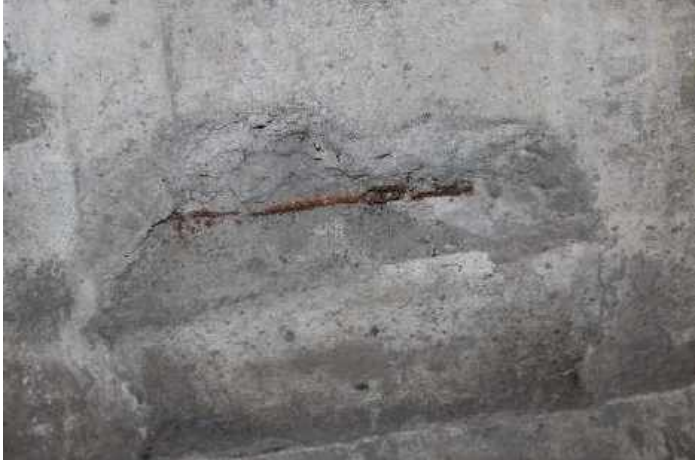
Obs. No.	Location (Area, Element/Joint ID, Wall ID)		Observation Notes	Photos
DS-11	Element II	Inner wall	Spall and exposed rebar

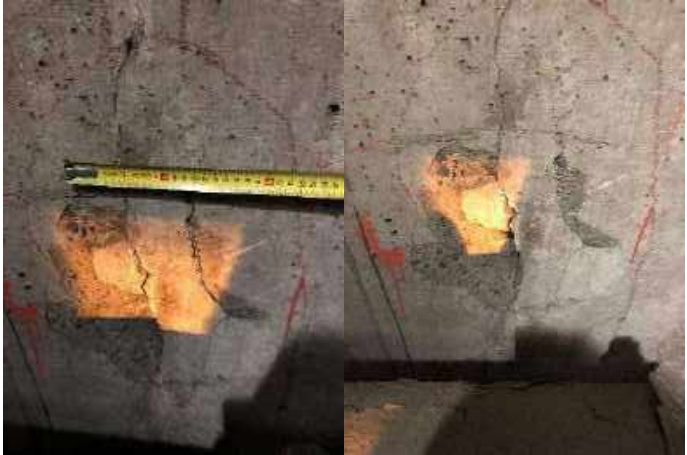
Obs. No.	Location (Area, Element/Joint ID, Wall ID)		Observation Notes	Photos
DS-13	Element III, Door 17	Outer (West) wall	Small area of delamination with large cracks

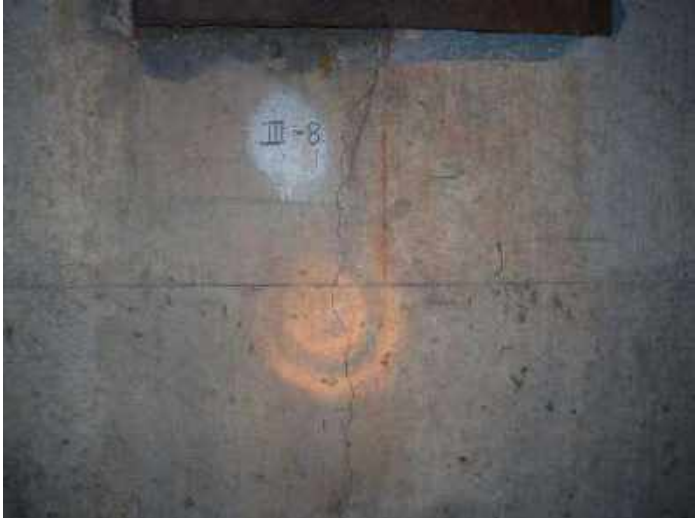
DS-14	Element III, Door 17	Inner (East) wall	Crack in inner wall at louvre cut out.

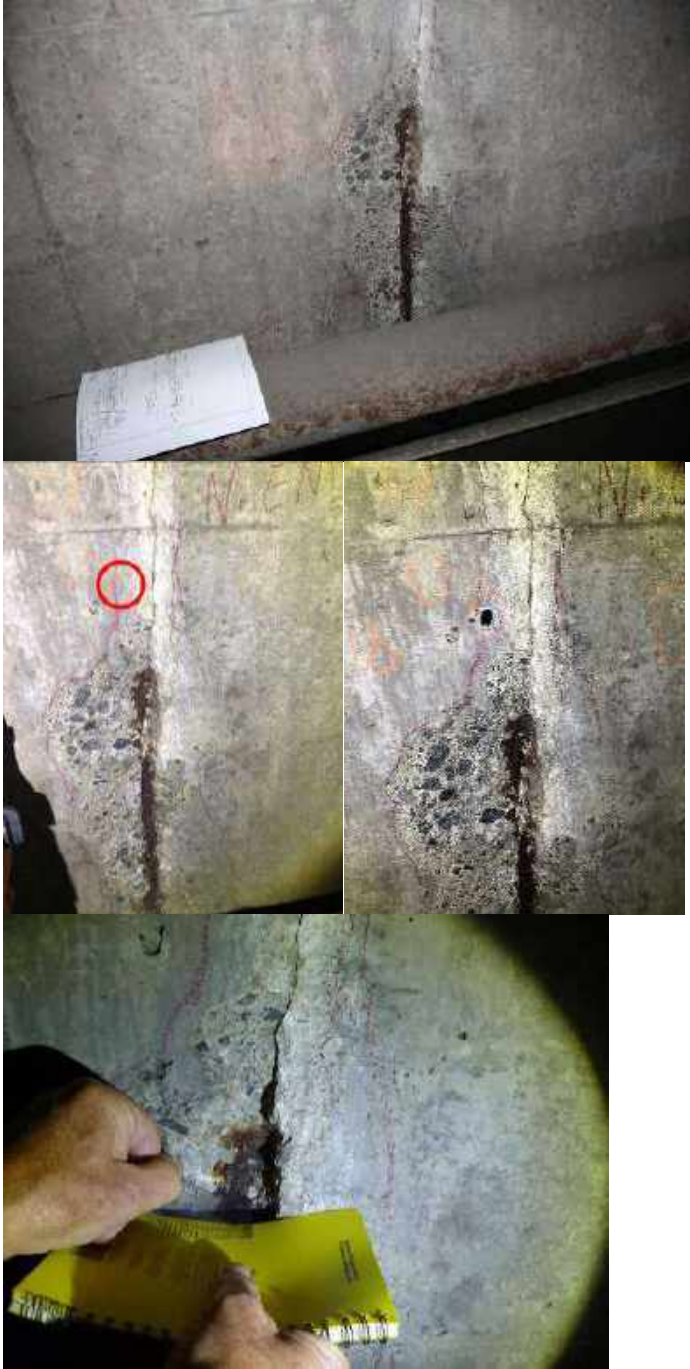
Obs. No.	Location (Area, Element/Joint ID, Wall ID)		Observation Notes	Photos
DS-15	Element III, Door 17/18	Outer (West) wall	<p>Spalled concrete. Cover was approximately 35 mm locally.</p> <p>Powder samples collected (S1). Sample location indicated in annotation.</p>

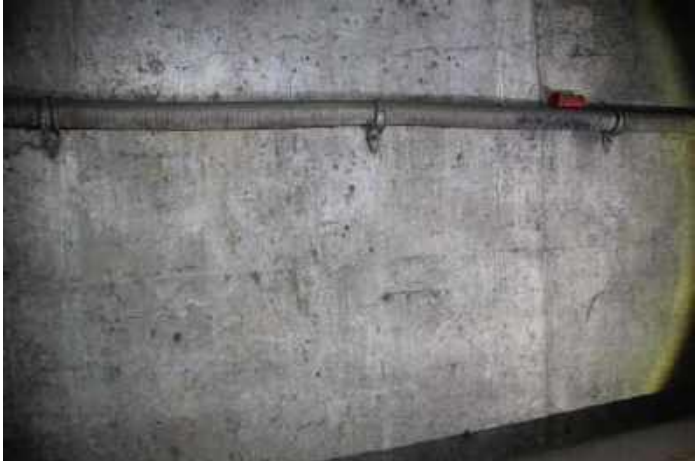
Obs. No.	Location (Area, Element/Joint ID, Wall ID)		Observation Notes	Photos
DS-16	Element III, Door 18	Outer (West) wall	Duplicate photo #16 in 2000 inspection report

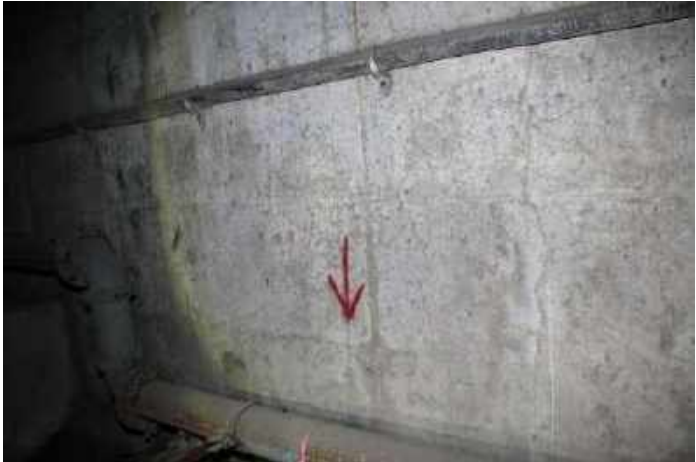
DS-17	Element III, Door 19	Outer (West) wall	Pattern cracking

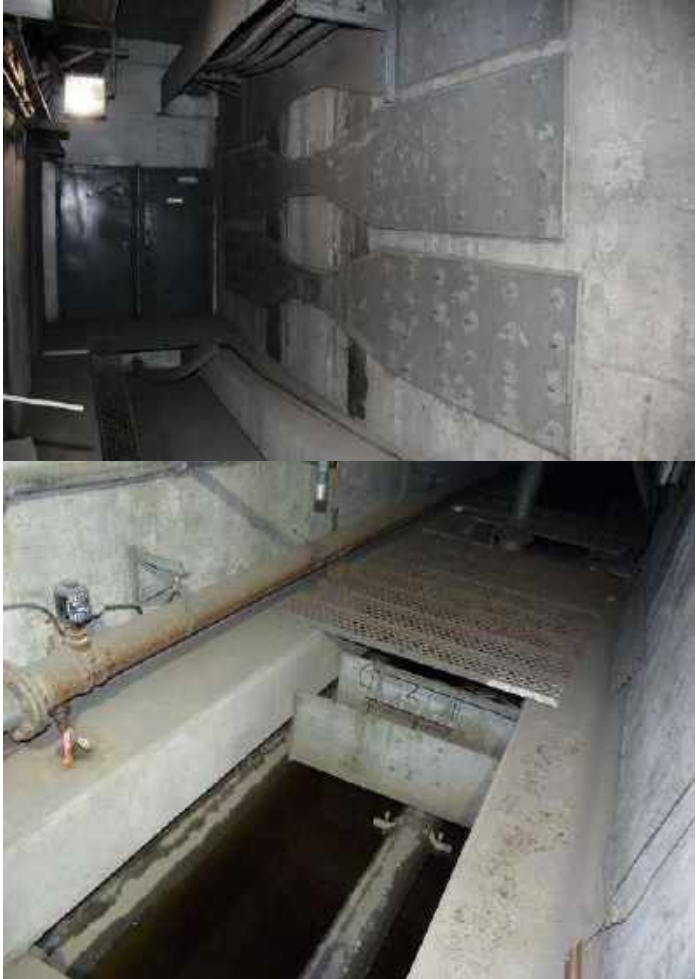
Obs. No.	Location (Area, Element/Joint ID, Wall ID)		Observation Notes	Photos
DS-19	Element III, Joint III/IV, Sump in Element IV	Outer wall and base slab near sump	Water collected in sump, none in walking areas

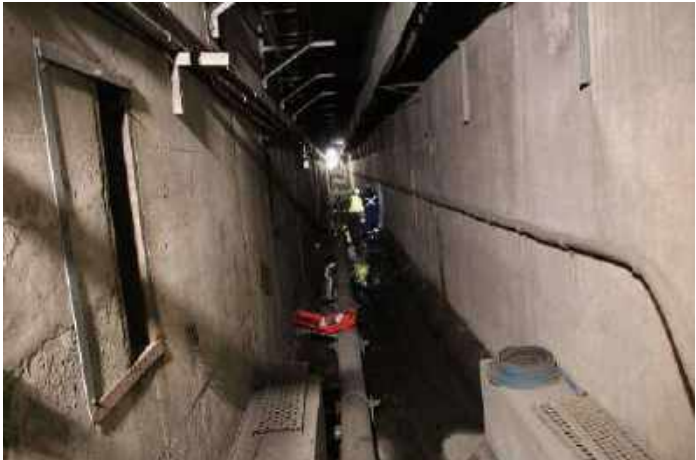
DS-20	Element IV	Overview near sump	Looking South into the airduct Walkway damp Photo taken in front of sump

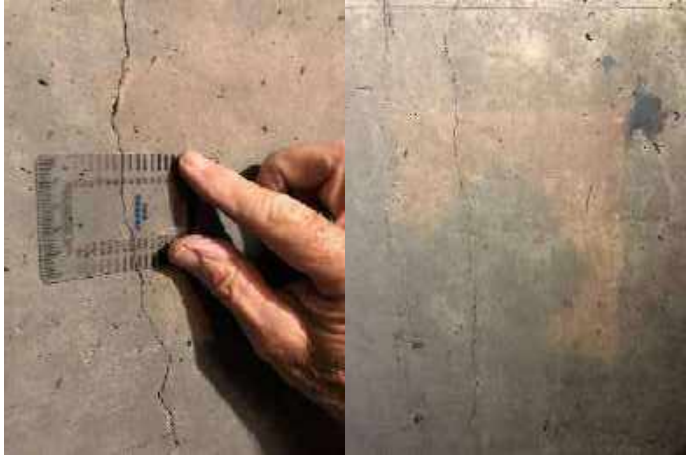
Obs. No.	Location (Area, Element/Joint ID, Wall ID)		Observation Notes	Photos
DS-21	Element IV, Door 20	Outer (West) wall	Crack, ~0.40 mm, no sign of leaks.

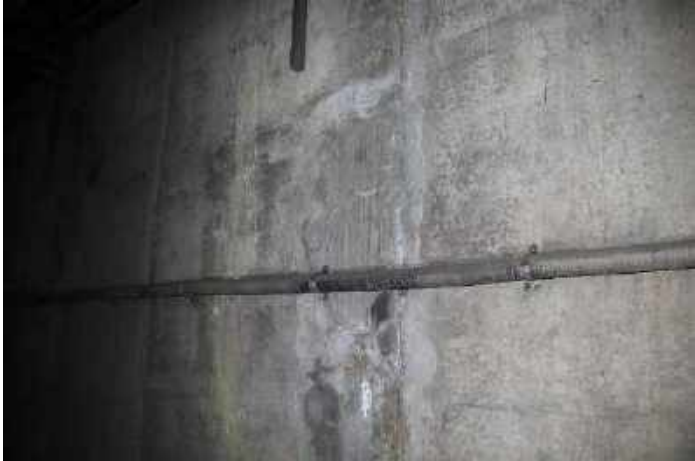
DS-22	Element IV, Door 20	Outer (West) wall	Duplicate photo #13 in 2000 inspection report In 2000, there was exposed rebar which is patched now

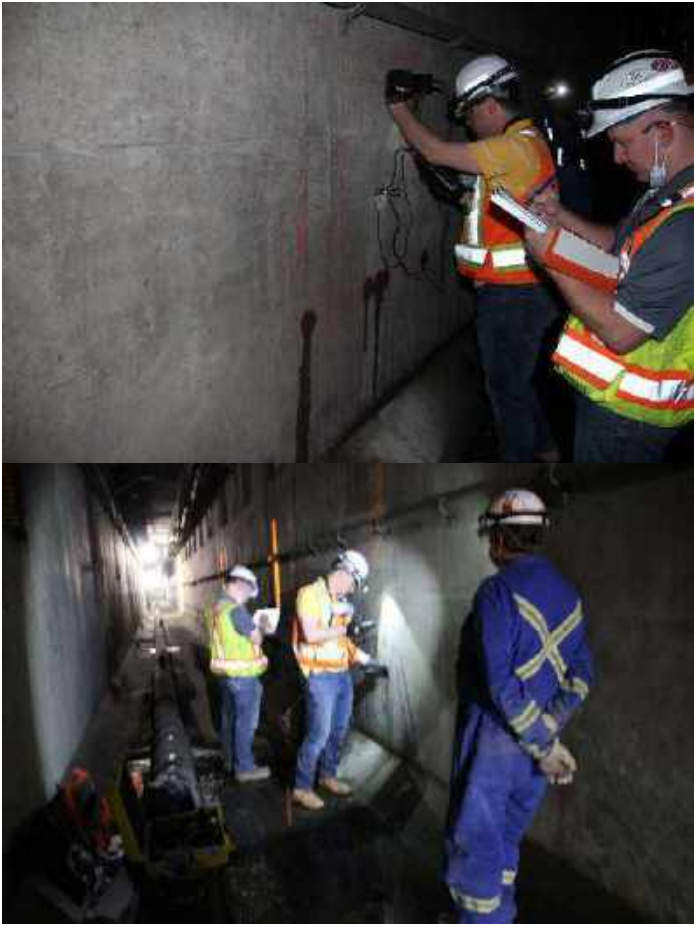
DS-23	Element IV, Door 20/21	Outer (West) wall	<p>NDT on element IV by WSP ~5 m north of door 21</p> <p>Rebar exposed at a past core repair location. Likely the location of 2000/2001 LPR measurement.</p> <p>No visual signs of corrosion on exposed rebar.</p>

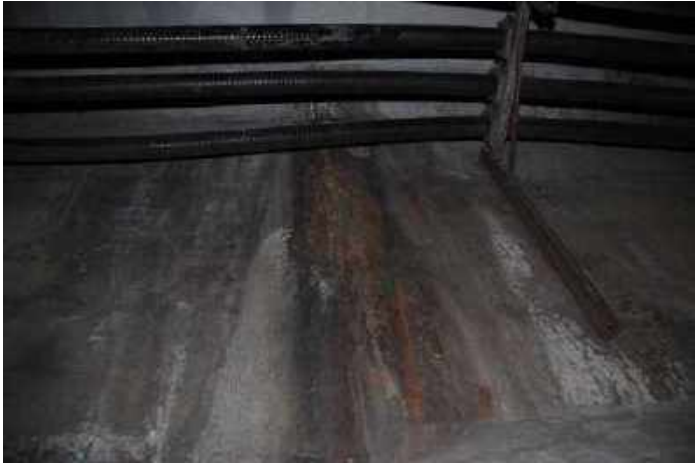
DS-26	Element IV, Door 23/24	Corner of soffit and outer (west) wall	Corrosion staining, dry

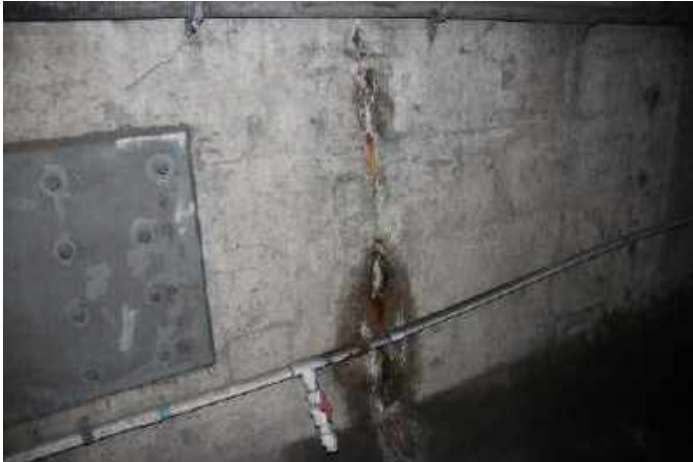
DS-29	Element IV, Door 24, near Joint IV/V	Outer (West) wall	Transverse crack with efflorescence, corrosion staining and weeping near bottom corner of wall.

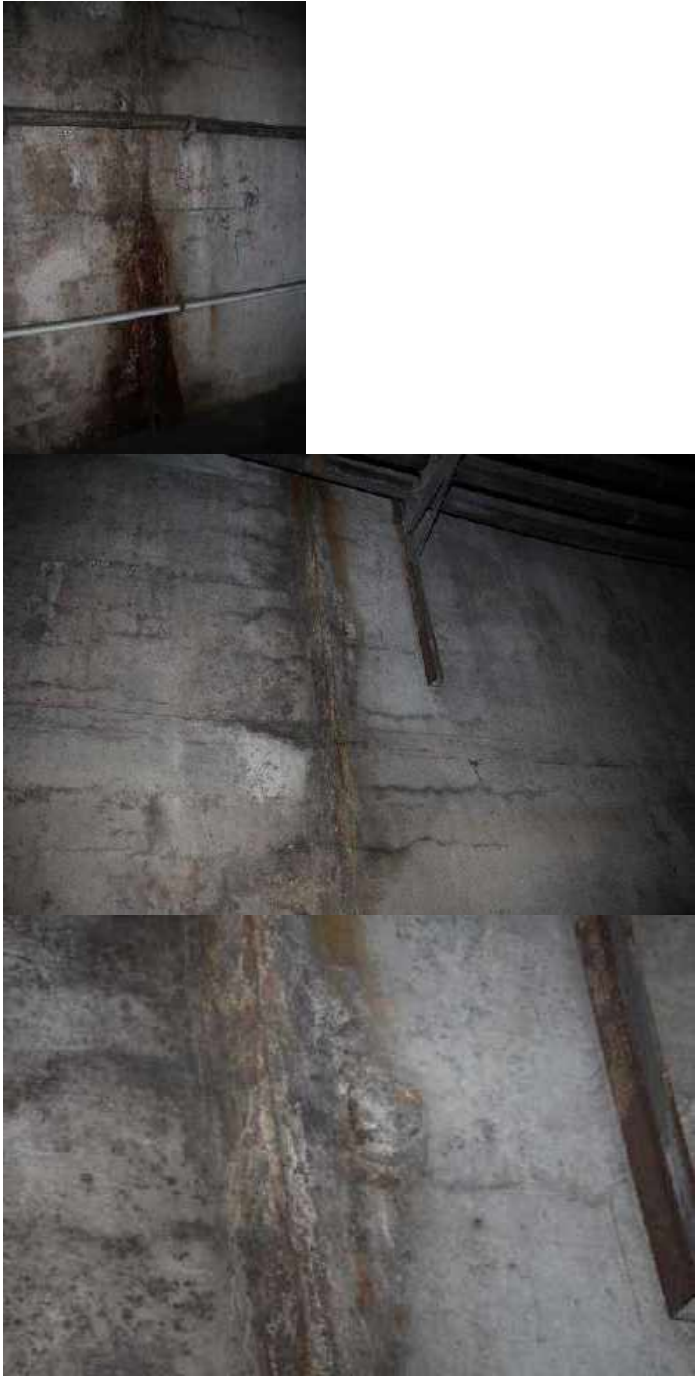
Obs. No.	Location (Area, Element/Joint ID, Wall ID)		Observation Notes	Photos
DS-31	Element V, Door 29	Outer (West) wall	Corrosion staining, spall, exposed rebar

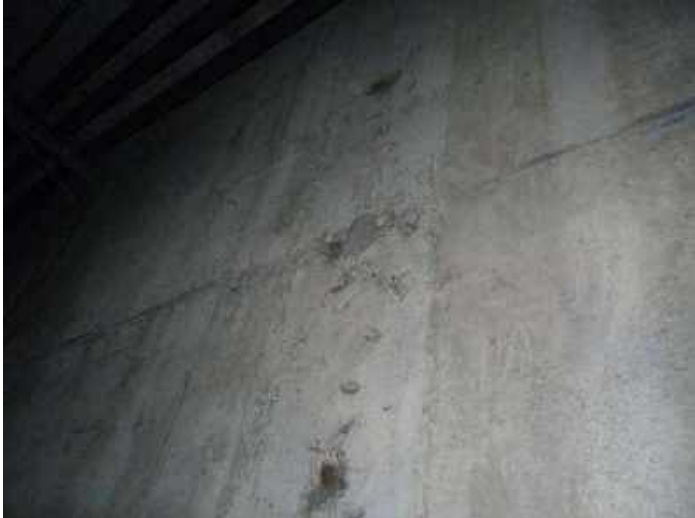
DS-36	-	Outer (West) wall	Similar to photo #12 of 2000 inspection (site where temporary bulkhead was removed). Minor surface corrosion of cut rebar.

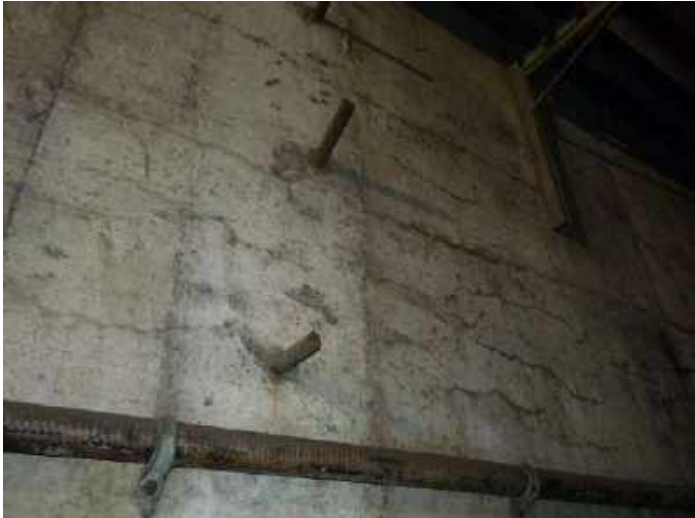
DS-37	Element V, North of Joint V/VI	Outer (West) wall	Rebar protruding from wall, possibly part of the temporary bulkheads. Horizontal cracking observed in precast tunnel concrete. Cracks were not damp, although had a darker appearance than neighboring uncracked concrete.

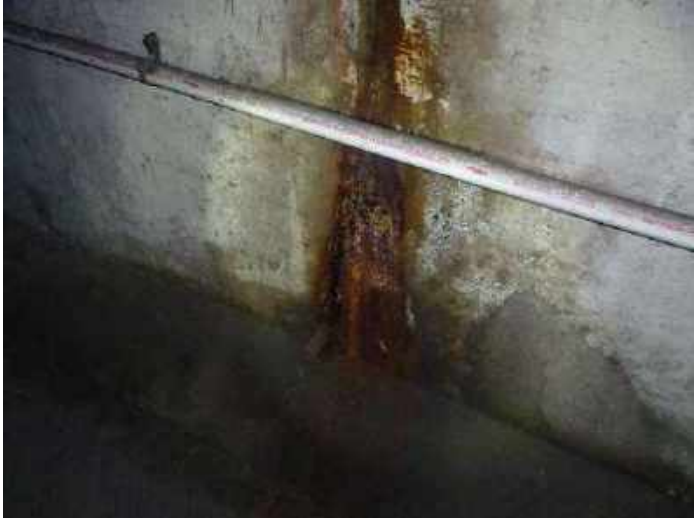
Obs. No.	Location (Area, Element/Joint ID, Wall ID)		Observation Notes	Photos
DS-38	Element VI, Door 31/32	Outer (West) wall	<p>Southern transversal construction joint at CP2 in Element VI (See Figure A-2(b) for CP numbering description).</p> <p>Significant corrosion product observed at construction joint.</p> <p>Corrosion product was damp above the drainpipe, indicating seeping water through the joint.</p>

"Leak" in the table indicates that water/moisture was present in the drainpipe. Observations DS-2, DS-3, and DS-38 in Table A-2 provide examples of this condition. The "Leak" equated to slow drips in the worst case, and in most cases

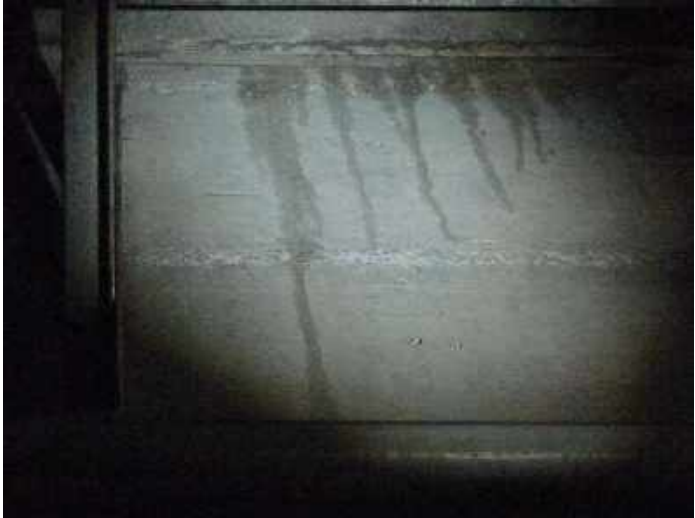
DS-39	Element II, Contraction Pour 3 (See Figure A-2(b))	Intermediate (East) wall	<p>Staining on the contraction pour, intermediate wall immediately under the soffit. The staining was not reachable during inspection.</p> <p>On site, the surface stain appeared to be dry (no shining).</p> <p>Similar observations were made at other contraction pours in the Downstream Air Duct including:</p> <ul style="list-style-type: none"> > CP1, 2, 3 and 6 in Element II; > CP2 in Element III; > CP2-4 in Element IV; abd > CP3 and 6 in Element VI <p>See Figure A-2(b) for contraction pour numbering.</p> <p>No such staining was observed in the Upstream Air Duct</p>

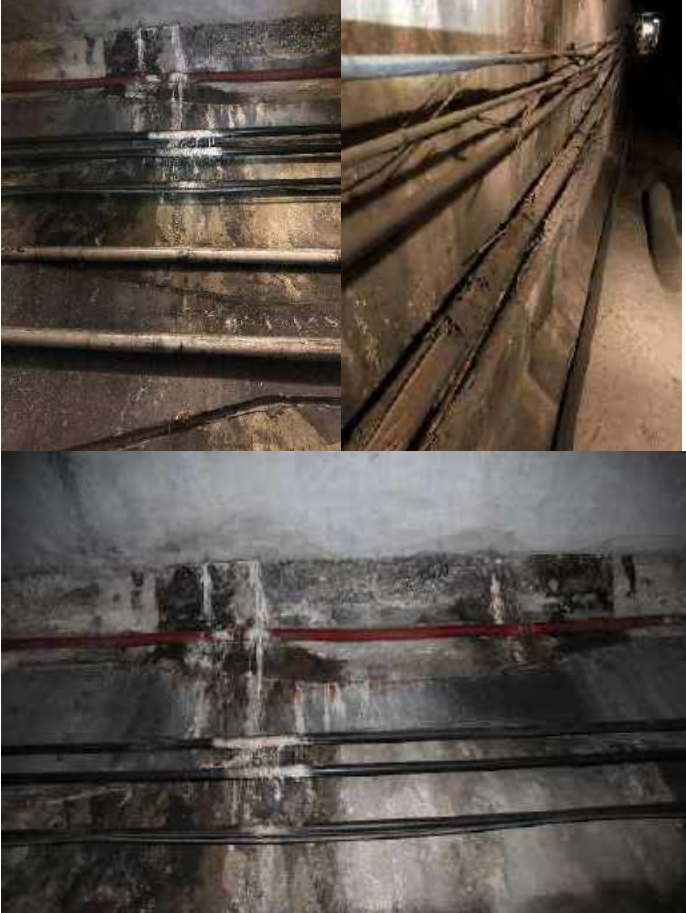
Obs No.	Location (Area, Element/Joint ID, Wall ID)		Observation Notes	Photos
US-1	Joint I/II	Outer (East) wall	Efflorescence high on wall, built up over top of seismic retrofitting Steel strands supporting the utility lines below this location are corroded through.

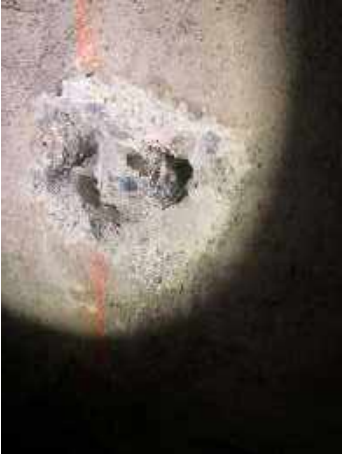
<p>The photos for US-1 show a concrete wall with white efflorescence. The top photo shows a close-up of the wall with a red horizontal line. The middle photo shows a long view of the wall with several steel strands running parallel to it. The bottom photo is another close-up of the efflorescence on the wall.</p>
US-2	Element II, ~5 m north of Door 13	Outer (East) wall	NDT on element II by WSP Rebar exposed at a past core repair location. Likely the location of 2000/2001 LPR measurement. No signs of corrosion on embedded bar.

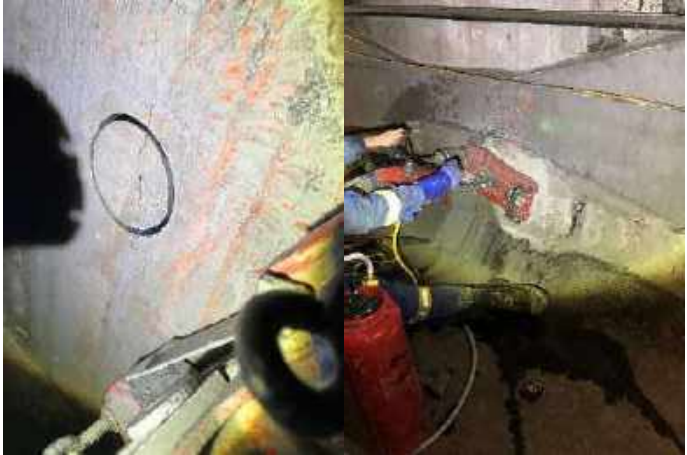
Obs No.	Location (Area, Element/Joint ID, Wall ID)		Observation Notes	Photos
US-3	Joint II/III	Outer (East Wall)	Transverse crack in joint. Core JUE-P3-C2 collected.

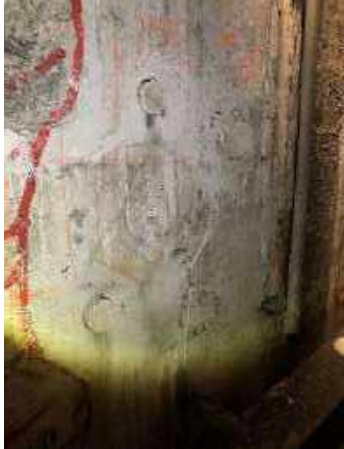
US-4	Joint II/III	Inner (West) wall	Delamination (shown in red paint) already observed in 2018/2019 Inspection Reports. Cores JUW-P1 and JUW-C1 collected.

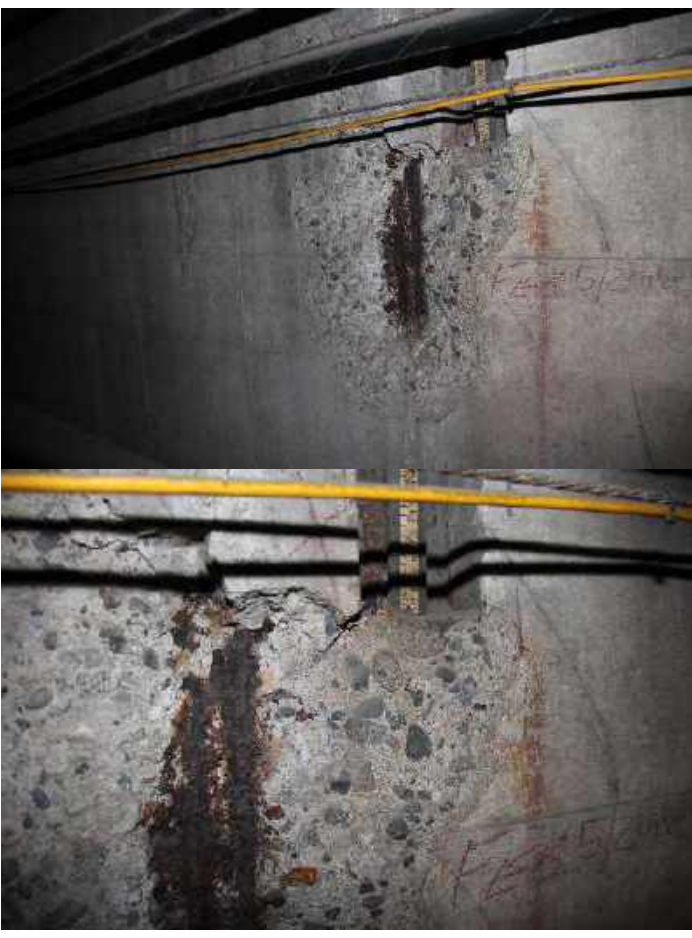
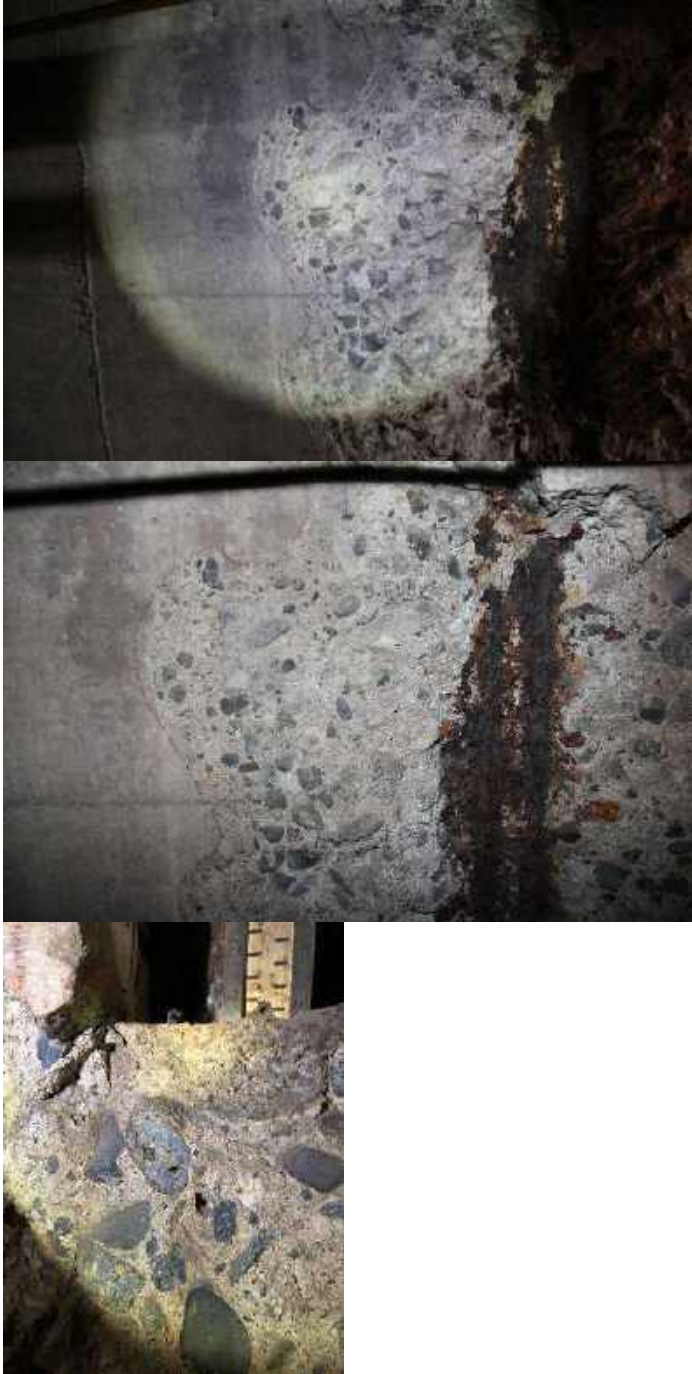
US-8	Element IV, Door 22	Outer (East) wall	Spall and exposed rebar. Possible indication of AAR with rim around coarse aggregates and gel Core WUE-P2 collected here
------	---------------------	-------------------	---

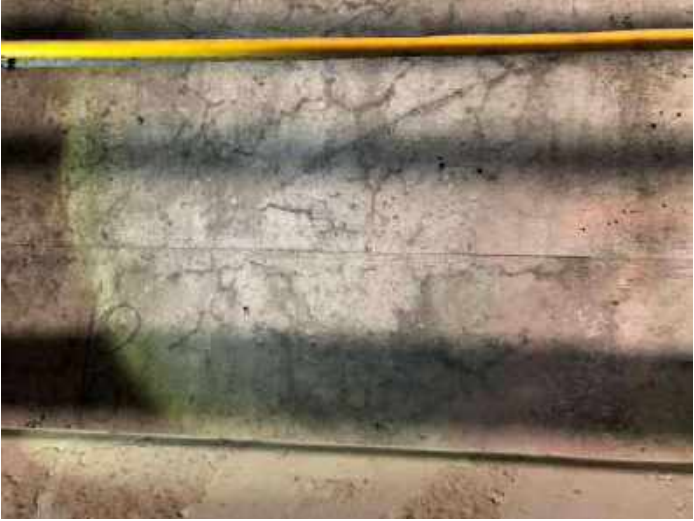
Obs No.	Location (Area, Element/Joint ID, Wall ID)		Observation Notes	Photos
US-9	Element IV, Door 24	Outer (East) wall	Fine cracks

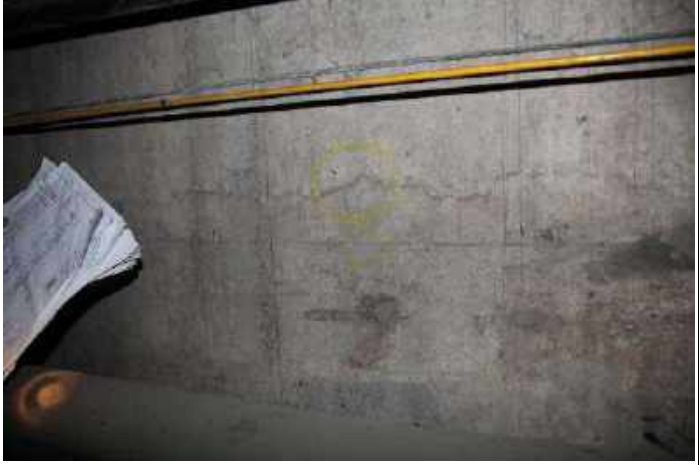
Obs No.	Location (Area, Element/Joint ID, Wall ID)		Observation Notes	Photos
US-11	Element V	Outer (East) wall	Fine cracks

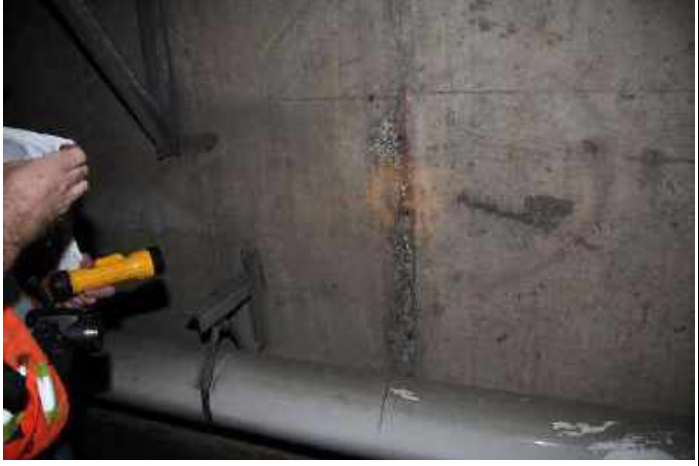
US-12	Element V	Outer (East) wall	Small spall and cracking

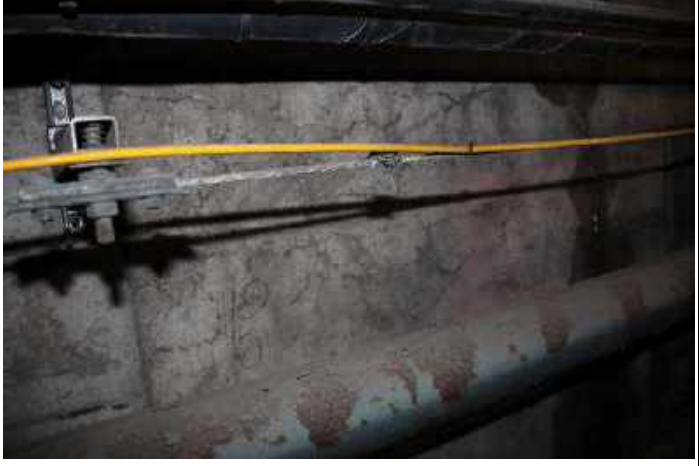
US-13	Element V	Outer (East) wall	Map cracking

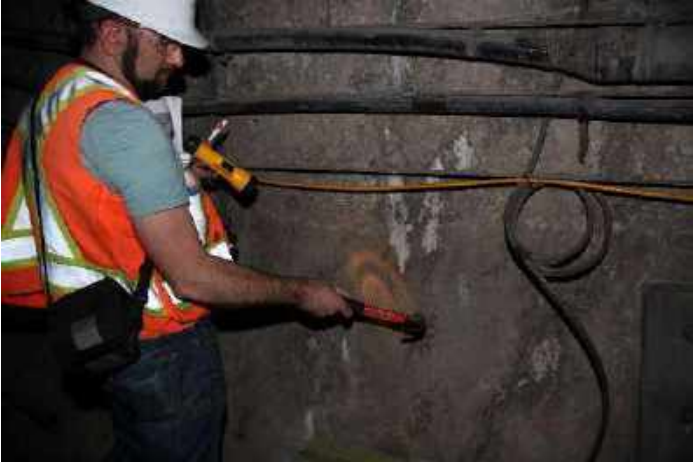
Obs No.	Location (Area, Element/Joint ID, Wall ID)		Observation Notes	Photos
US-14	Joint 0/I	Outer (East) Wall	Efflorescence, no delamination noted

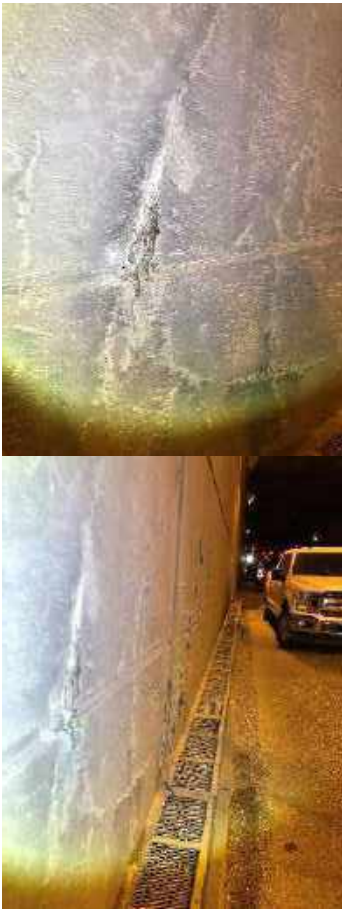
S4 (efflorescence sample)	N/A	Southern (Deas) Approach Ramp Element A2, Door 37, East wall	N/A	Vertical crack	N/A	Efflorescence built up at a crack in approach ramp	Chloride content and pH	Southern (Deas) Approach Ramp Efflorescence built up at a crack in approach ramp

Obs. No.	Location (Area, Element/Joint ID, Wall ID)		Observation Notes	Photos
SA-2	Element A2, North of Door 37	East wall, roadway level	Efflorescence build up, sample collected (S4).

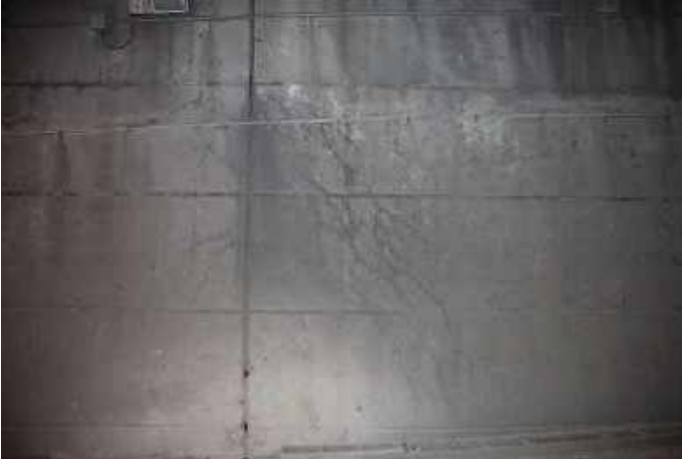
SA-3	Element A1 and A2, Near Door 37	East wall	Indication of AAR also approaching roadway level.
