Re: George Massey Crossing Project – Use of Existing Immersed Tube Tunnel

As part of a detailed tunnel condition review undertaken by COWI (George Massey Crossing Assessment – Existing Tunnel Condition Assessment Report, December 11 2020), sampling and testing of the precast concrete tunnel sections and cast-in-place

CONDITION ASSESSMENT REPORT - DRAFT

A127810 GMC-rpt-41-ext-cowi-Condition Assessment-Rev0C-11-Dec-2020

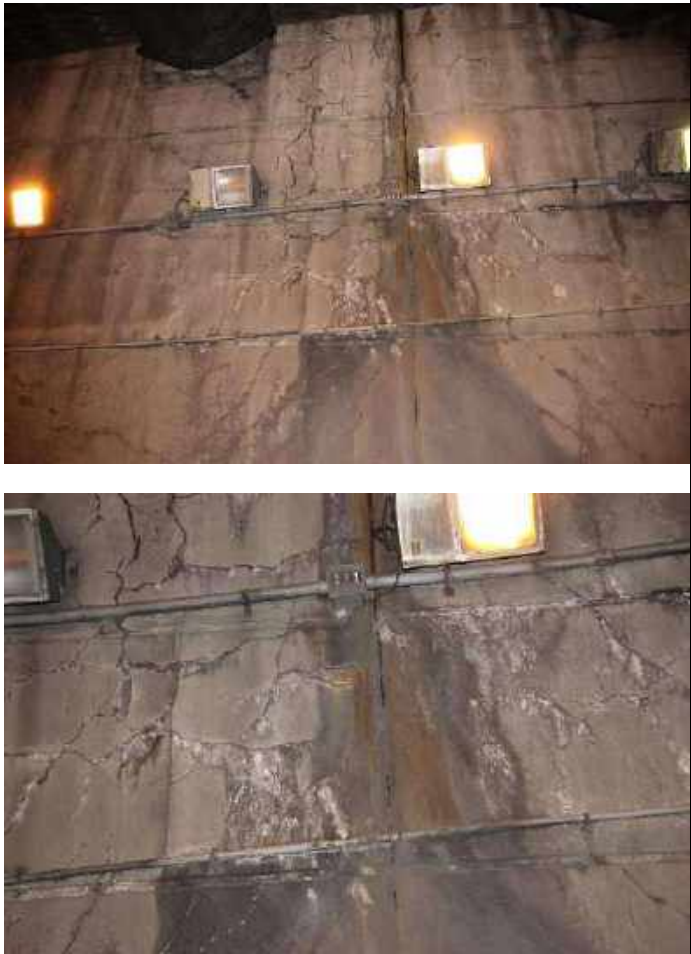
Obs. No.	Location (Area, Element/Joint ID, Wall ID)		Observation Notes	Photos
SA-4	Elements A1 and A2, North of Door 37	East wall, roadway level	Indication of AAR under T-beams Corrosion staining at joint

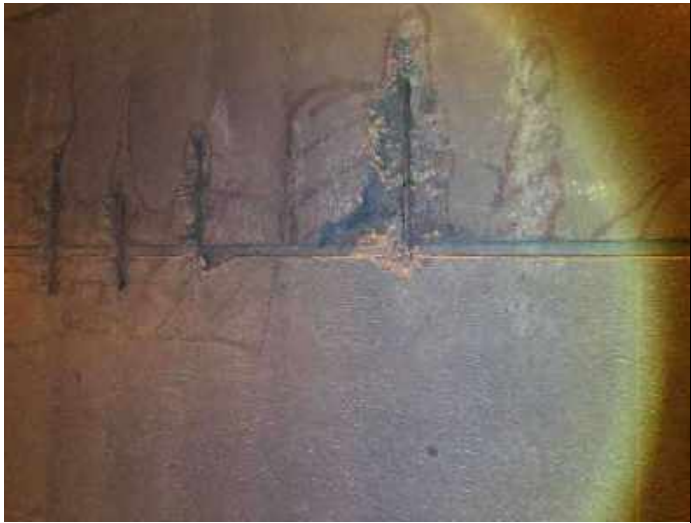
Obs. No.	Location (Area, Element/Joint ID, Wall ID)		Observation Notes	Photos
SA-6	Element A8, Door 38	East wall, roadway level	Delamination and spalling

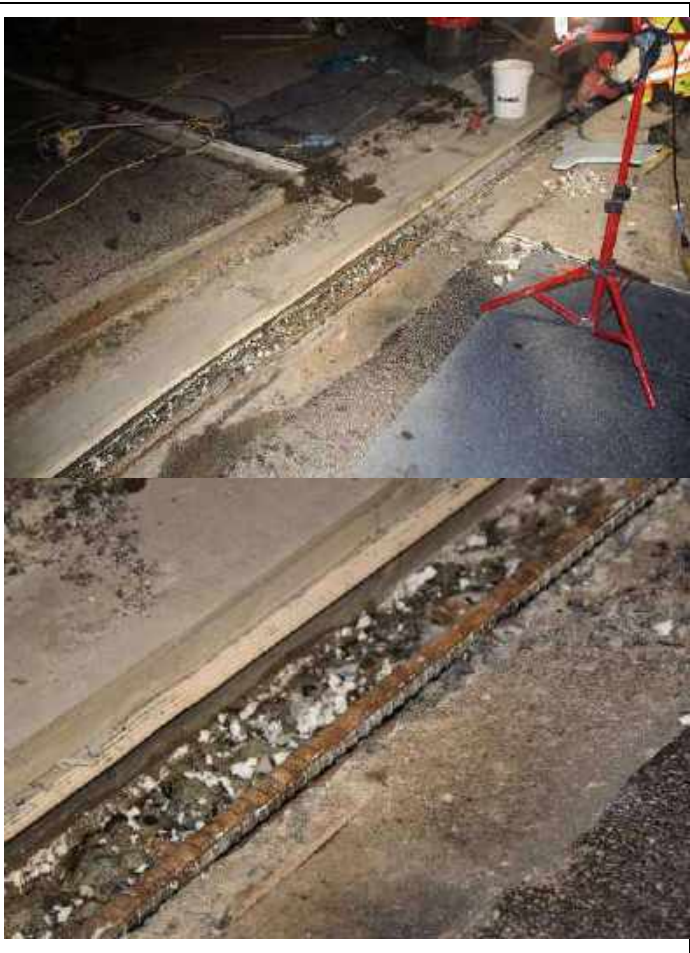
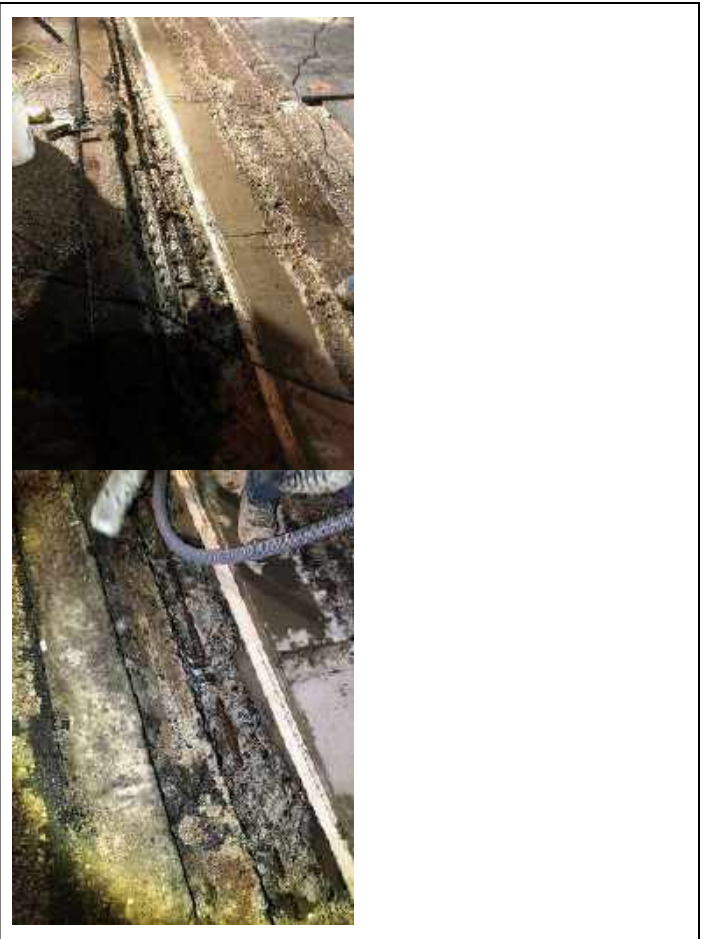
SA-8	B and C type elements	Base slab joints	<p>Ongoing repair of joints on the roadway. Asphalt was locally removed to expose concrete.</p> <p>Exposed rebar at base slab corner shown signs of local corrosion with limited cross section reductions.</p> <p>Areas were inaccessible for coring due to ongoing rehab works.</p>
------	-----------------------	------------------	--

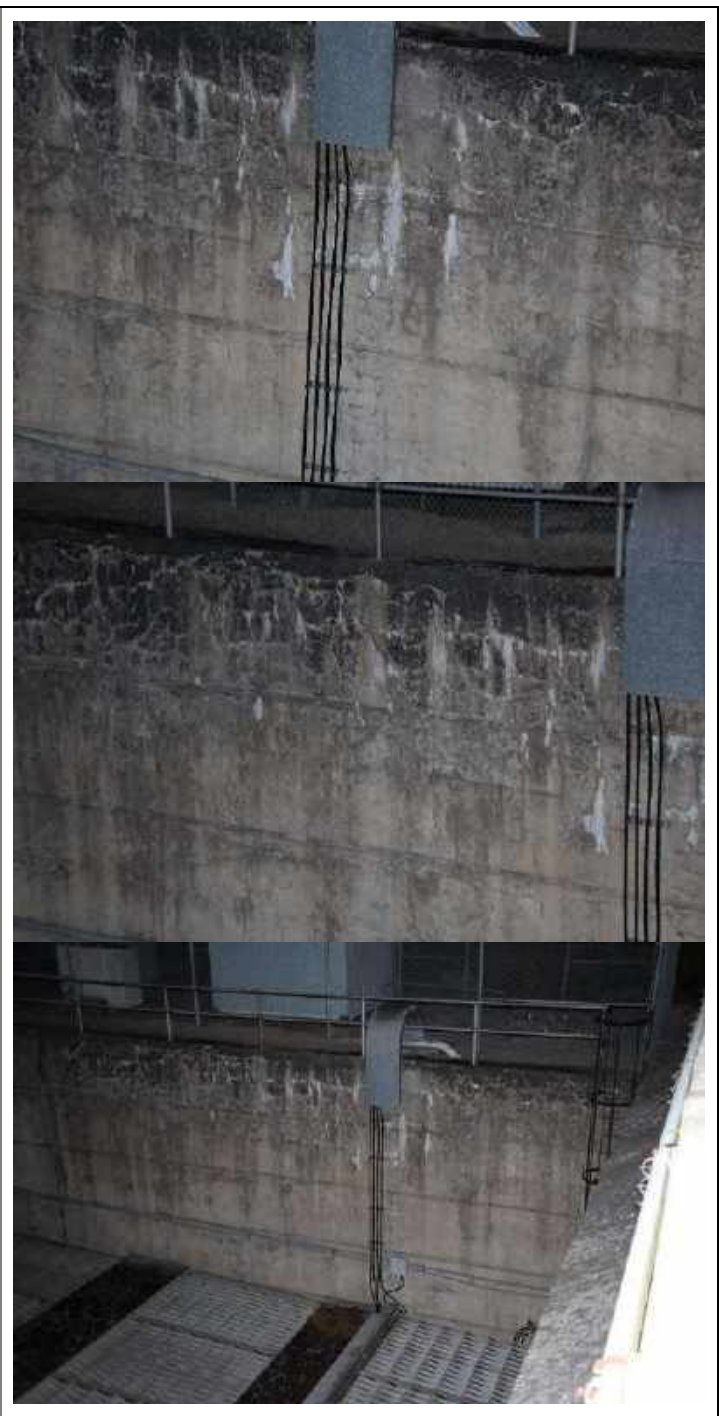
Figure 4-6: Comparison of photo 32 from [1] with (a) showing the condition during the current inspection and (b) the condition during the 2000 inspection – Northern (Lulu) Approach, Element A1, West wall.

NA-2	Element A1	West wall	Duplicate photo #32 of 2000 inspection

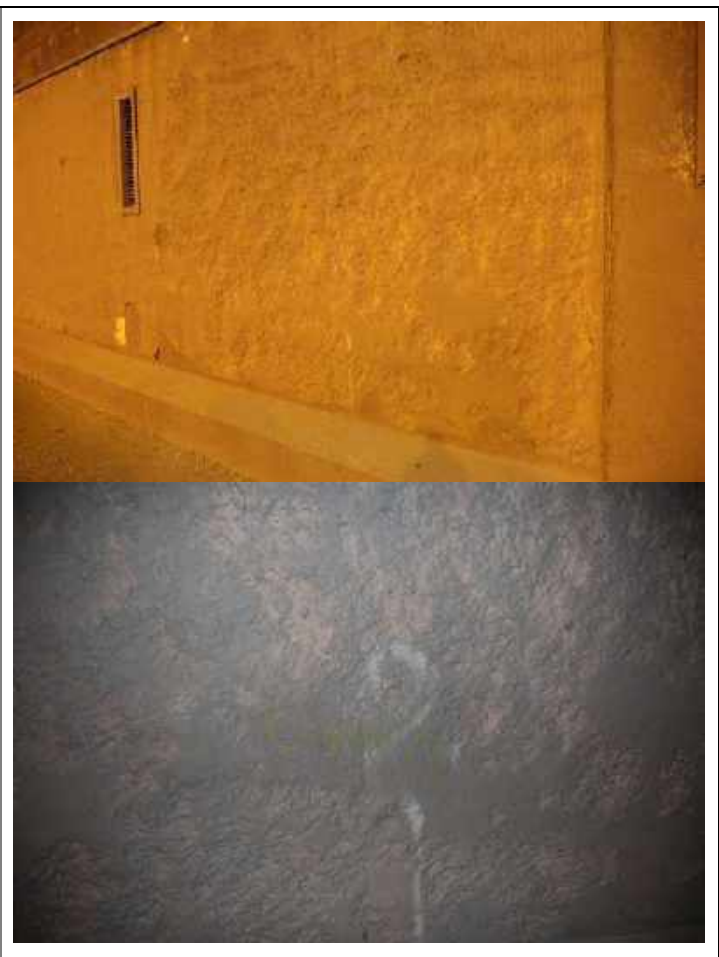
NB-3	Element II, Door 12	East wall	Seemed to be affected by fire in the past Core WNE-P5 location.

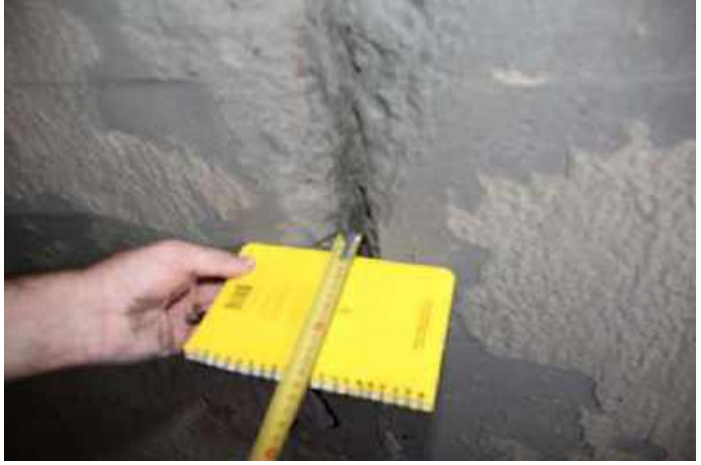
Obs. No.	Location (Element/Joint ID, Wall ID)		Observation Notes	Photos
NB-4	Element II, South of Door 13	West wall	Spall and exposed rebar Low cover, ~30 mm

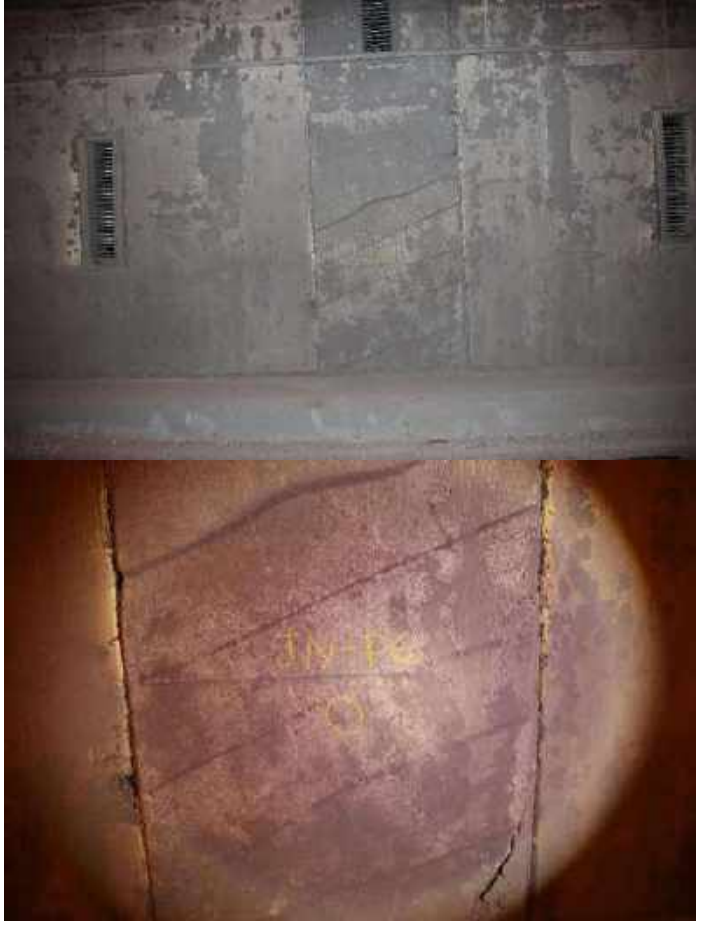
NB-5	Joint II/III	East wall	Sounded delaminated (Hammer) Core JNE-P6 location

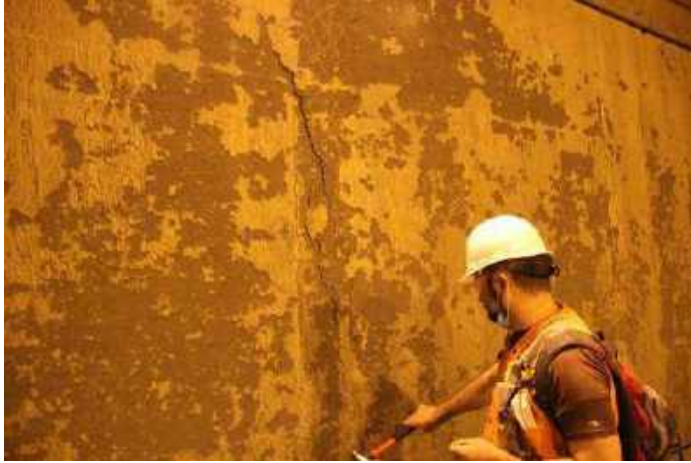
Obs. No.	Location (Element/Joint ID, Wall ID)		Observation Notes	Photos
NB-6	Element III, North of Door 18	West wall	Delaminated area

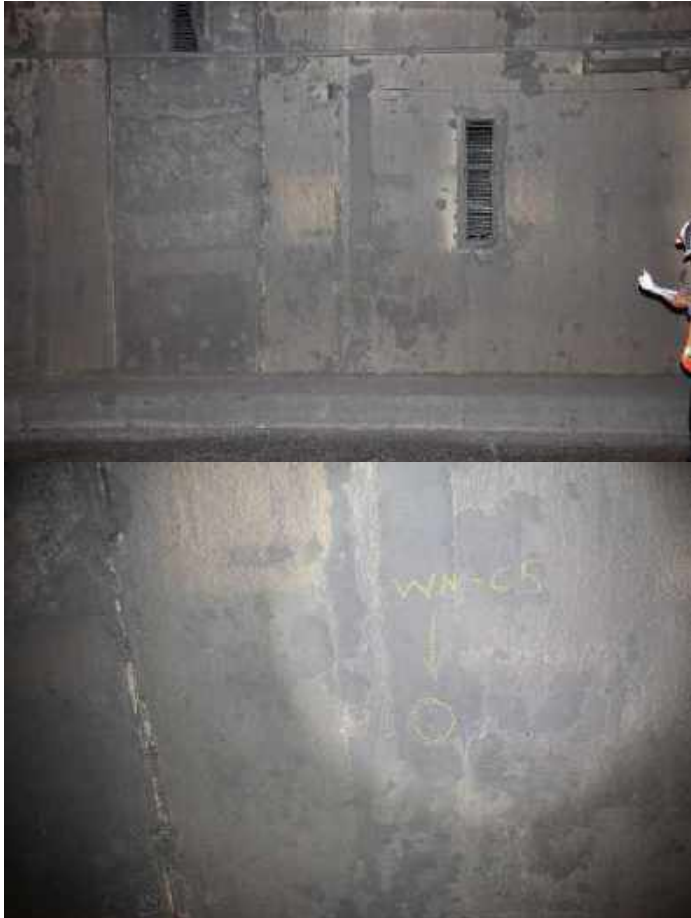
NB-7	Element IV, Door 20	East wall	Core WNE-C5 location

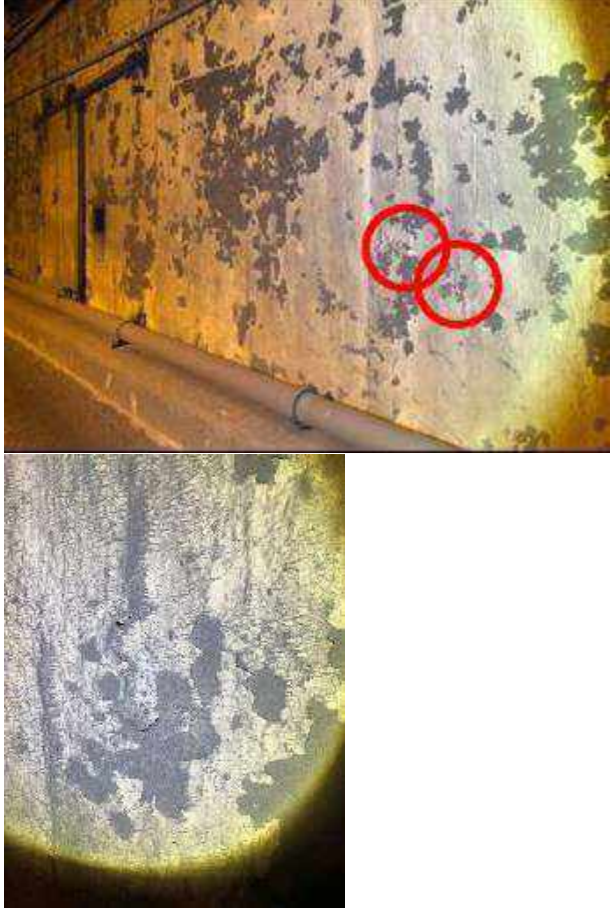
NB-9	Element V, ~10 m north of Door 27	Central Wall	Small areas of delaminated concrete

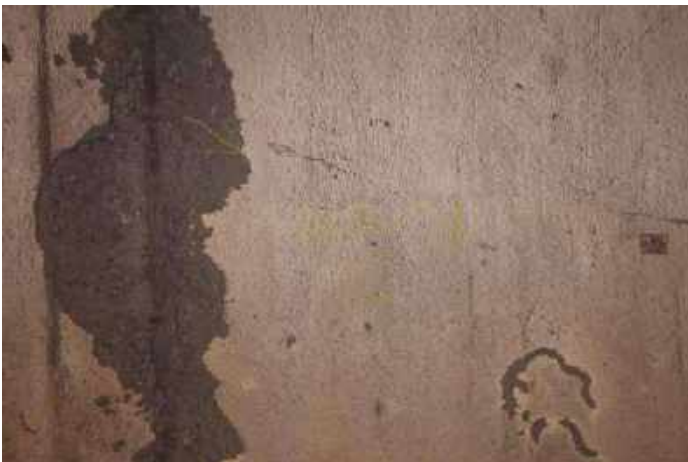
NB-11	Element V, North of Door 28	West wall	Core WNW-C4 location adjacent to spall/exposed vertical rebar.

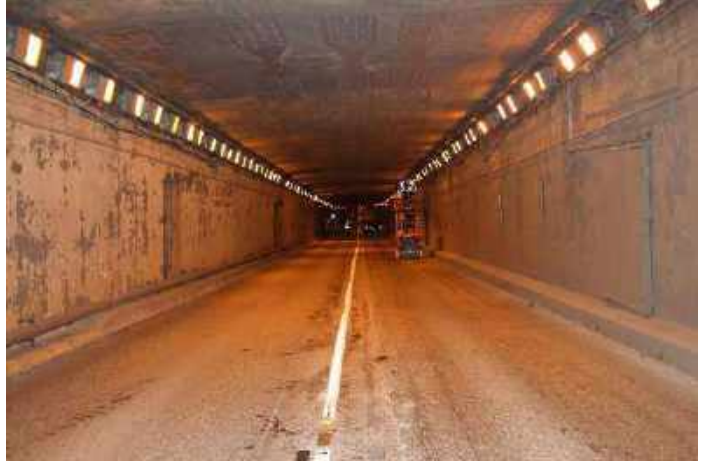
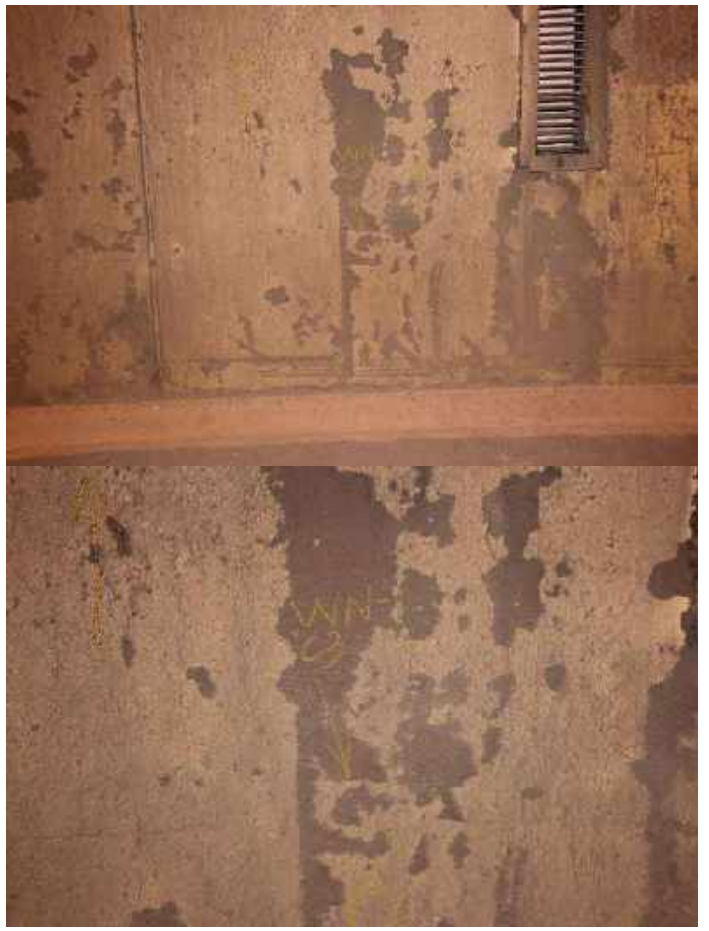
Obs. No.	Location (Element/Joint ID, Wall ID)	Observation Notes	Photos
NB-12	Joint V/VI area, Looking North	Overview, including joint in top slab	Overview showing general condition of roadway tunnel with peeling paint/coating on walls, joint with seismic retrofit plates
NB-13	Element VI, Door 33/34	East wall	Core WNE-C3 location.

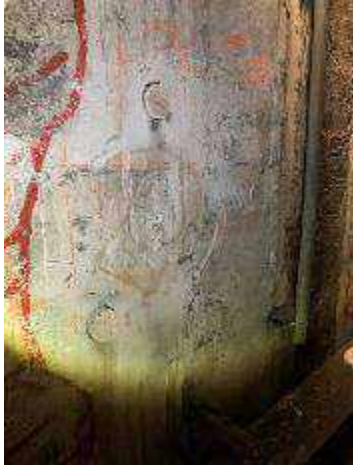
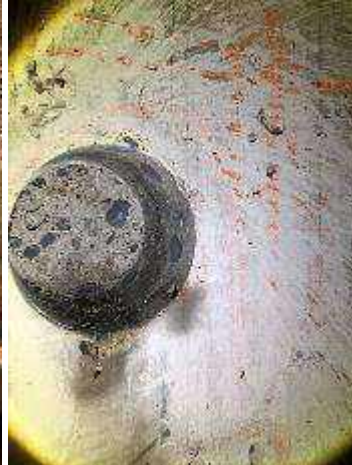
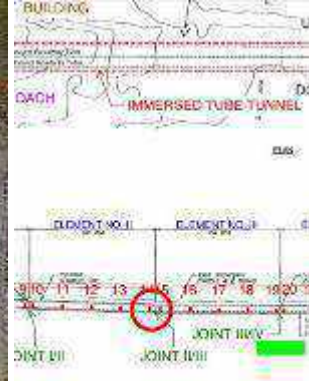
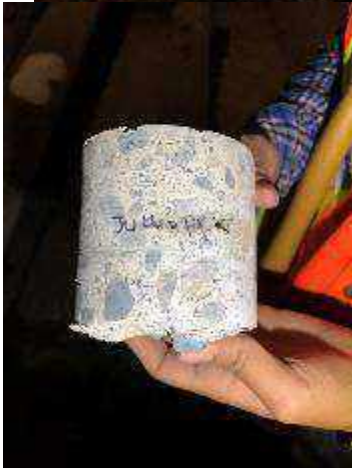
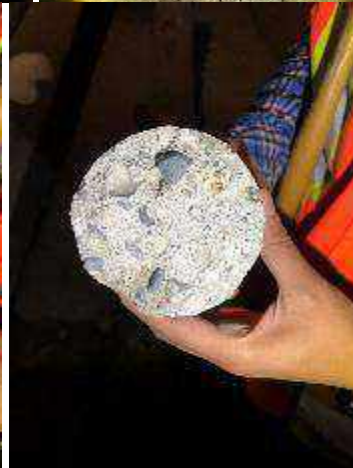
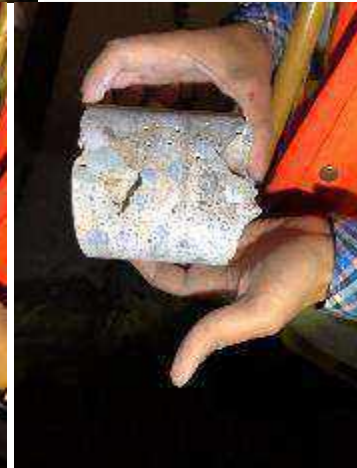
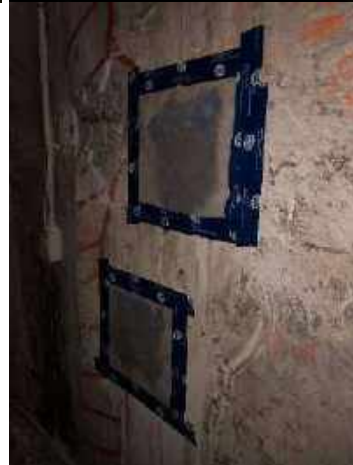
Date		27 July 2020		Inspector		BRPE	
Core number		JUW-P1		Reinforcement		No	
Diameter	4"	Location	Joint II/III, Inner wall	Length		9-10 cm

- > Joint Concrete, Inner (West) Wall
- > Cored adjacent to large/full height delamination in Joint II/III
- > Core JUW-C1 is companion sample for chloride profile. Honeycombing observed near core location

- > No visible cracks
- > Porous concrete with 2 large voids

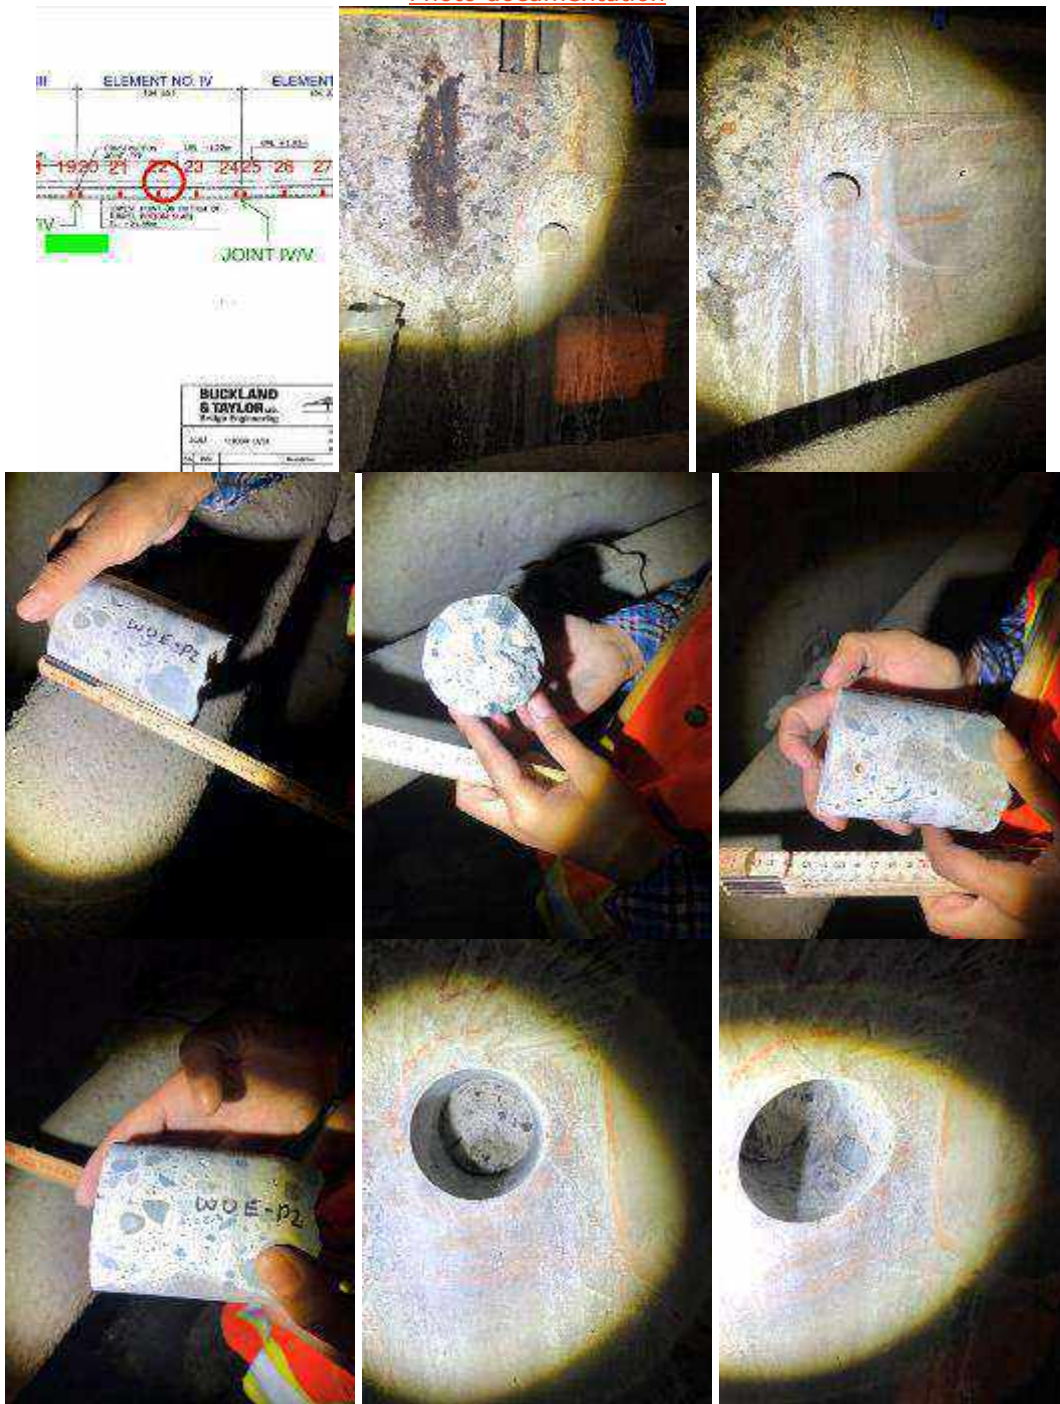
Date		28 July 2020		Inspector	BRPE
Core number		WUE-P2		Reinforcement	No
Diameter	3"	Location	Element IV, Door 22, Outer wall	Length	80 mm

- > No visible cracks observed in the core.
- > Well consolidated concrete.
- > Rim seen on 2 aggregate particles (photos taken)

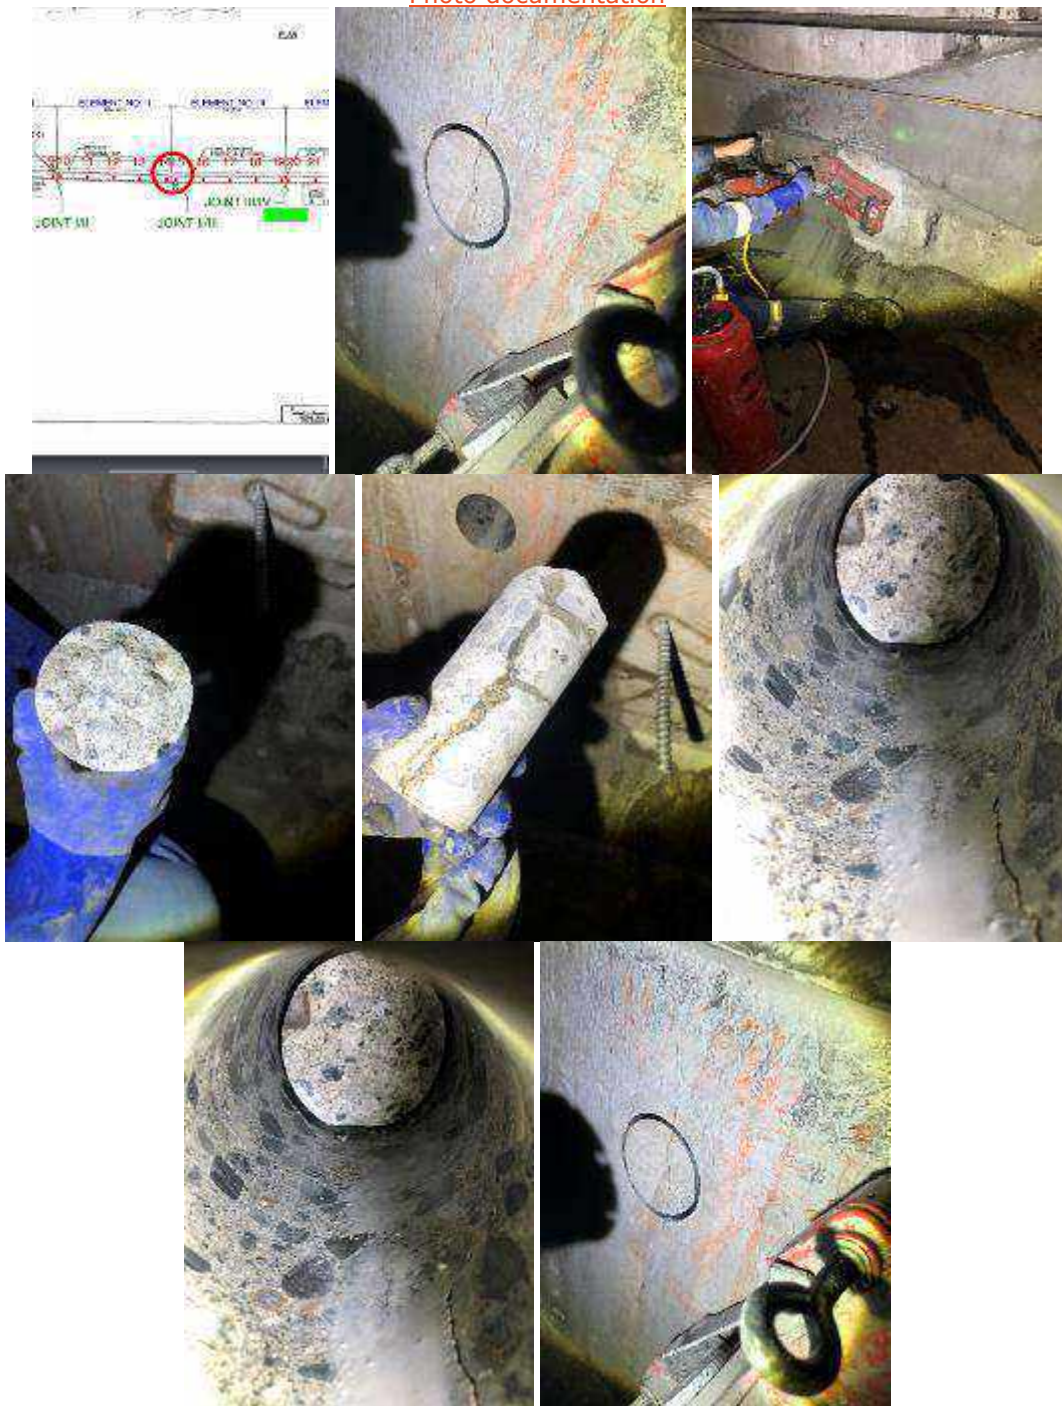
Date		28 July 2020		Inspector	BRPE
Core number		JUE-P3-C2		Reinforcement	No
Diameter	3"	Location	Joint II/III, Outer wall	Length	~30 cm

- > Core at outer wall of upstream air duct, Joint II/III
- > Core taken at a vertical crack in the joint

- > 2 pieces
- > Core appeared to fracture during removal, approximately ½ depth.
- > Clear color change near crack in the core (likely carbonation)
- > Crack appears to penetrate ~1/2 depth of core

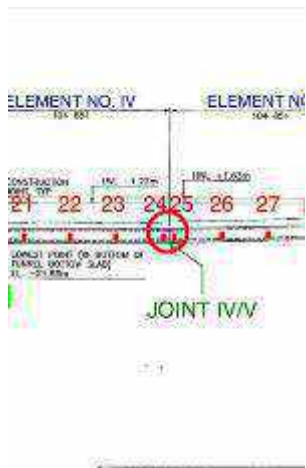
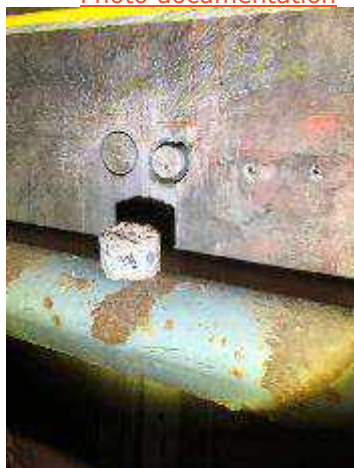
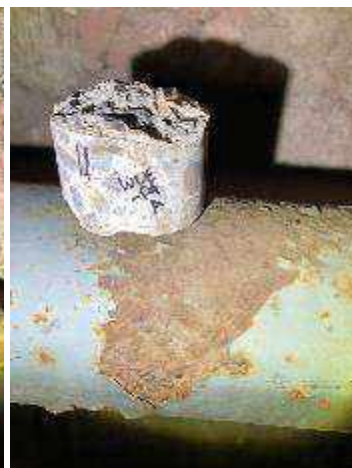
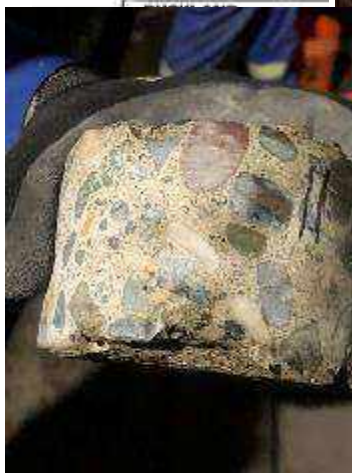
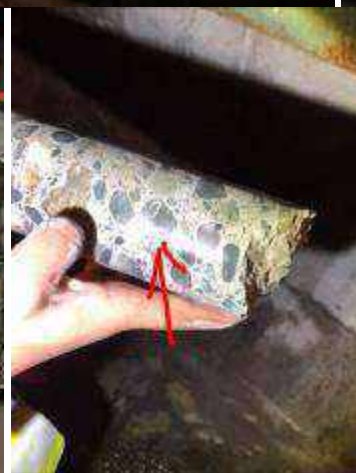
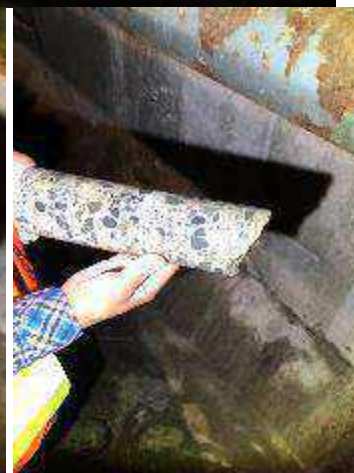
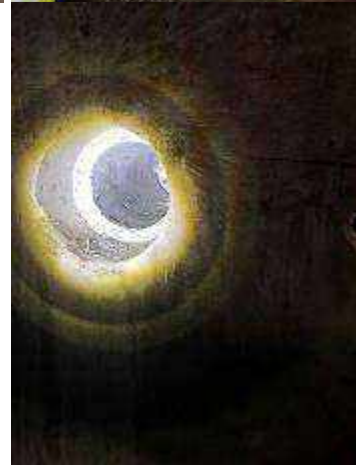
Date	28 July 2020		Inspector	BRPE	
Core number	WUE-P4		Reinforcement	Yes	
Diameter	4" top 7 cm, 3" after	Location	Element IV, Door 24, Outer wall	Length	~30 cm (total)

- > Deep core in outer (east) wall of upstream air duct.
- > Check for AAR (petrographic analysis core)
- > Fine, random cracks observed at concrete surface (hypothesized to potentially be caused by/early signs of AAR)

- > 4" core started, but encountered rebar and therefore core continued with a 3" core. No signs of corrosion.
- > Dense, well consolidated concrete
- > No crack visible
- > Some rims at aggregates, but no clear signs of AAR gel.

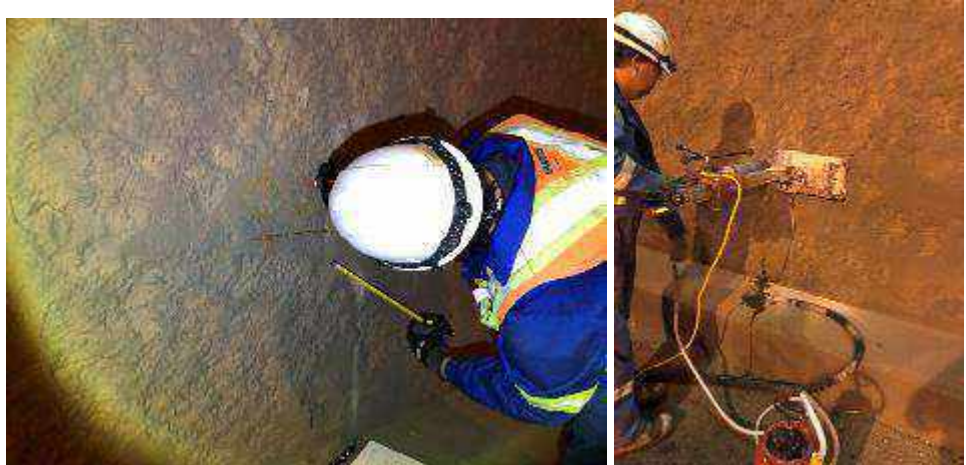
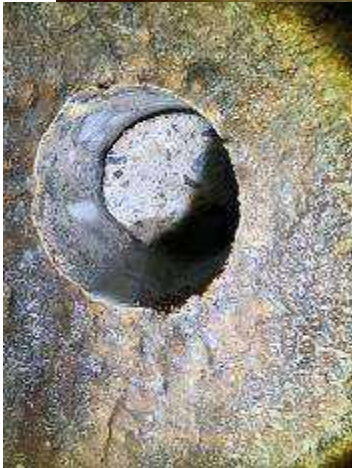
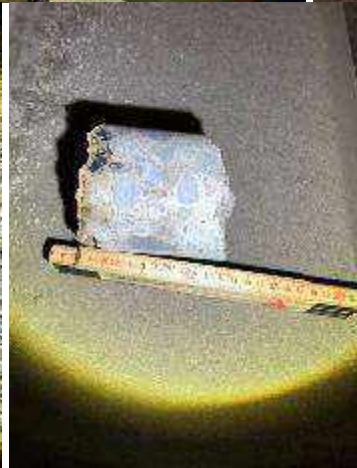
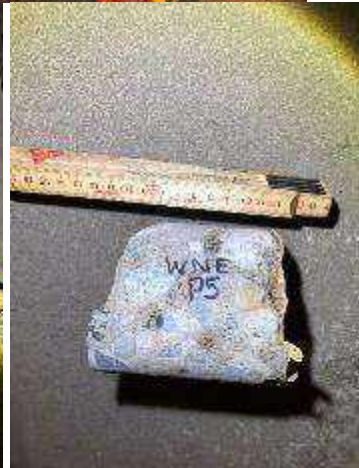
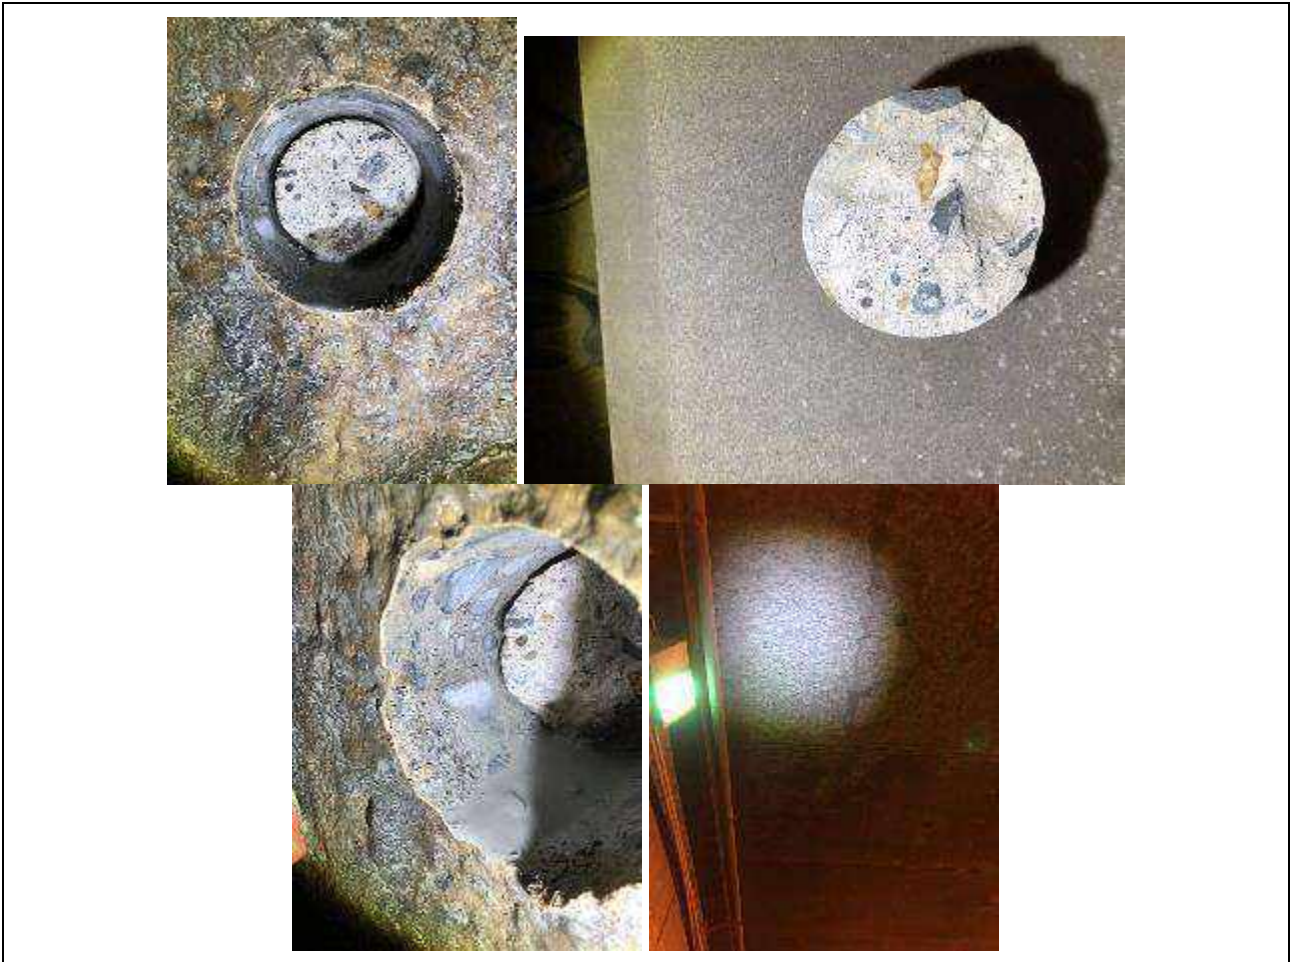
Date		29 July 2020		Inspector		BRPE	
Core number		WNE-P5		Reinforcement		No	
Diameter	4"	Location	Northbound Roadway Tube, East wall, Door 12	Length		~8-10 cm

- > Petrographic core at area of interest in northbound roadway tube.
- > Core taken ~110 cm over road level (@ curb).
- > A coating is on top surface of concrete. Concrete surface appears to be rough. Soffit at same location also has surface spalling. Possibly fire damage on wall and soffit.

- > Flexible coating ~1 mm thick on surface
- > Possible repair after fire damage
- > No visible cracks in core.

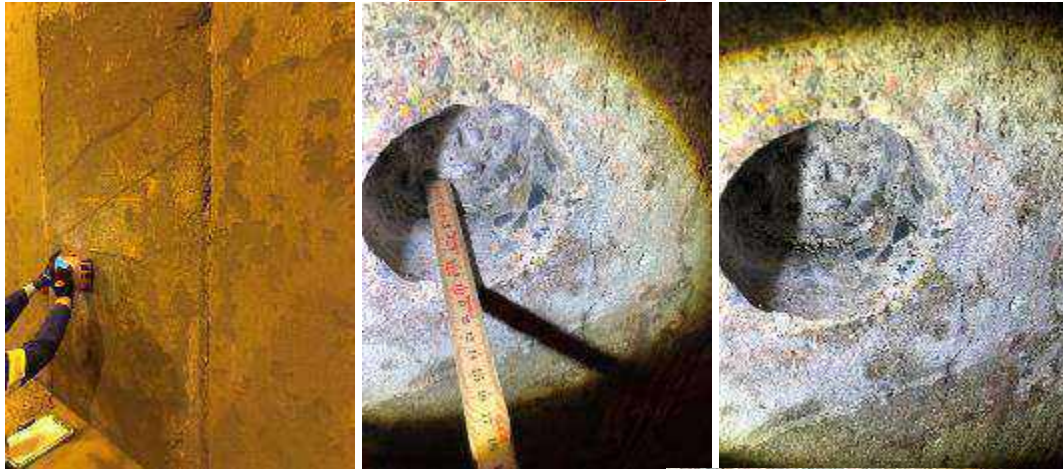
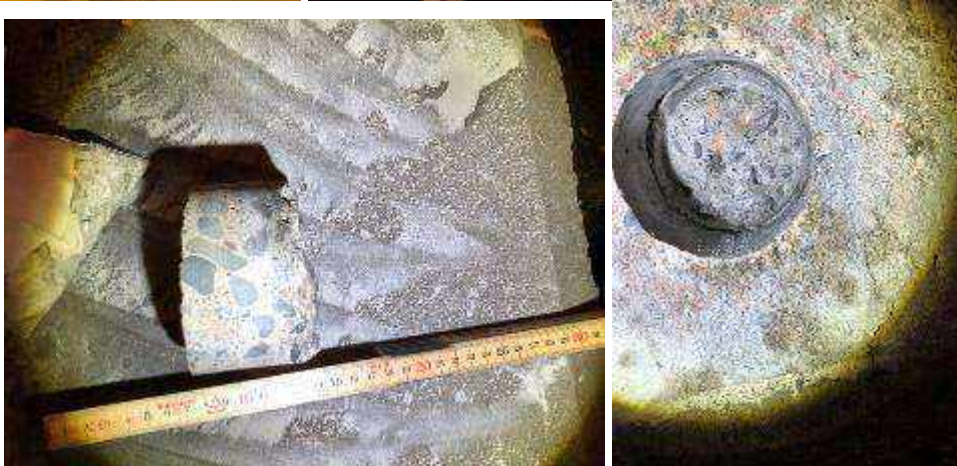
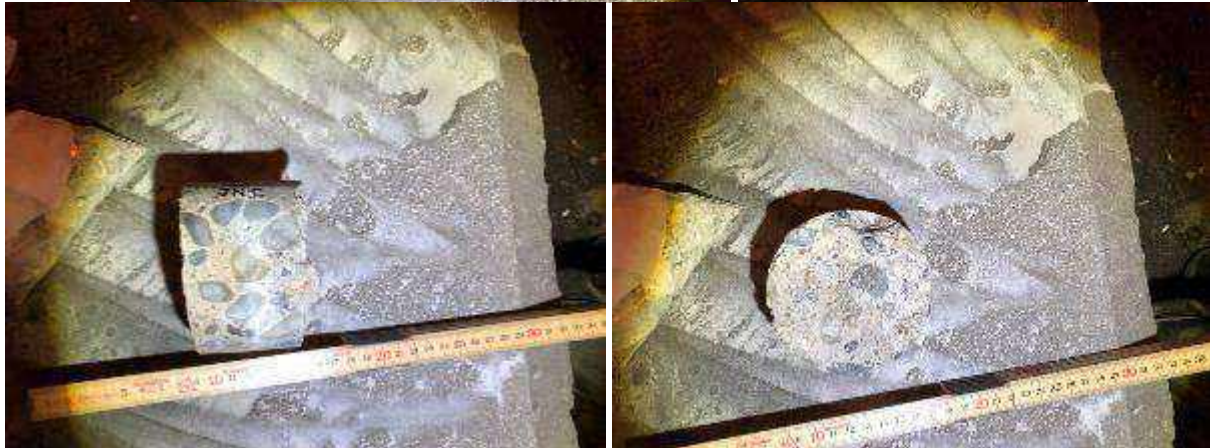
Date		29 July 2020		Inspector		BRPE	
Core number		JNE-P6		Reinforcement		No	
Diameter	4"	Location	Northbound Roadway Tube, Joint II/III, East wall	Length	~6 cm plus additional ~3 cm of shards collected

- > ~30 mm depth of a 'pinkish' concrete
- > Gaps are present between aggregate and paste at deepest parts of the 6 cm deep core
- > No visible "vertical" cracks in the core, horizontal fracture/delamination at 6 cm depth
- > ~10 mm gaps are present at core site at ~5-6 cm depth in core hole (photo taken)

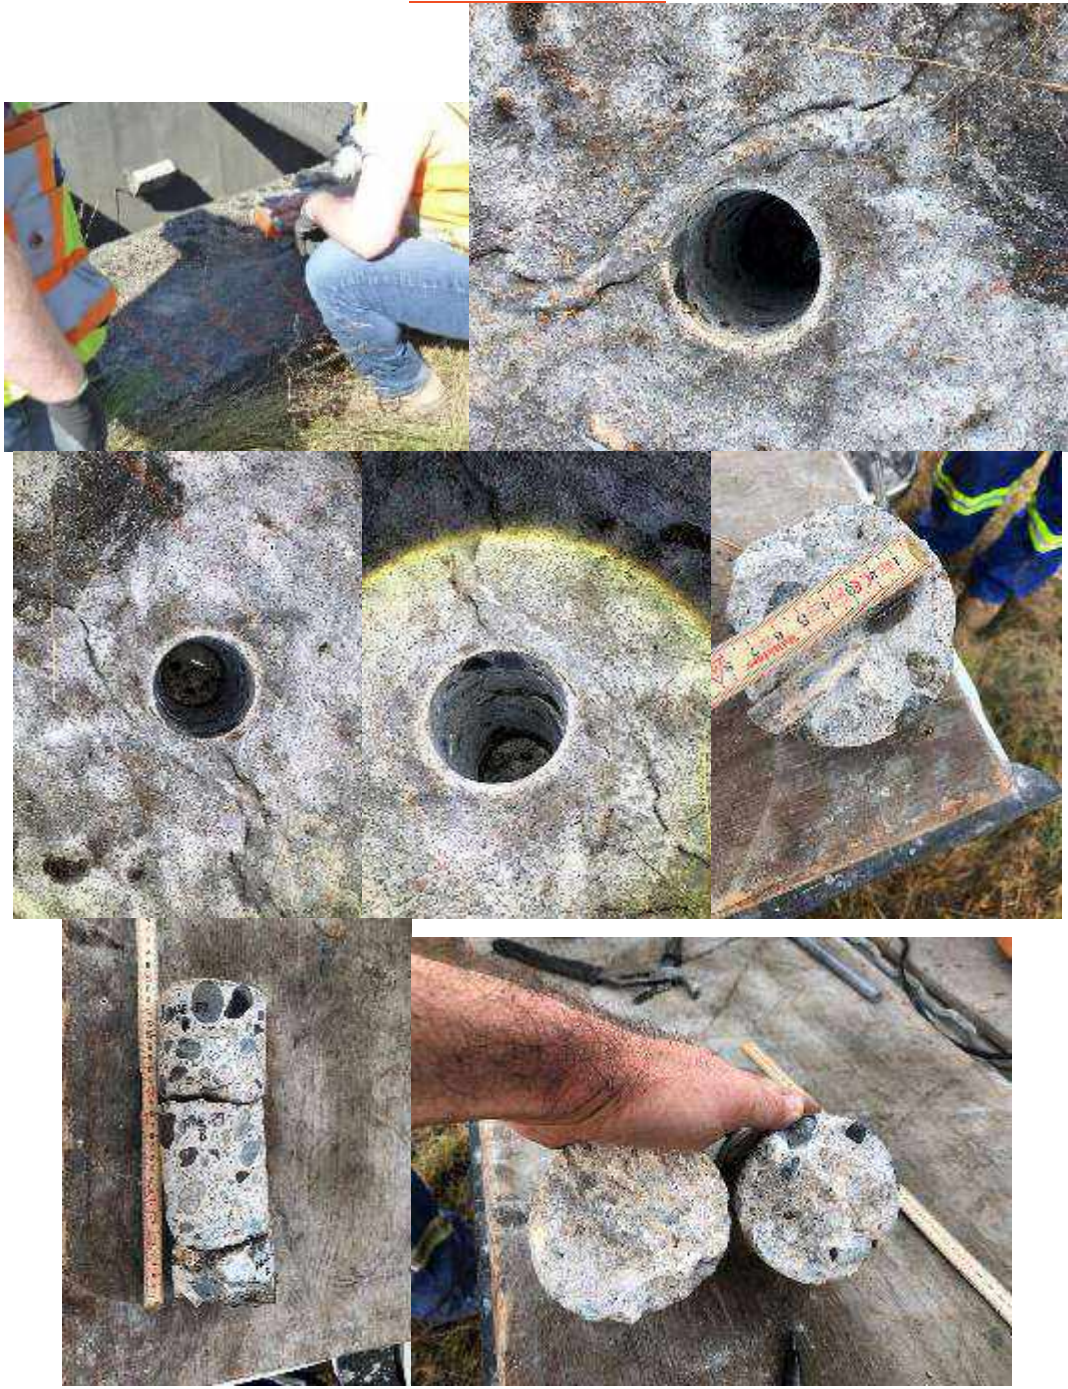
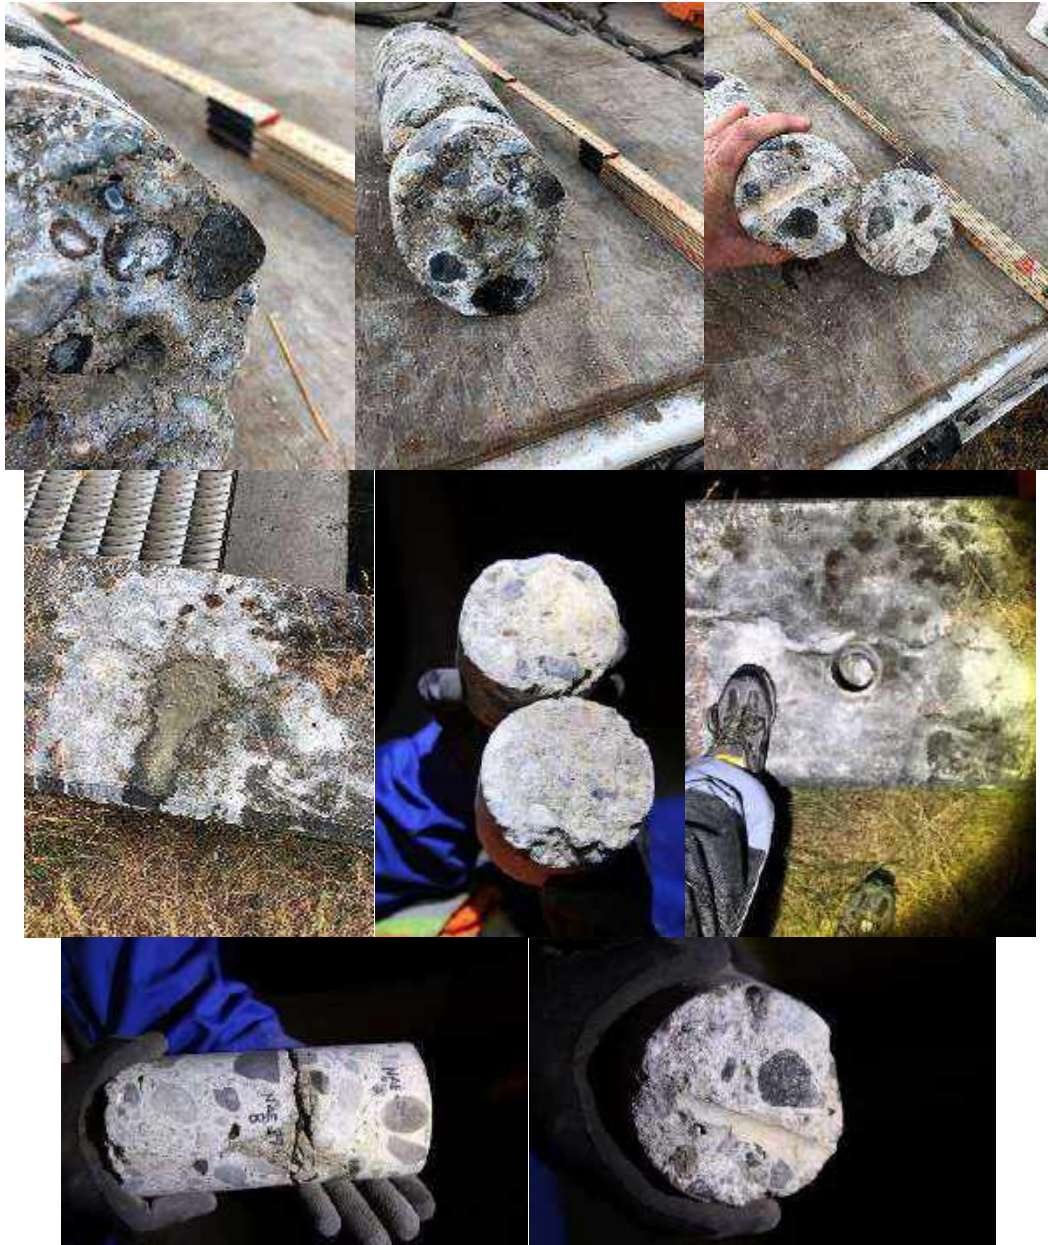
Date		28 July 2020		Inspector		BRPE	
Core number		NAE-P7		Reinforcement		Yes	
Diameter	4"	Location	Northern (Lulu) Approach, Element A5E	Length	29 cm

- > Core immediately next to past core (2000/2001 study).
- > Core was centered on a vertical crack in the wall
- > Core from top of retaining wall, northern approach east side wall A5W

- > Core came out in 3 pieces – horizontal cracks in concrete (did not appear to be fractures from coring process)
- > Signs of AAR. White deposits on horizontal cracks in the core.
- > Rebar encountered, smooth bar, ~21 cm deep. Some corrosion stains.

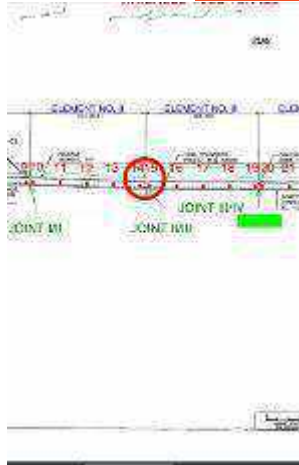
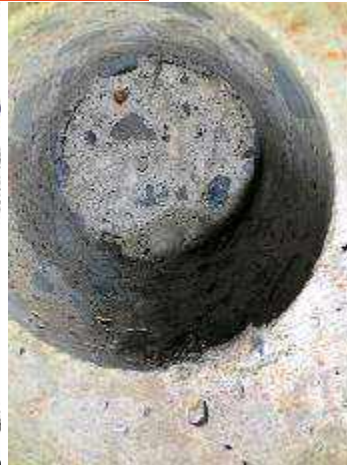
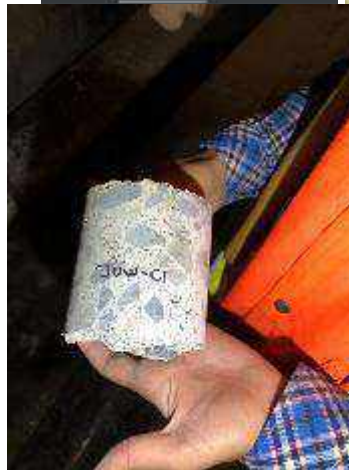
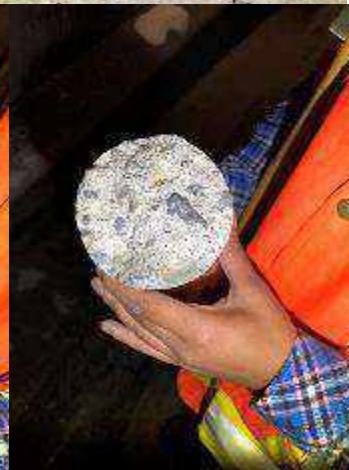
Date		28 July 2020		Inspector		BRPE	
Core number		JUW-C1		Reinforcement		No	
Diameter	4"	Location	Upstream air duct, Inner (West) wall, Joint II/III	Length	~10 cm

- > No visible cracks
- > Somewhat porous concrete, apparently more so than tunnel concrete
- > Better consolidation in this core than JUW-P1
- > Top 10-40 mm concrete has differing color (pinkish) paste.

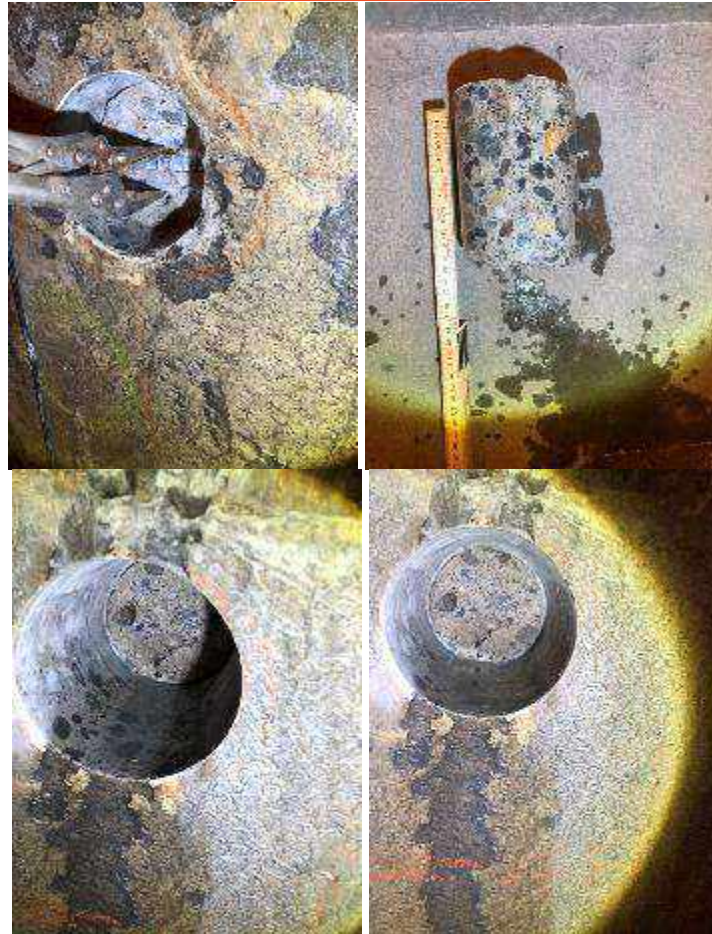
Date		29 July 2020		Inspector		BRPE	
Core number		WNE-C3		Reinforcement		No	*
Diameter	4"	Location	Northbound Roadway Tube, East wall, Door 34	Length	~13 cm

- > Northbound roadway tunnel entry, approximately 10 north of door 34 - chloride profile
- > Core from 85-90 cm over roadway level @ curb
- > Companion NDT (corrosion and cover measurements) completed at this site

- > No visible cracks
- > Coating/paint on surface of core.

* Rebar was encountered at core used to expose rebar for NDT. Minimal signs of corrosion on exposed bar.
