Re: George Massey Crossing Project – Use of Existing Immersed Tube Tunnel

As part of a detailed tunnel condition review undertaken by COWI (George Massey Crossing Assessment – Existing Tunnel Condition Assessment Report, December 11 2020), sampling and testing of the precast concrete tunnel sections and cast-in-place

CONDITION ASSESSMENT REPORT - DRAFT

A127810 GMC-rpt-41-ext-cowi-Condition Assessment-Rev0C-11-Dec-2020

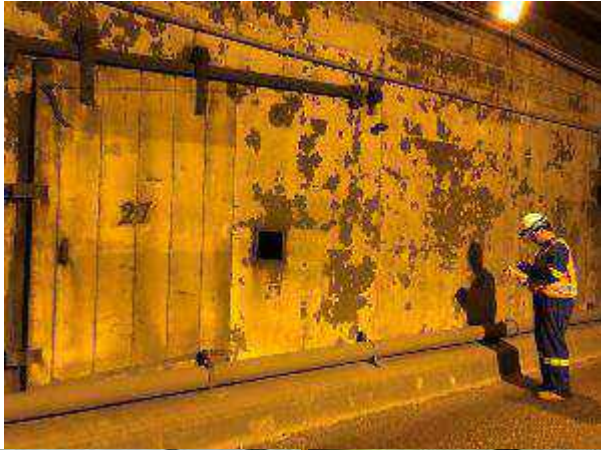
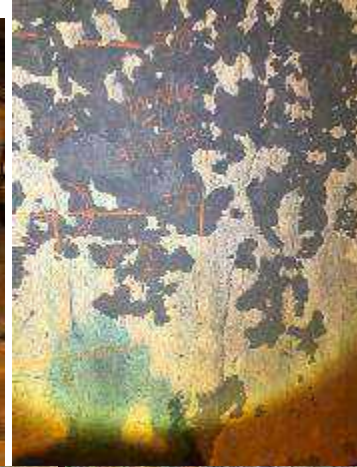
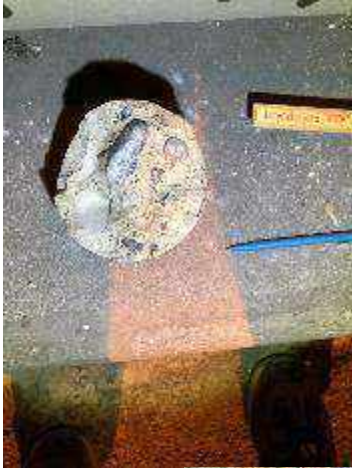
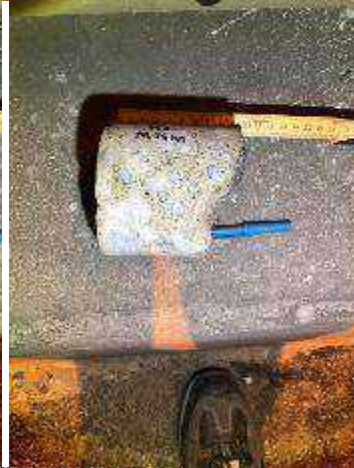
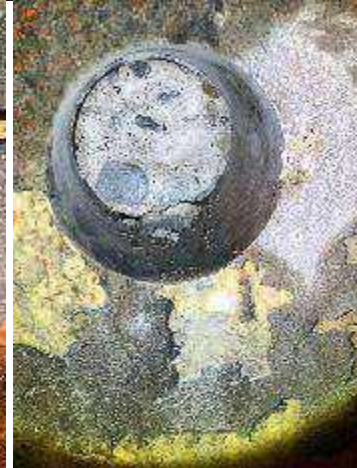
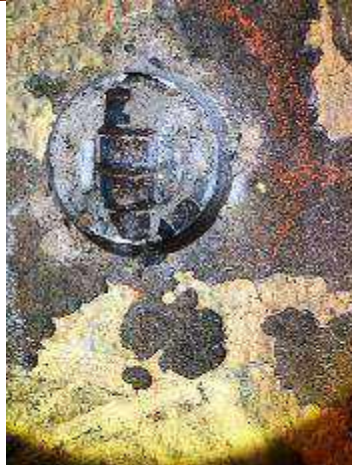
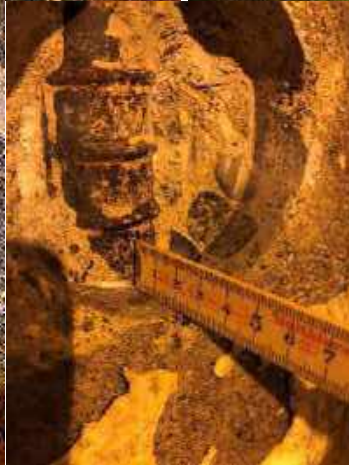
Date		29 July 2020		Inspector		BRPE	
Core number		WNW-C4		Reinforcement		No	*
Diameter	4"	Location	Northbound Roadway Tube, West wall, Door 27	Length	~9 cm

- > Core ¼ way into tunnel for chloride profile
- > Core from ~130 cm over roadway level @ curb
- > Companion NDT (corrosion and cover measurements) completed at this site

- > No visible cracks in core.
- * Rebar was encountered at core used to expose rebar for NDT. Low cover (~25 mm) and corrosion seen.

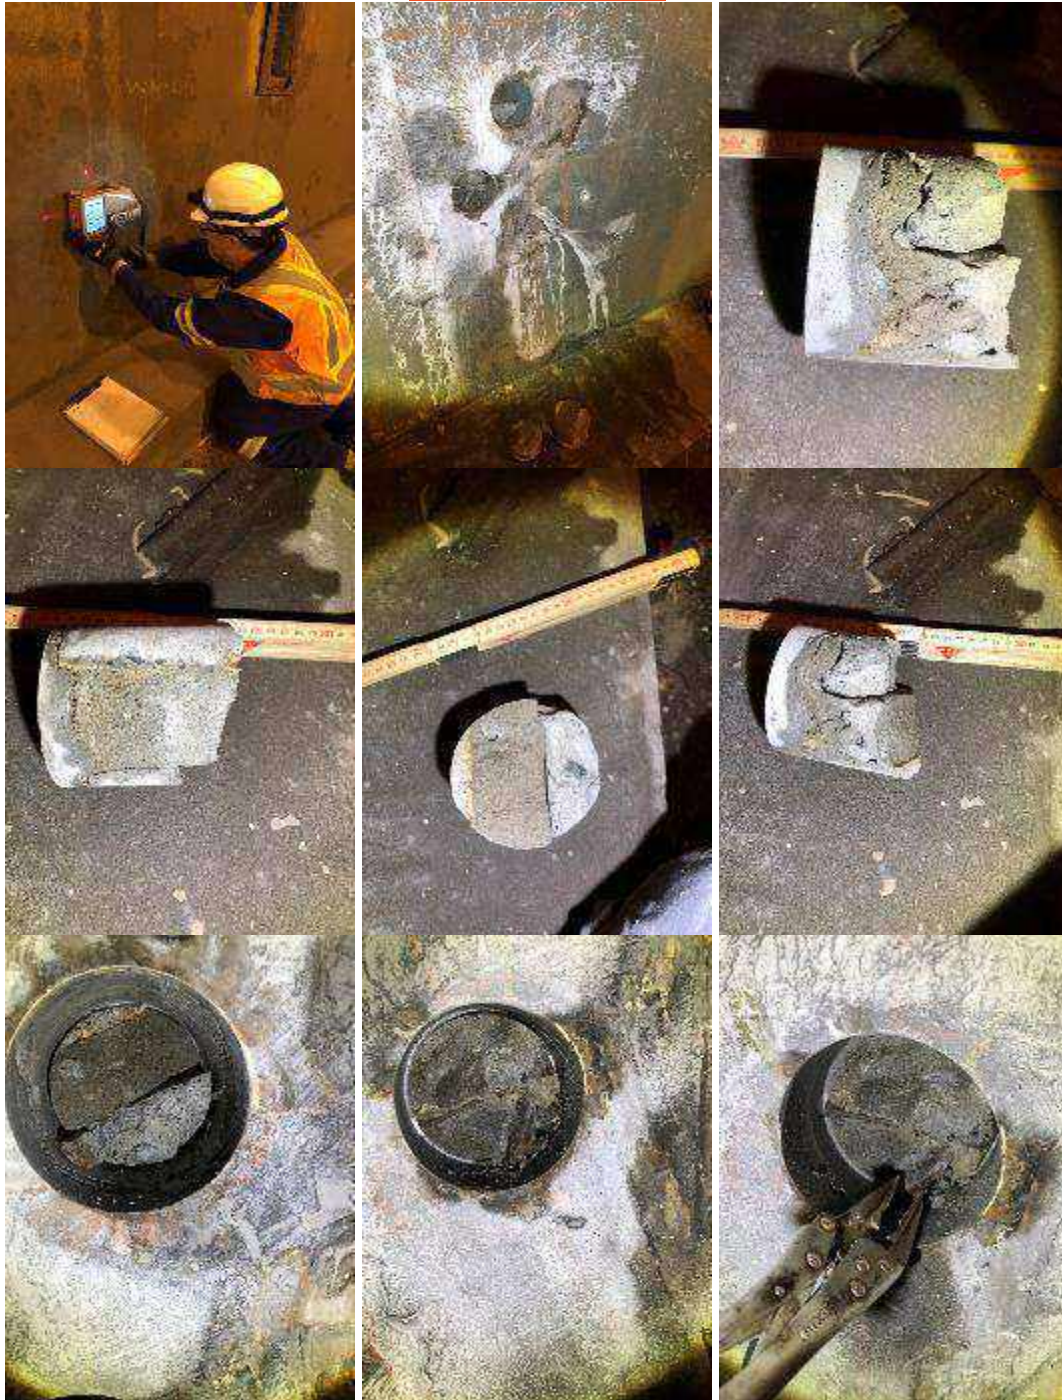
Date		29 July 2020		Inspector		BRPE	
Core number		WNE-C5 (A & B)		Reinforcement		No	
Diameter	4"	Location	Northbound Roadway Tube, East wall, Door 20	Length	7-10 cm

- > Core ½ way into tunnel for chloride profile
- > Core from ~100 cm over roadway level @ curb
- > Companion NDT (corrosion and cover measurements) completed at this site

- > At least 3 materials encountered. Porous brown material at center of core under ~5-20 mm of what appears to be a SFRC. Possibly original concrete at sides of core.
 - > Core for accessing rebar was also kept (core B). Core B was approximately 4 cm deep. This core seems to be entirely the (possible) SFRC outer layer seen in the first core. Determined to complete chloride profile on Core B.
- * Rebar was encountered at core used to expose rebar for NDT, limited signs of corrosion.

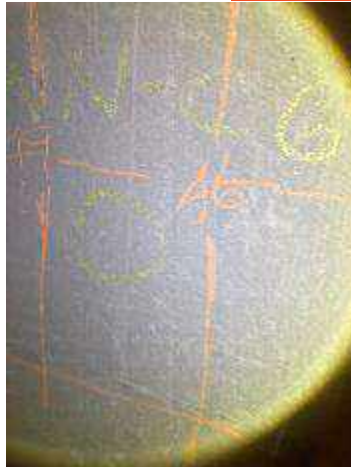
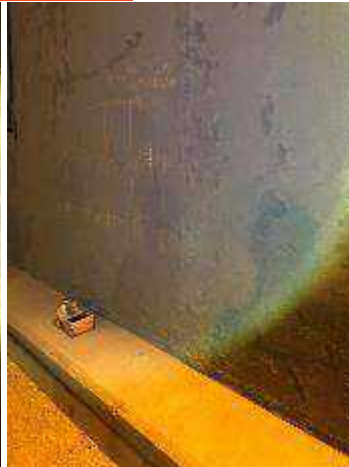
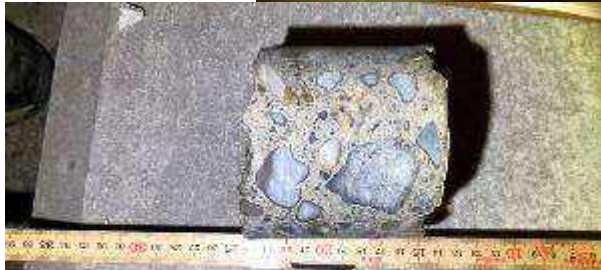
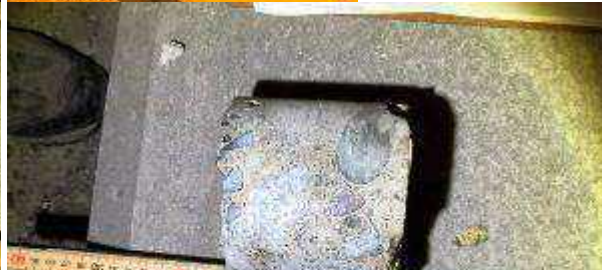
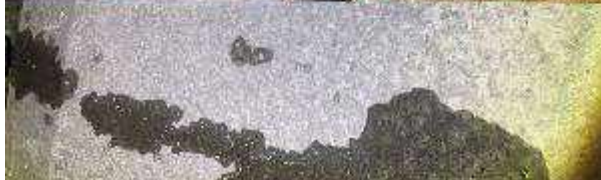
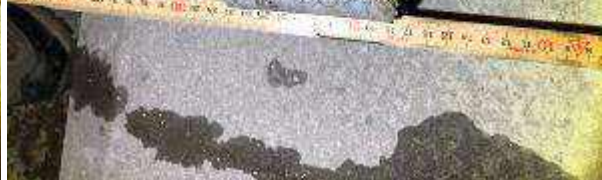
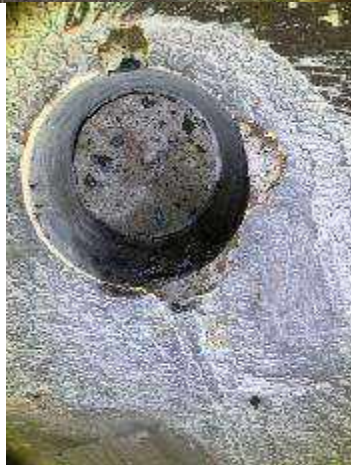
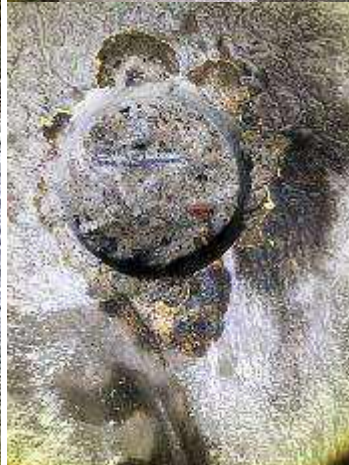
Date		29 July 2020		Inspector		BRPE	
Core number		WNE-C6		Reinforcement		No	*
Diameter	4"	Location	Northbound Roadway Tube, East wall, Door 5	Length	8-9 cm

- > Point of interest chloride profile core near door 5, 'exit' of tunnel.
- > Core from ~125 cm over roadway level @ curb
- > Companion NDT (corrosion and cover measurements) completed at this site

- > Coating/paint on surface of core
 - > No visible cracks
 - > Well consolidated concrete
- * Rebar was encountered at core used to expose rebar for NDT. No signs of corrosion.

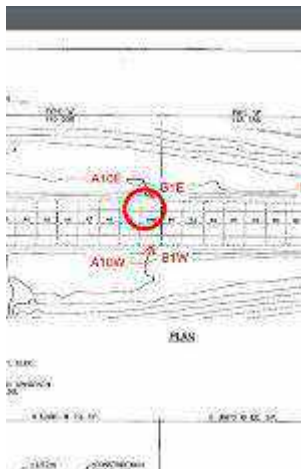
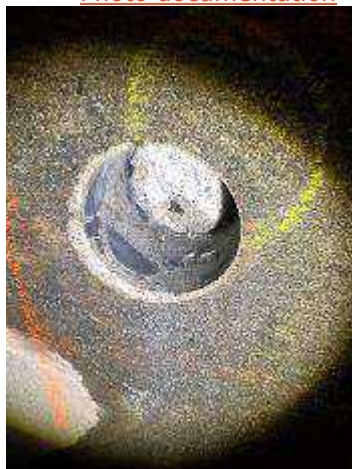
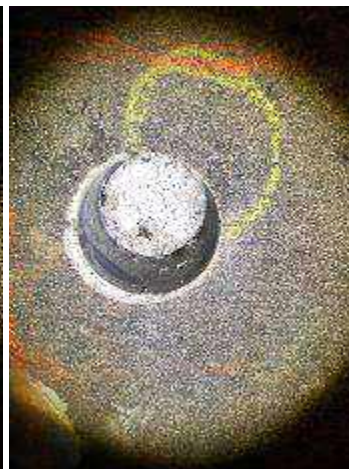
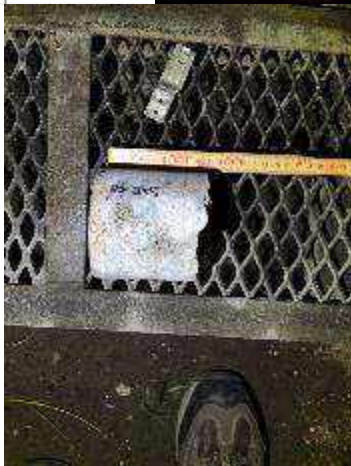
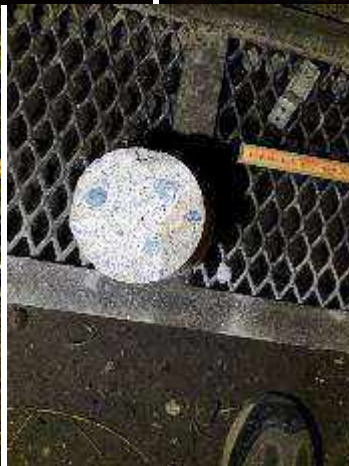
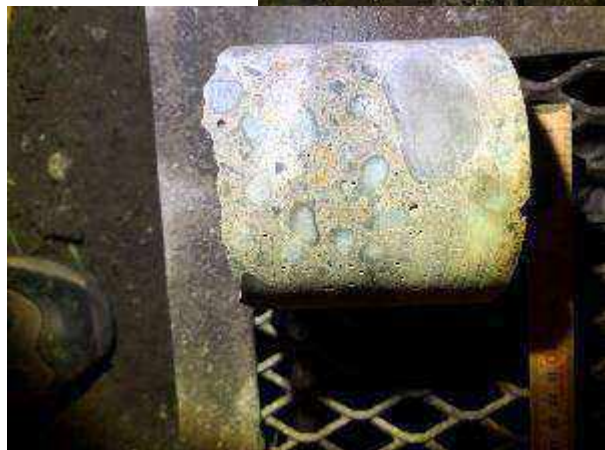
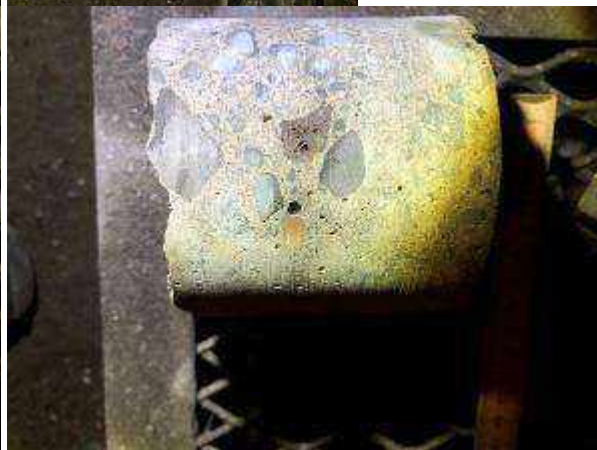
Date		29 July 2020		Inspector		BRPE	
Core number		SAE-C8		Reinforcement		No	*
Diameter	4"	Location	Southern (Deas) Approach, Element A10, East wall		Length	~9 cm

- > No visible cracks
- > Some rims and rust colored staining around aggregate and a porous aggregate seen (photo taken)

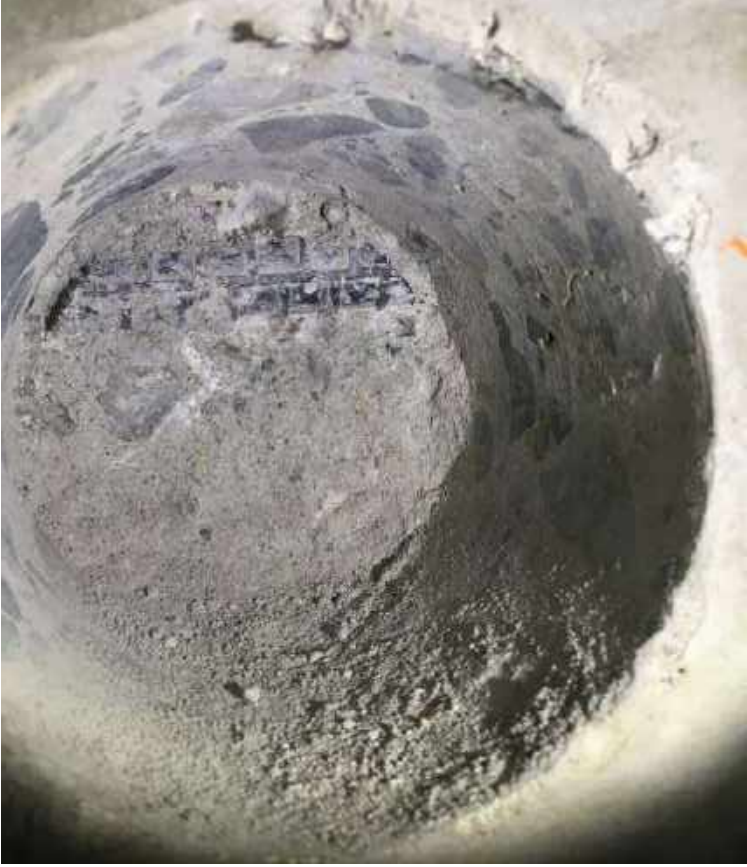
Table 1 – Test Results for West Side Air Duct, between Doors 20 and 21

<p style="text-align: center;">Rebar for electrical connection</p>
Testing	Rebar Spacing and Cover; Corrosion Current; Half-cell Potential.
Results	Rebar Spacing: Horizontal - Average 395 mm, Min 360 mm, Max 430 mm Rebar Spacing: Vertical - Average 130 mm, Min 100 mm, Max 180 mm Rebar Cover: Horizontal - Average 108 mm, Min 101 mm, Max 120 mm Rebar Cover: Vertical - Average 60 mm, Min 45 mm, Max 75 mm Corrosion Current: Average 2.6 $\mu\text{A}/\text{cm}^2$, Min < 0.5 $\mu\text{A}/\text{cm}^2$, Max 4.7 $\mu\text{A}/\text{cm}^2$ Half-cell Potential: Average -25 mV _{CSE} , Min -33 mV _{CSE} , Max -13 mV _{CSE}

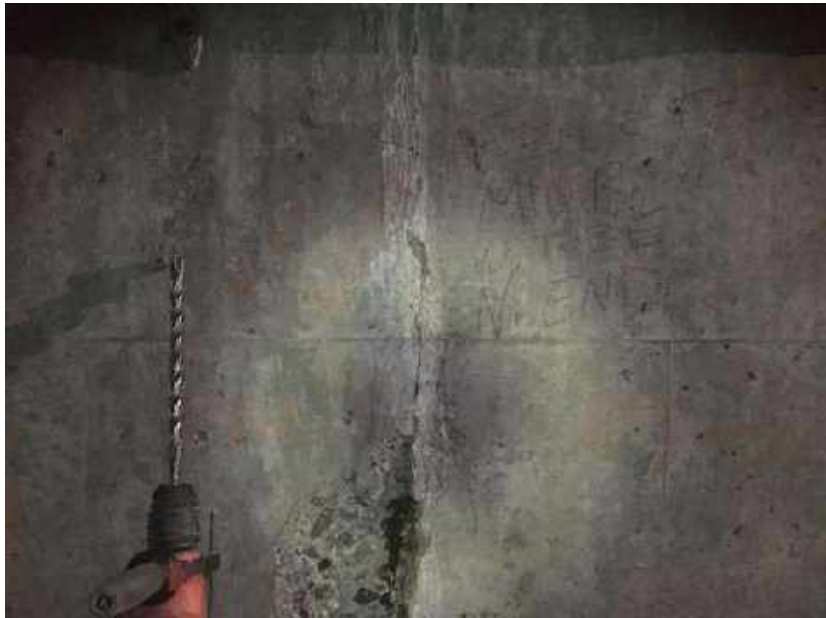
Table 2 – Test Results for West Side Air Duct West Wall, between Doors 17 and 18

<p data-bbox="834 942 1118 972">Sample location near spall</p>
Testing	Powder Samples for Chlorides/pH
Results	Chloride Ion Content (% wt. concrete)/pH: 0-20mm = 0.120/12.29 20-40mm = 0.102/11.64 40-60mm = 0.136/12.36 60-80mm = 0.076/12.37

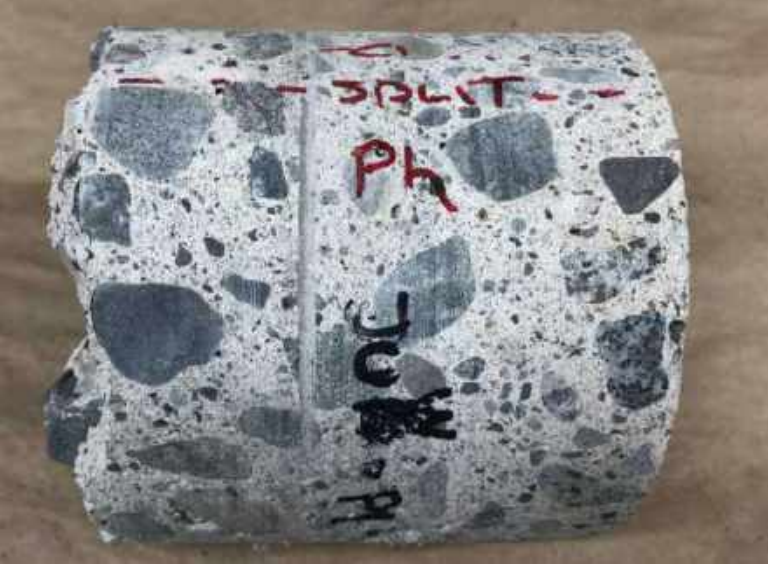
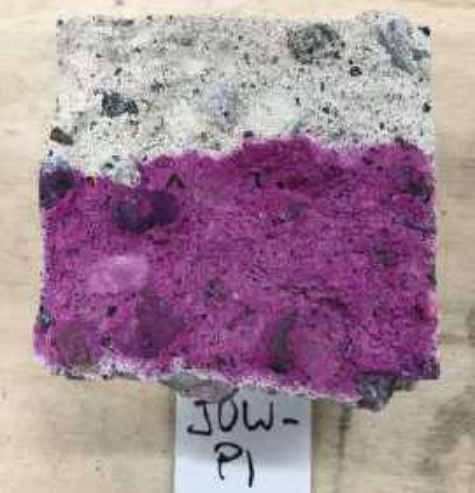
Table 6 – JUW-P1

<p data-bbox="922 884 1036 905">Intact core</p>

<p data-bbox="561 1404 1393 1430">Core split along longitudinal axis; fractured face treated with phenolphthalein.</p>
Testing	Chloride Profile and pH, Carbonation Depth Rebar Depth: 68 mm
Results	Chloride Ion Content (% wt. concrete)/pH: 0-15mm = < 0.010/10.78 15-30mm = < 0.010/9.88 30-45mm = < 0.010/12.15 45-60mm = 0.021/12.51 60-75mm = 0.030/12.58 Carbonation Depth: 33 to 45 mm; Average = 38 mm

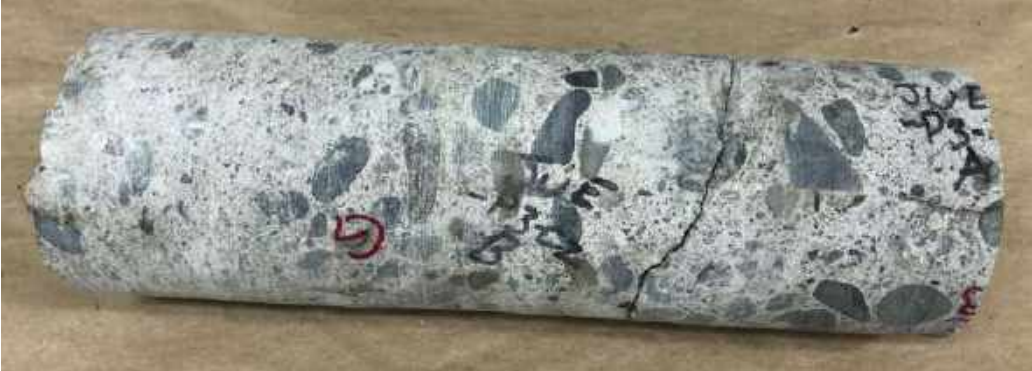
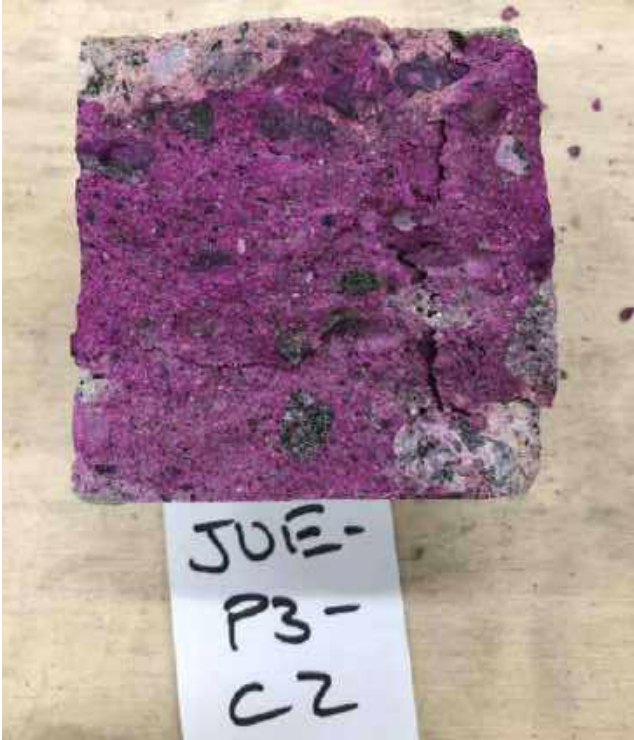
Table 7 – JUE-P3-C2

<p data-bbox="922 688 1036 716">Intact core</p>

<p data-bbox="561 1455 1393 1482">Core split along longitudinal axis; fractured face treated with phenolphthalein.</p>
Testing	Chloride Profile and pH for top 80mm of core, Carbonation Depth for top 80mm of core. Detailed petrographic analysis to be completed by others on remaining length of core.
Results	<p data-bbox="444 1549 894 1577">Chloride Ion Content (% wt. concrete)/pH:</p> <p data-bbox="444 1581 688 1608">0-15mm = 0.050/12.61</p> <p data-bbox="444 1612 704 1640">15-30mm = 0.068/12.65</p> <p data-bbox="444 1644 704 1671">30-45mm = 0.056/12.64</p> <p data-bbox="444 1675 727 1703">45-60mm = < 0.010/12.68</p> <p data-bbox="444 1707 704 1734">60-75mm = 0.023/12.61</p> <hr/> <p data-bbox="444 1745 976 1772">Carbonation Depth: 3 to 13 mm; Average = 5 mm</p>

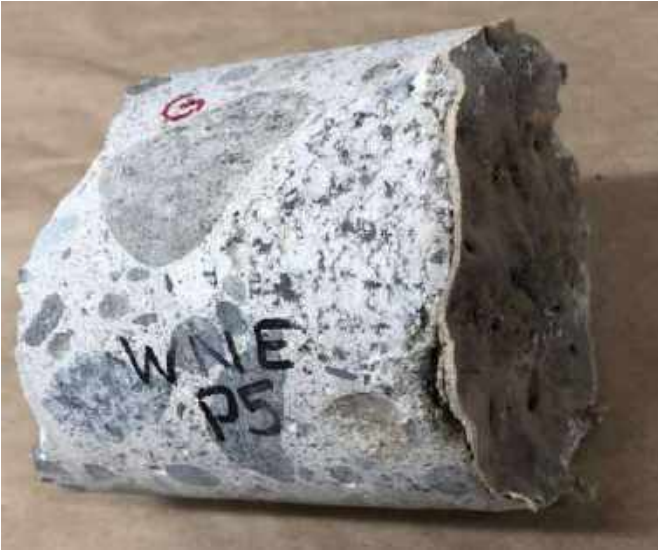
Table 10 – WNE-P5

Location ID	Photo
WNE-P5 - 6 m S of Door 12, 1.1 m above roadway

Testing	Core extracted. Detailed petrographic analysis to be completed by others.
Results	N/A

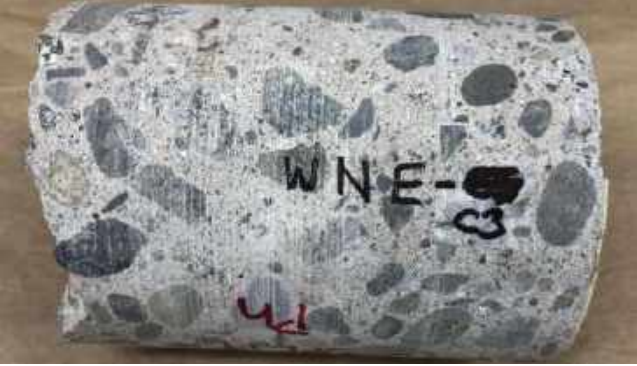
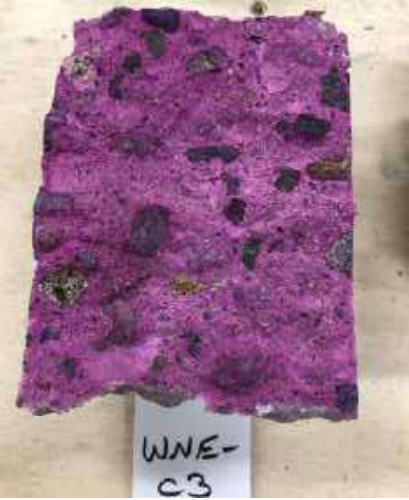
Table 12 – WNE-C3

Location ID	Photo
<p>WNE-C3 - 9 m N of Door 34, 0.9 m above roadway</p>	<div style="text-align: center;">

<p>Core split along longitudinal axis; fractured face treated with phenolphthalein</p> </div>
<p>Testing</p>	<p>Rebar Spacing and Cover; Corrosion Current; Half-cell Potential; and Powder Samples for Chlorides/pH</p>
<p>Results</p>	<p>Rebar Spacing: Horizontal - Average 306 mm, Min 300 mm, Max 320 mm</p> <p>Rebar Spacing: Vertical - Average 223 mm, Min 200 mm, Max 240 mm</p> <p>Rebar Cover: Horizontal - Average 43 mm, Min 39 mm, Max 46 mm</p> <p>Rebar Cover: Vertical - Average 61 mm, Min 59 mm, Max 63 mm</p> <p>Corrosion Current: Average 3.5 $\mu\text{A}/\text{cm}^2$, Min 2.0 $\mu\text{A}/\text{cm}^2$, Max 4.9 $\mu\text{A}/\text{cm}^2$</p> <p>Half-cell Potential: Average -134 mV_{CSE}, Min -245 mV_{CSE}, Max -53 mV_{CSE}</p> <p>Chloride Ion Content (% wt. concrete)/pH:</p> <p>0-15mm = 0.058/12.59 15-30mm = 0.027/12.61 30-45mm = < 0.010/12.61 45-60mm = < 0.010/12.65 60-75mm = < 0.010/12.68</p> <p>Carbonation Depth: 0 mm</p>

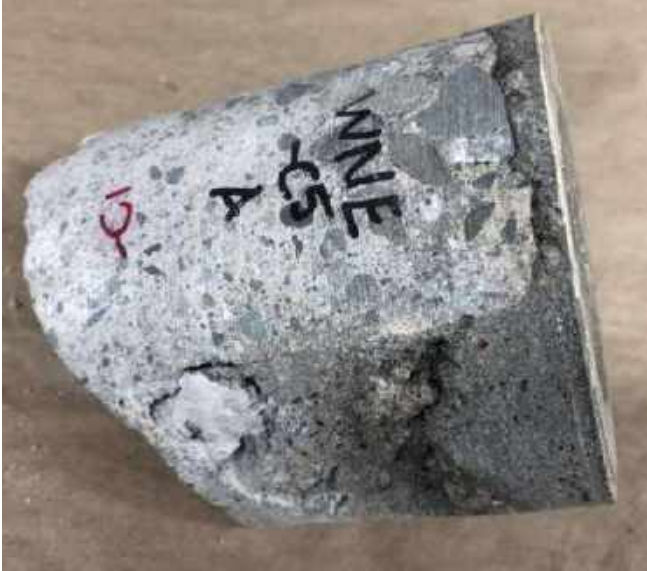
Table 14 – WNE-C5

Location ID	Photo
WNE-C5 - 4 m N of Door 20, 1.0 m above roadway

<p style="text-align: center;">Intact core</p>
Testing	Rebar Spacing and Cover; Corrosion Current; and Half-cell Potential.
Results	Rebar Spacing: Horizontal - Average 325 mm, Min 310 mm, Max 340 mm Rebar Spacing: Vertical - Average 162 mm, Min 130 mm, Max 200 mm Rebar Cover: Horizontal - Average 46 mm, Min 45 mm, Max 49 mm Rebar Cover: Vertical - Average 54 mm, Min 50 mm, Max 57 mm Corrosion Current: Average < 0.5 $\mu\text{A}/\text{cm}^2$, Min <0.5 $\mu\text{A}/\text{cm}^2$, Max <0.5 $\mu\text{A}/\text{cm}^2$ Half-cell Potential: Average -320 mV _{CSE} , Min -369 mV _{CSE} , Max -250 mV _{CSE}

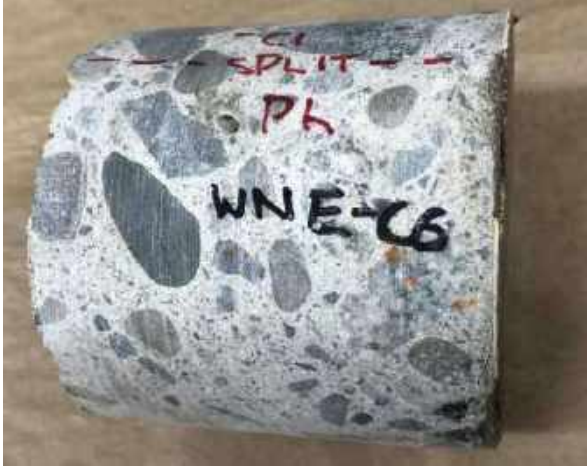
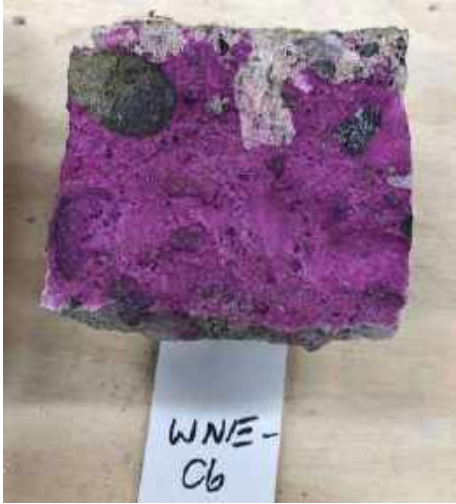
Table 15 – WNE-C6

Location ID	Photo
<p>WNE-C6 - 0 m of Door 15, 1.2 m from roadway</p>	<div style="text-align: center;">

<p>Core split along longitudinal axis; fractured face treated with phenolphthalein</p> </div>
<p>Testing</p>	<p>Rebar Spacing and Cover; Corrosion Current; Half-cell Potential; and Powder Samples for Chlorides/pH</p>
<p>Results</p>	<p>Rebar Spacing: Horizontal - Average 305 mm, Min 300 mm, Max 310 mm</p> <p>Rebar Spacing: Vertical - Average 225 mm, Min 220, Max 230 mm</p> <p>Rebar Cover: Horizontal - Average 44 mm, Min 43 mm, Max 45 mm</p> <p>Rebar Cover: Vertical - Average 49 mm, Min 46 mm, Max 54 mm</p> <p>Corrosion Current: Average 9.5 $\mu\text{A}/\text{cm}^2$, Min 5.6 $\mu\text{A}/\text{cm}^2$, Max 13.5 $\mu\text{A}/\text{cm}^2$</p> <p>Half-cell Potential: Average -170 mV_{CSE}, Min -196 mV_{CSE}, Max -150 mV_{CSE}</p> <p>Chloride Ion Content (% wt. concrete)/pH:</p> <p>0-15mm = 0.154/12.46 15-30mm = 0.019/12.56 30-45mm = <0.010/12.59 45-60mm = <0.010/12.59 60-75mm = <0.010/12.55</p> <p>Carbonation Depth: 6 to 16 mm; Average = 11 mm</p>

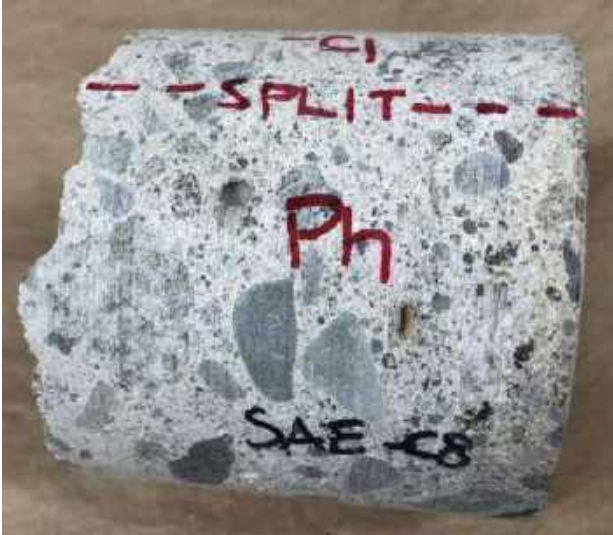
Table 16 – SAE-C8

Location ID	Photo
<p>SAE-C8 – 8 m N of 1st T-beam on S end, 0.8 m above roadway</p>	<div style="text-align: center;">

<p>Intact core</p> <p>Core split along longitudinal axis; fractured face treated with phenolphthalein</p> </div>
<p>Testing</p>	<p>Powder Samples for Chlorides/pH; and half core sent for detailed petrographic analysis by others.</p>
<p>Results</p>	<p>Chloride Ion Content (% wt. concrete)/pH:</p> <p>0-15mm = 0.154/12.47 15-30mm = 0.172/12.51 30-45mm = 0.105/12.53 45-60mm = 0.065/12.62 60-75mm = 0.040/12.57</p>

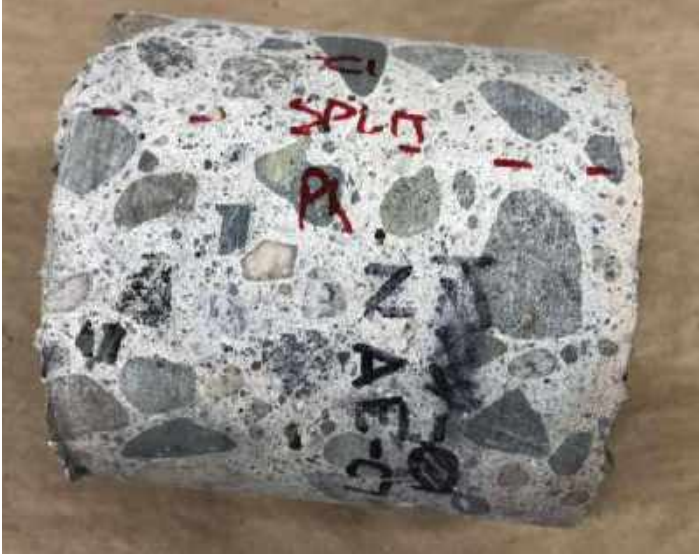
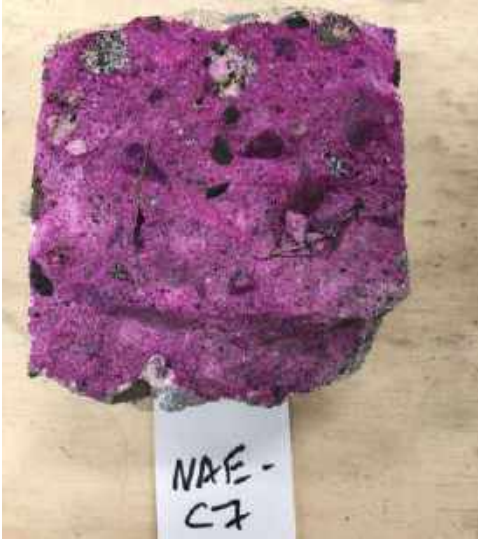
Table 17 – NAE-C7

Location ID	Photo
<p>NAE-C7 – 13th T-beam at N end, from top of curb</p>	<div style="text-align: center;">

</div> <p style="text-align: center;">Core split along longitudinal axis; fractured face treated with phenolphthalein.</p>
<p>Testing</p>	<p>Powder Samples for Chlorides/pH; and Carbonation Depth. Reinforcement at 56 mm</p>
<p>Results</p>	<p>Chloride Ion Content (% wt. concrete)/pH: 0-15mm = 0.078/12.29 15-30mm = 0.215/12.50 30-45mm = 0.133/12.52 45-60mm = 0.132/12.56 60-75mm = 0.084/12.58 Carbonation Depth: 5 to 8 mm; Average = 6 mm</p>

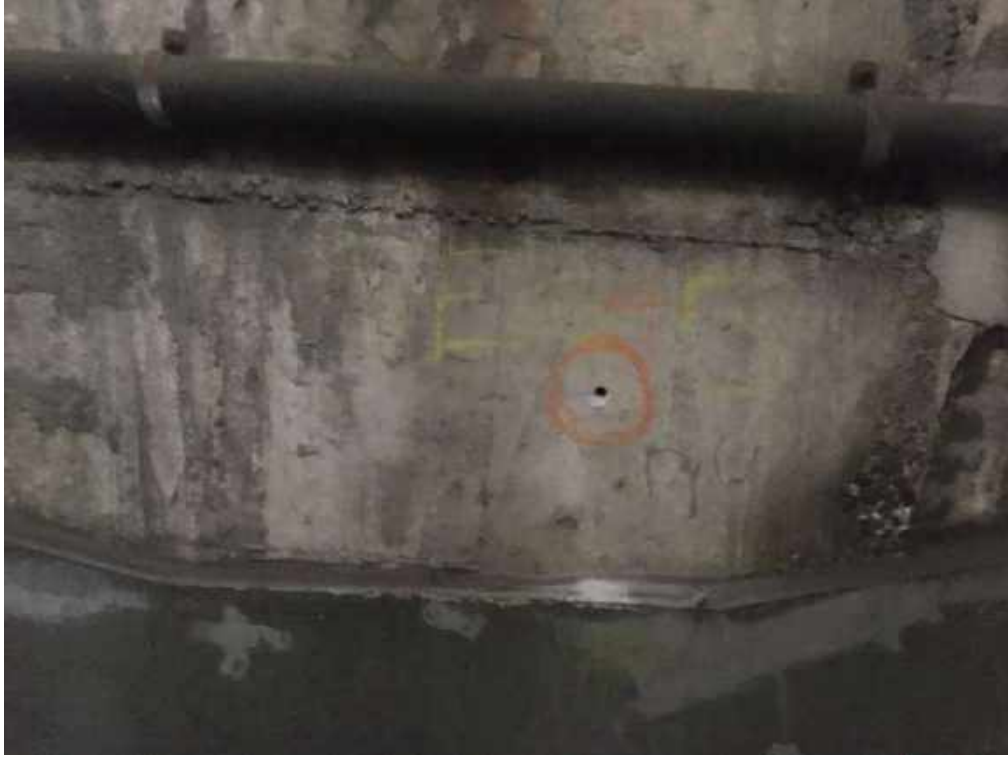
Photo 1 – Typical view of sample location at Downstream Air Duct at Element V/VI at Joint on Outer Wall.

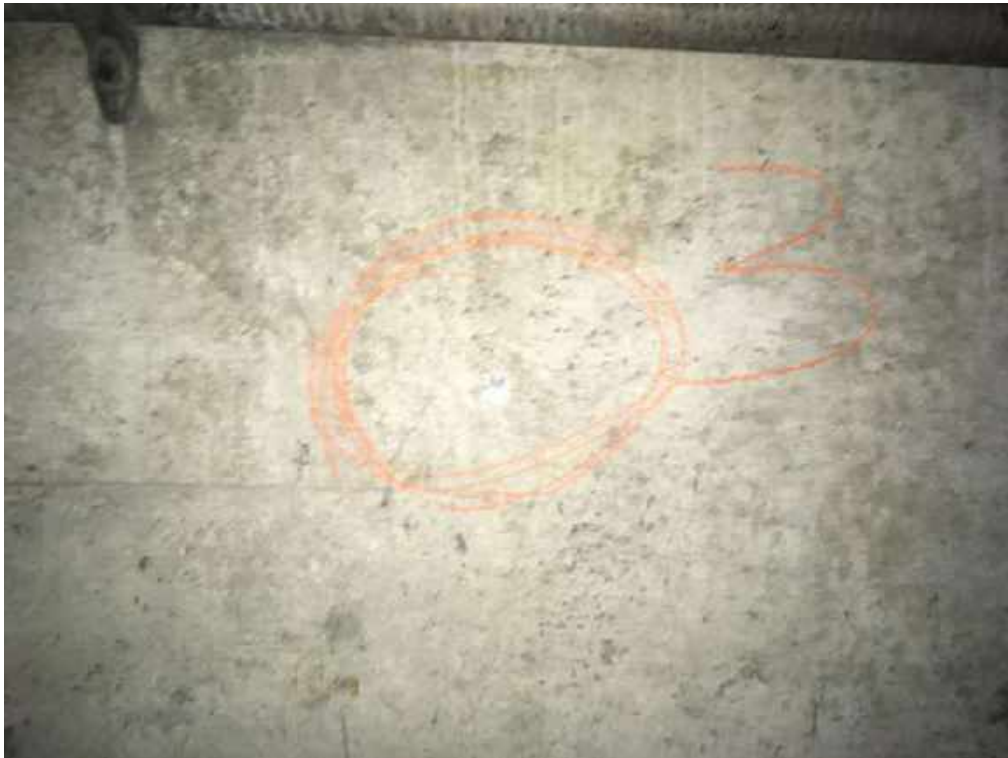
Photo 2 – Typical view of sample location at Downstream Air Duct Element V near 1st Contraction Pour on Outer Wall.

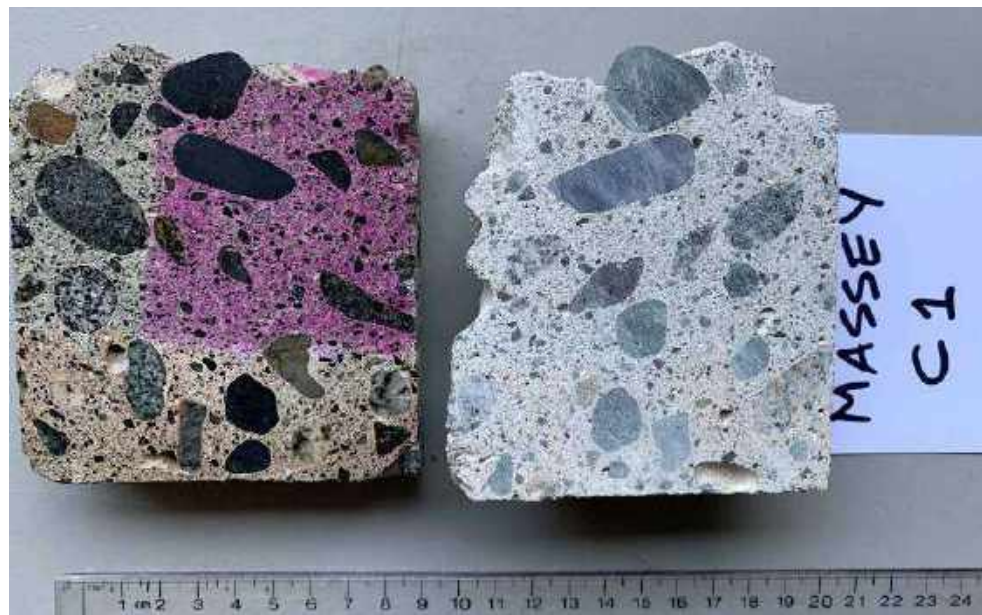
2. Cut and polished sample – outer surface is at bottom of view. Carbonation depth indicated by stain.

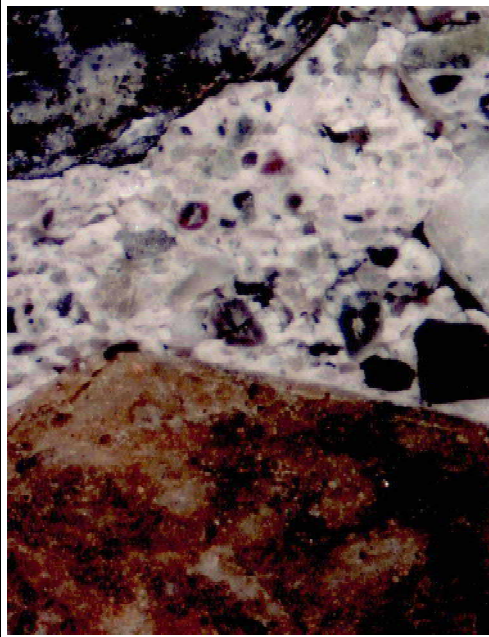
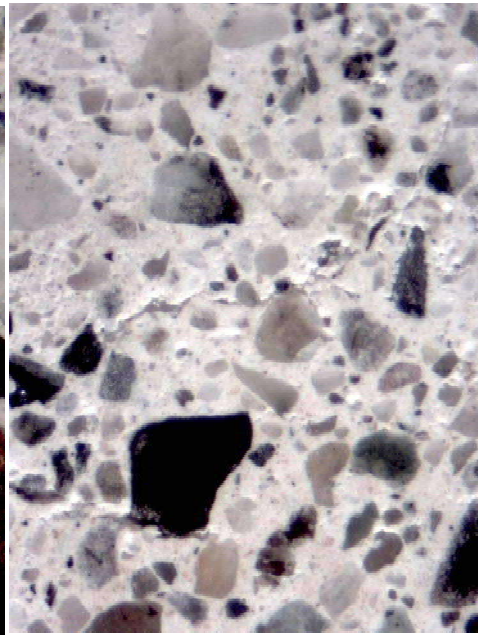
3a. Three aggregate particles debonded from paste, magnification 10x, field of view 8.7 mm long.
3b. Crack in soft/weak paste. Mag. 20x, fov = 5 mm.

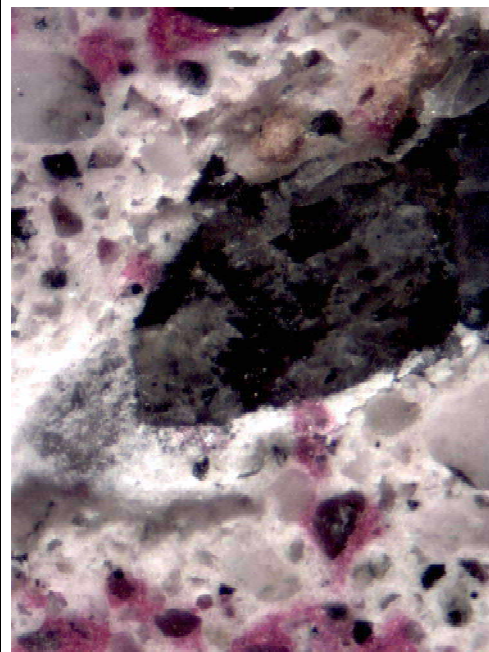
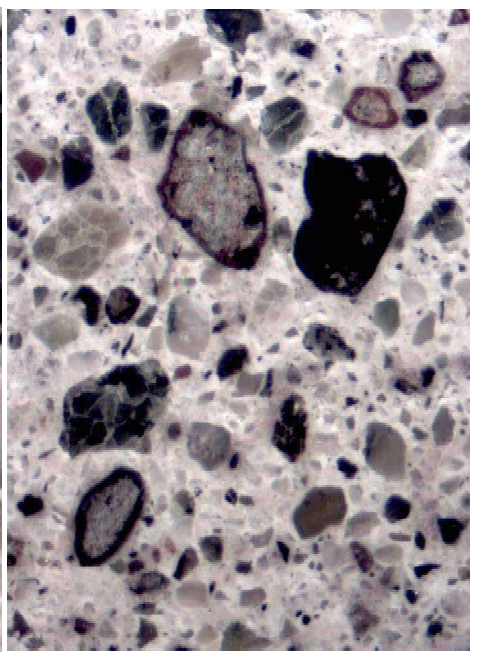
4a. Debonded aggregate with ASR gel. Magnification of 20x, with a field of view of 5 mm long.
4b. Group of volcanic rocks with reaction rims, mag. 10x, fov 8.7 mm.

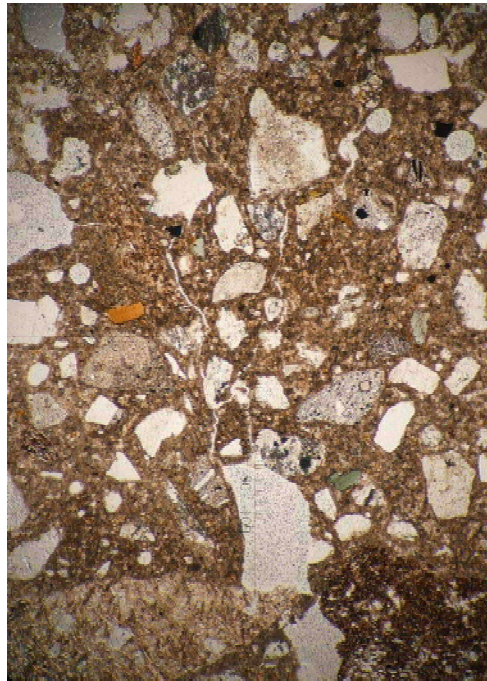
6a. Plane-polarized light view showing a series of cracks in the paste, some associated with ASR gel. Mag. 50x, fov 3 mm.

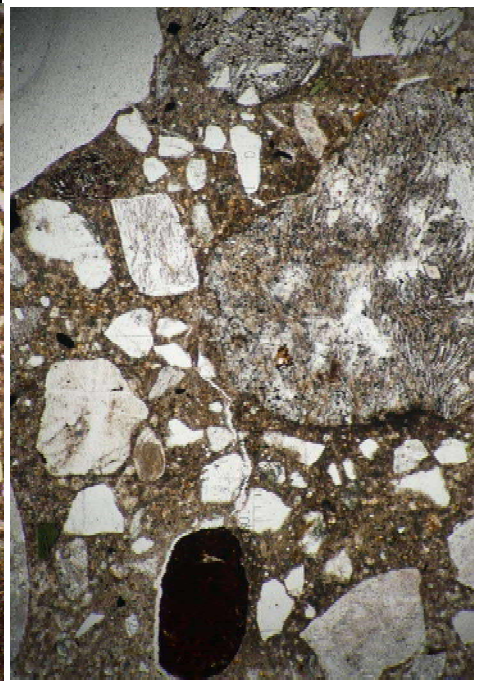
6b. Plane-polarized light view showing crack that passes along two aggregates and passes through paste. Magnification is 50x, fov 3 mm.

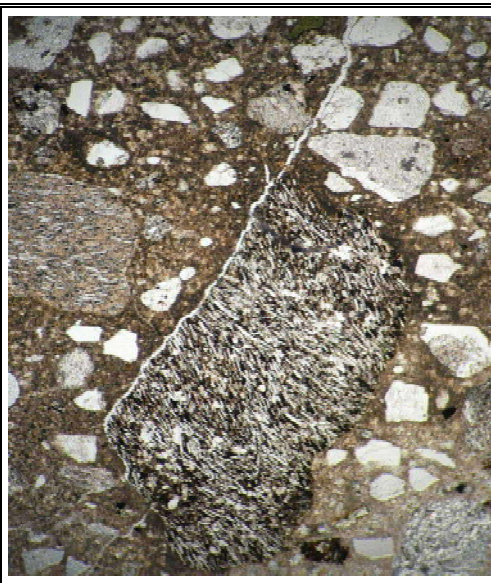
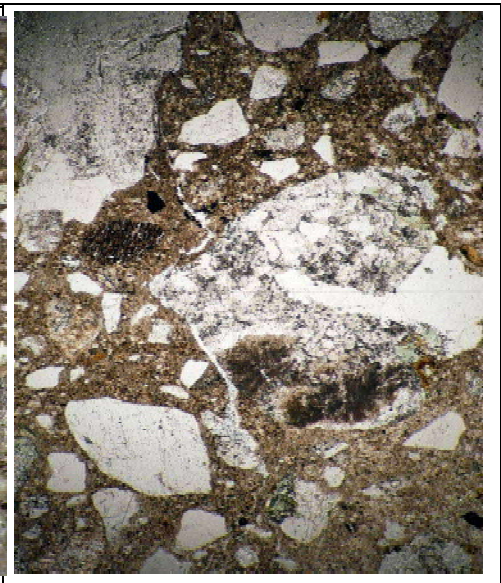
<p>7a. Crack passes along a volcanic aggregate particle. Mag. 50x, fov 3 mm.</p> <p>7b. ASR gel-lined crack in paste Mag. 50x, field of view is 3 mm in length.</p>

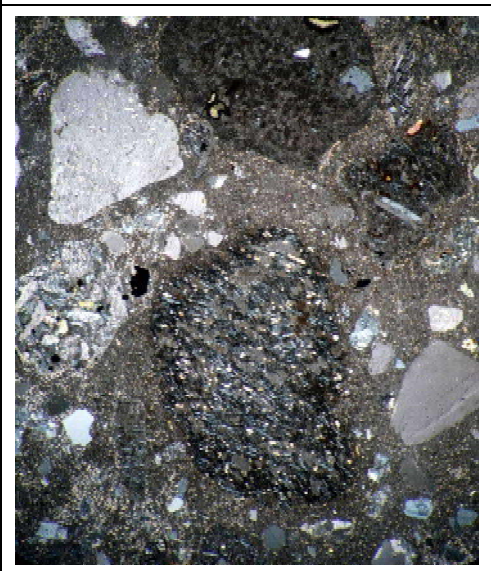
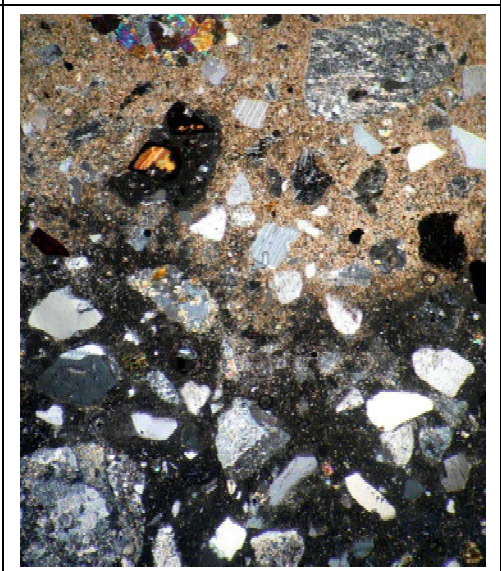
<p>8a. Volcanic aggregate with reaction rim, seen in cross-polarized light, magnification 50x, fov 3 mm.</p> <p>8b. Carbonation front about 30 mm below the top surface is seen as brown paste, uncarbonated paste appears black/dark grey-brown. Mag. 50x, fov is 3 mm length.</p>

<p>SUMMARY</p>	<p>The outer ~30 mm of the paste is carbonated. Localized patches of softer, more absorbent paste are observed in the sample.</p> <p>Frequent indications of Alkali-Silica Reaction (ASR) observed in the concrete. Cracking in paste is moderate. Reaction rims on some aggregate types are common.</p>

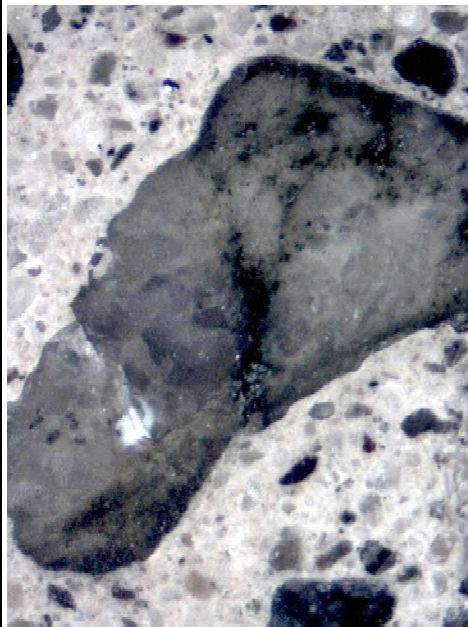
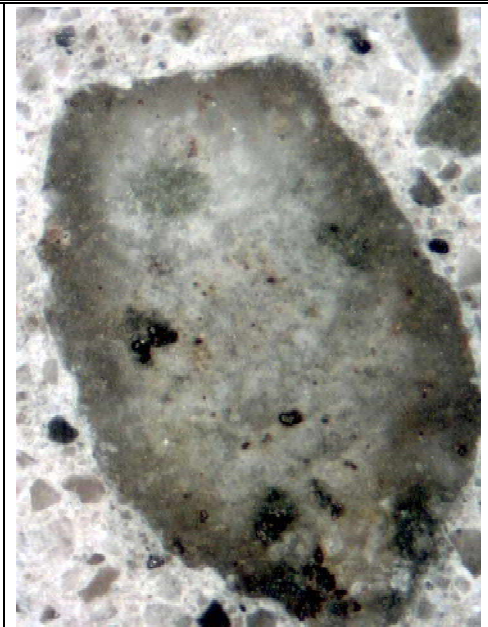
3a. Reaction rim has formed on the granite particle, and ASR gel (white) is observed on the interior of the aggregate, along a crack.
3b. Reaction rim on a metagranite particle.
Both images are at a magnification of 10x, field of view of 8.7 mm long.

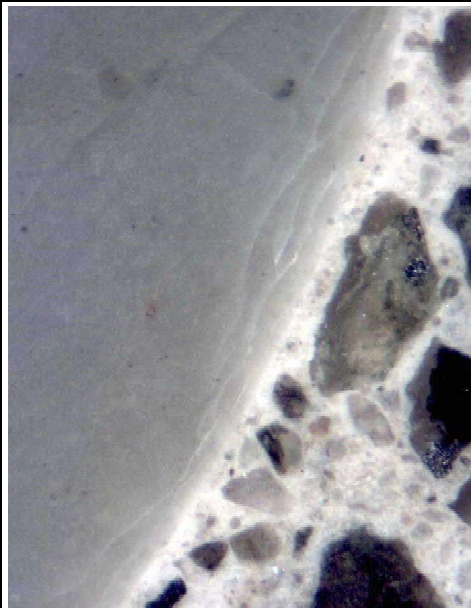
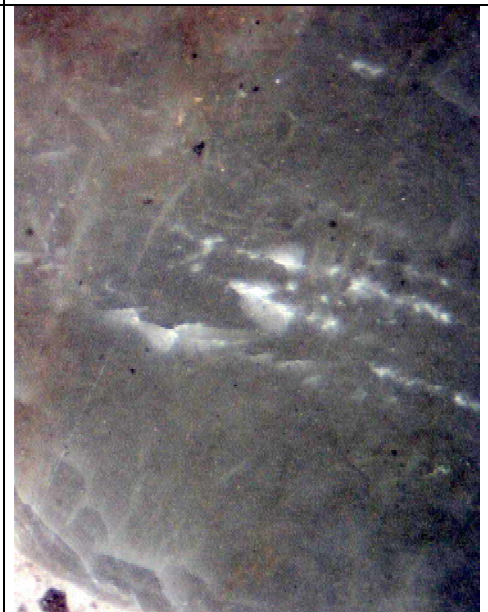
4. Two views of the same siliceous aggregate particle, showing ASR-shattered edge and resulting crack development in the left view, and ASR-filled cracks within the particle's interior. Magnification 10x, FOV is 8.8 mm length.

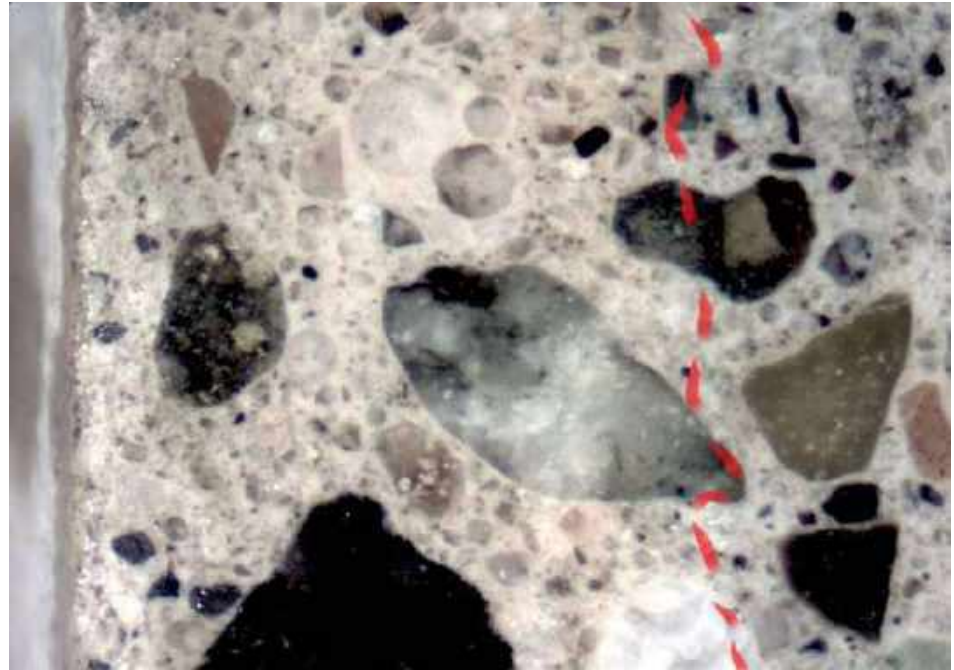
5. A profile is observed in the paste with depth below the surface in this view, where the cement transitions from the pinkish-beige carbonated outer zone to the light grey zone at about 6 mm depth, indicated with red line. Magnification 10x, FOV is about 8.7 mm long.

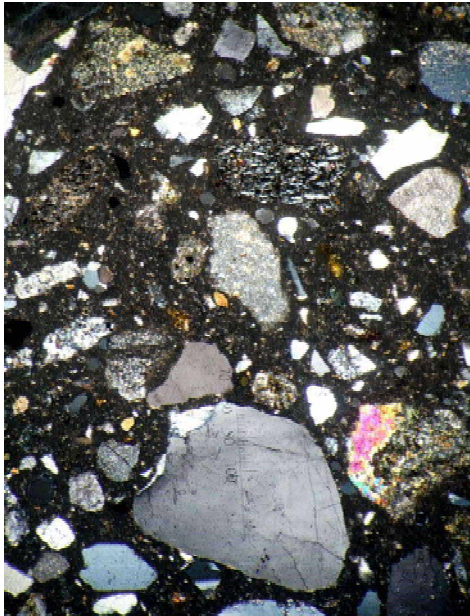
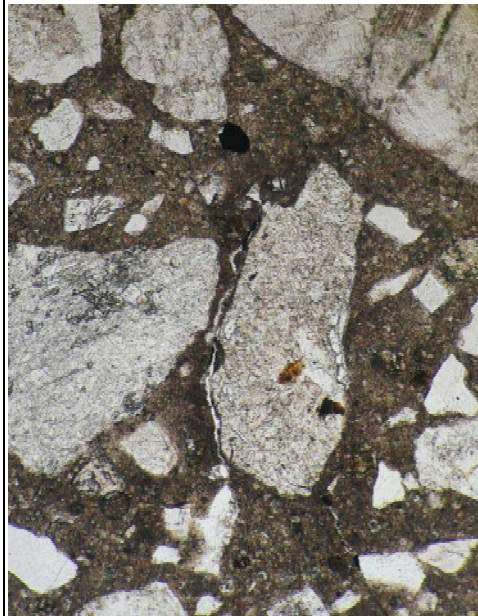
6. Cross-polarized light view of thin-section illustrating overall dense paste enclosing aggregates. 50x magn., field of view 3 mm length.
 7. Plane-polarized light view showing an example of a two microcracks in the paste containing ASR gel. Mag. 100x, FOV 1.5 mm.

The concrete is well-consolidated with adequate proportioning and distribution of aggregates in the paste matrix. Paste interface is good. The outer 7-12 mm of the concrete is carbonated. ASR-related effects are minimal: minor microcracking, reaction rims, ASR gel in a few locations.

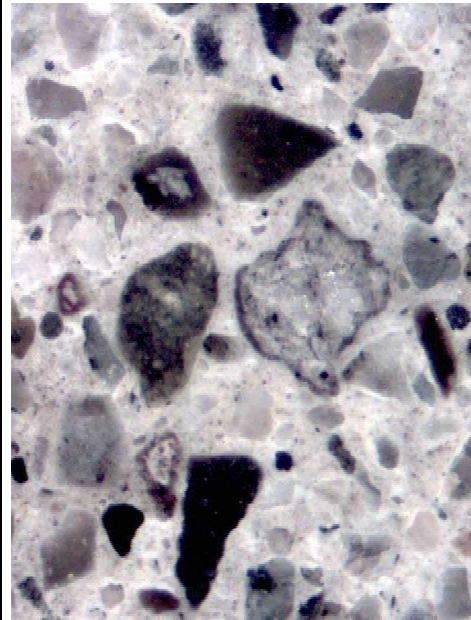
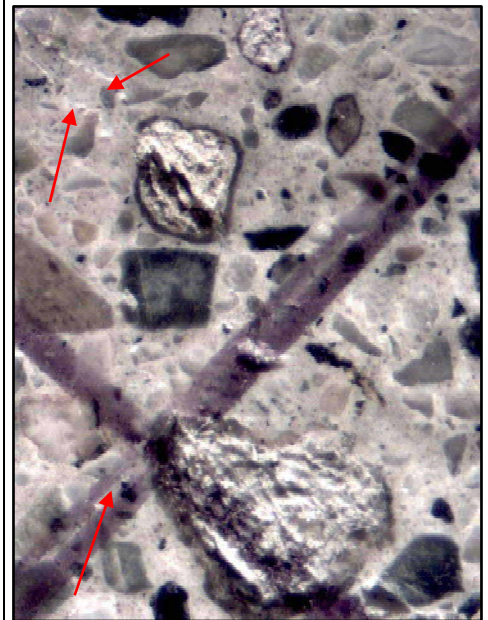
2. Two views showing corroded volcanic aggregate particles with reaction rims. In the right view, cracks extend from/to the aggregate particles and are lined with ASR gel (arrows). 10x magnification, field of view 8.7 mm length.

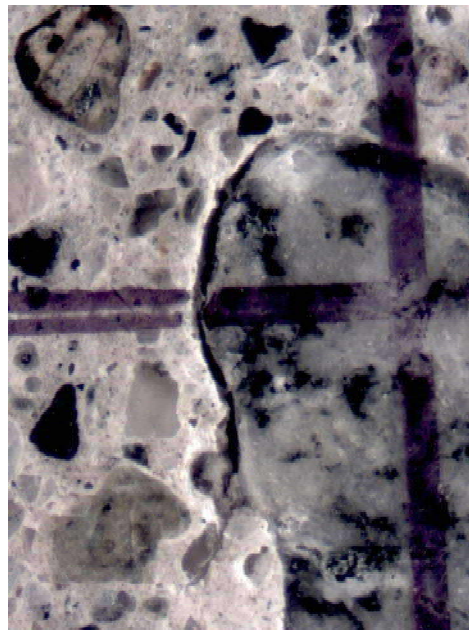
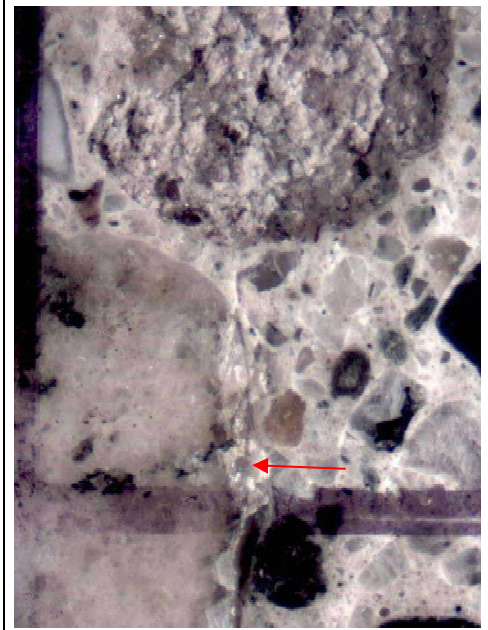
3. Debonded aggregates shown in both views with associated ASR gel-filled cracks.
Mag. 10x, fov 8.7 mm.
