Re: George Massey Crossing Project – Use of Existing Immersed Tube Tunnel

As part of a detailed tunnel condition review undertaken by COWI (George Massey Crossing Assessment – Existing Tunnel Condition Assessment Report, December 11 2020), sampling and testing of the precast concrete tunnel sections and cast-in-place

CONDITION ASSESSMENT REPORT - DRAFT

A127810 GMC-rpt-41-ext-cowi-Condition Assessment-Rev0C-11-Dec-2020

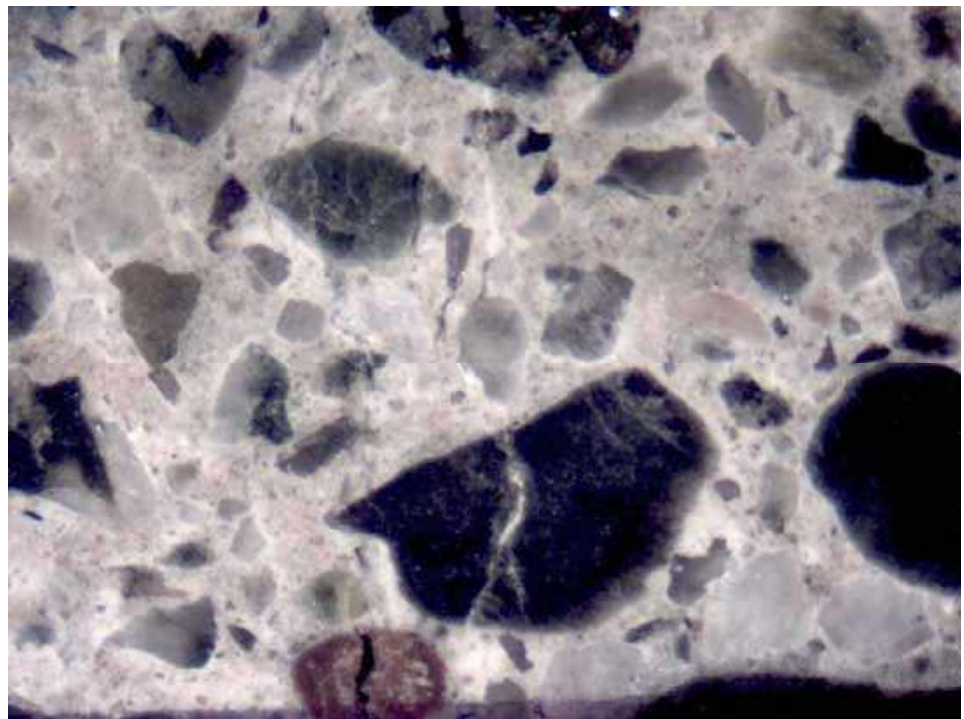
4. Microcracks extend through paste and through aggregate particles, filled with ASR gel. Open crack in purplish aggregate at bottom of view.
Magnification 10x, field of view is 8.7 mm across.

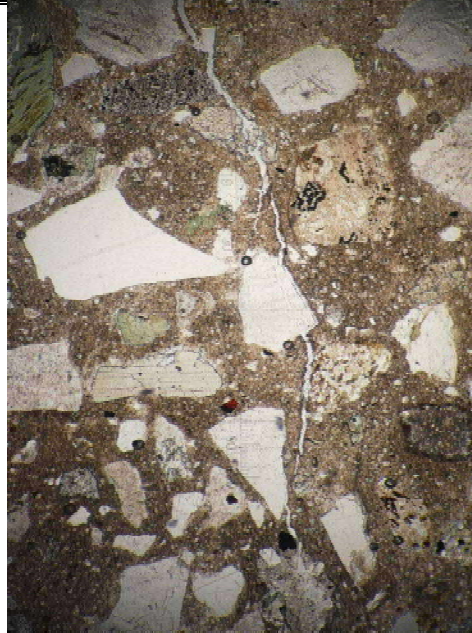
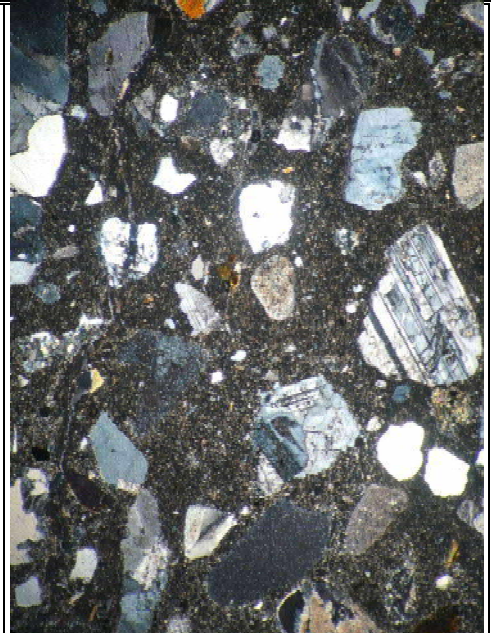
5a,b. Views in plane- (left) and cross-(right) polarized light illustrating hairlines cracks that pass through both paste and aggregates. Both view magnification 50x, fov 3 mm.

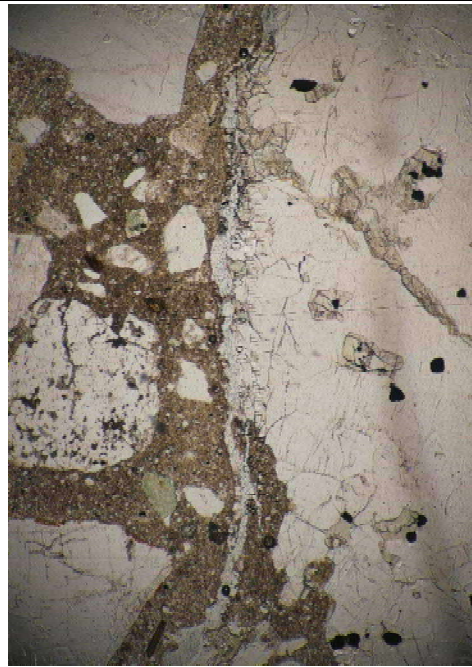
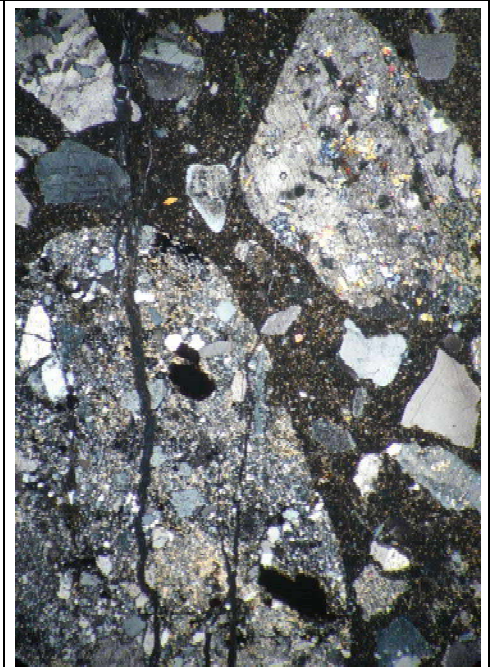
6. Two views illustrating cracks that pass through the pass and aggregates. Both views at a magnification of 10x, fov = 8.7 mm. Left image in plane-polarized light, right is in cross-polarized light.

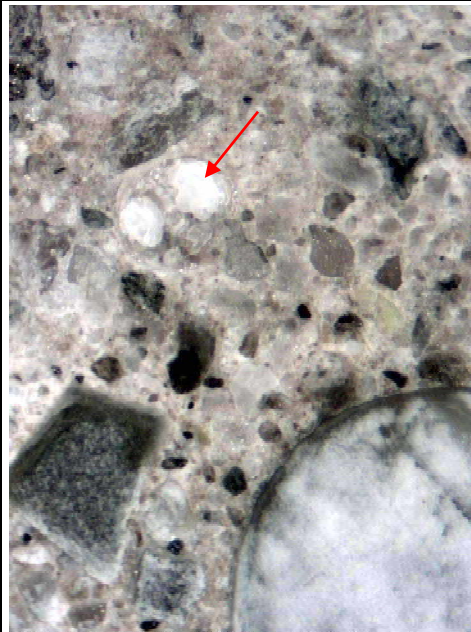
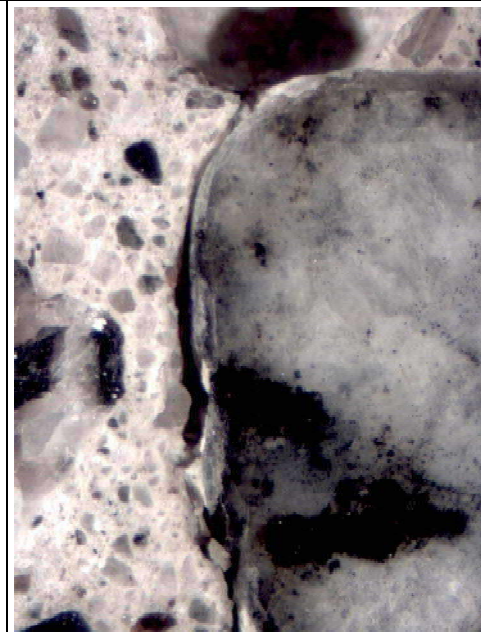
3a. Reaction rim on siliceous aggregate particle at lower right of view; ASR gel-filled void indicated with arrow. Mag. 10x, FOV of view is 8.7 mm.
3b. Debonded aggregate particle, with some ASR gel in resulting crack. Mag. 10x, fov = 8.7 mm.

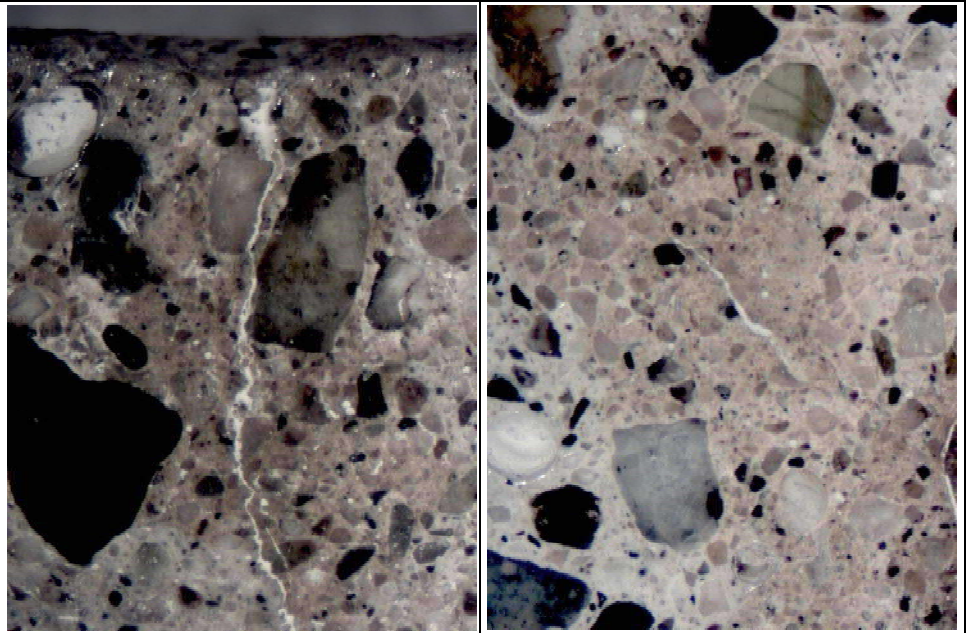
4a. Views of cracks in P4 concrete. Left view is from surface, and right view is about 15 mm below surface. Both cracks are ASR-gel-lined. Both are at a magnification of 10x, with a lengthwise fov of 8.7 mm.

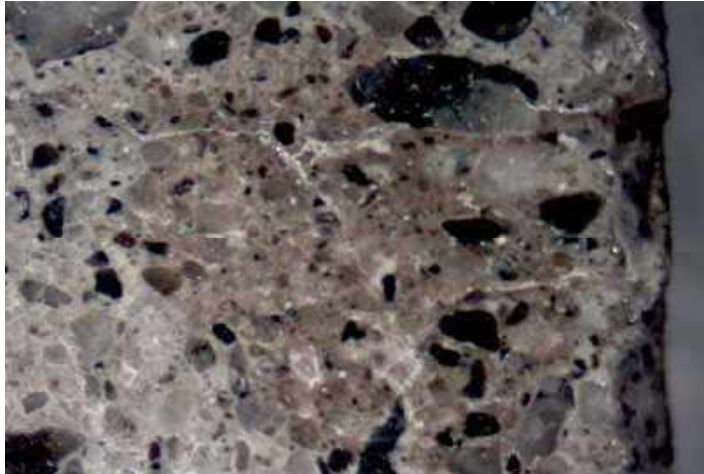
5. A multi-trace crack extends through brownish-coloured paste. Magnification 10x, fov = 8.7 mm long.

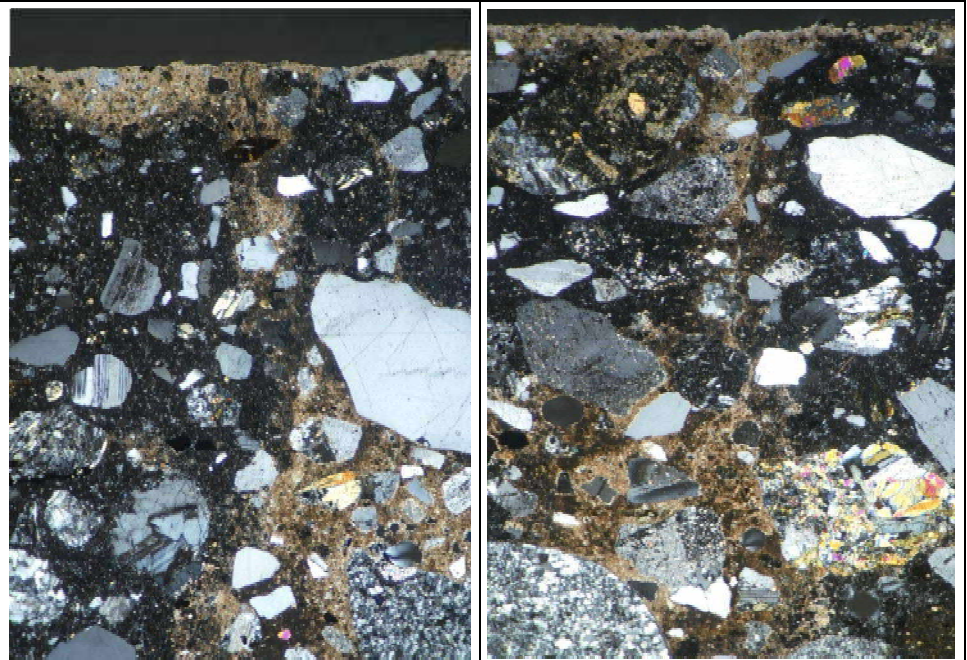
6a, b. Thin-section views in cross-polarized light at surface of core P4 showing cracks that extend through paste and expressed at surface. Discoloured paste follows the trace of the cracks beneath to surface to at least 8 mm (FOV = 8.7 mm). Magnification 50x.

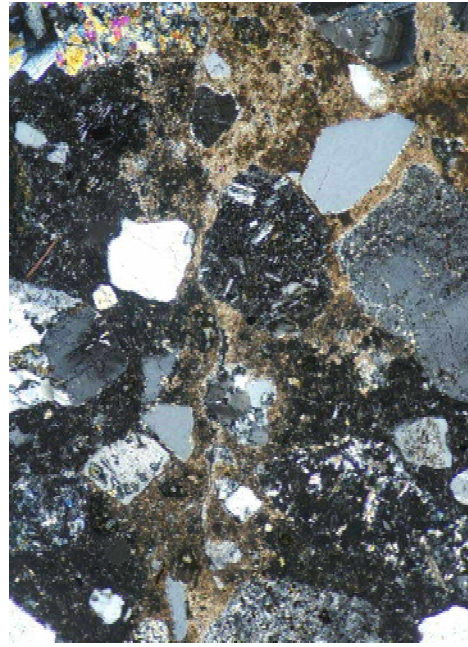
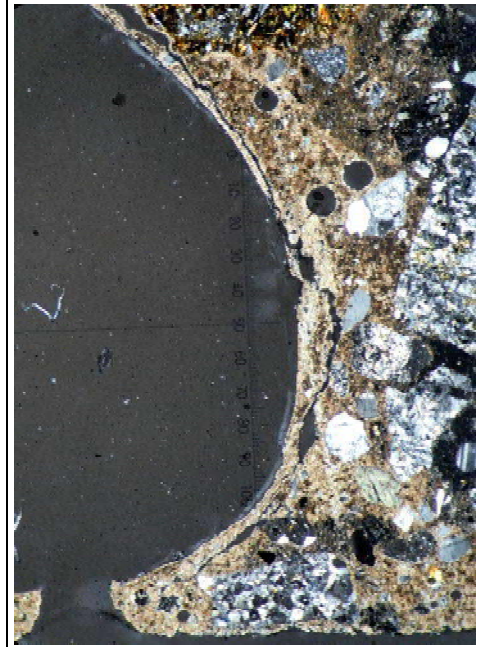
7a, b. Thin-section views, both in cross-polarized light, showing cracks that pass through the paste at depths of about 35 mm (left) and 45 mm (right). Left view is at 100x magnification, right view at 50x . FOVs are 1.8 mm and 3.5 mm respectively.

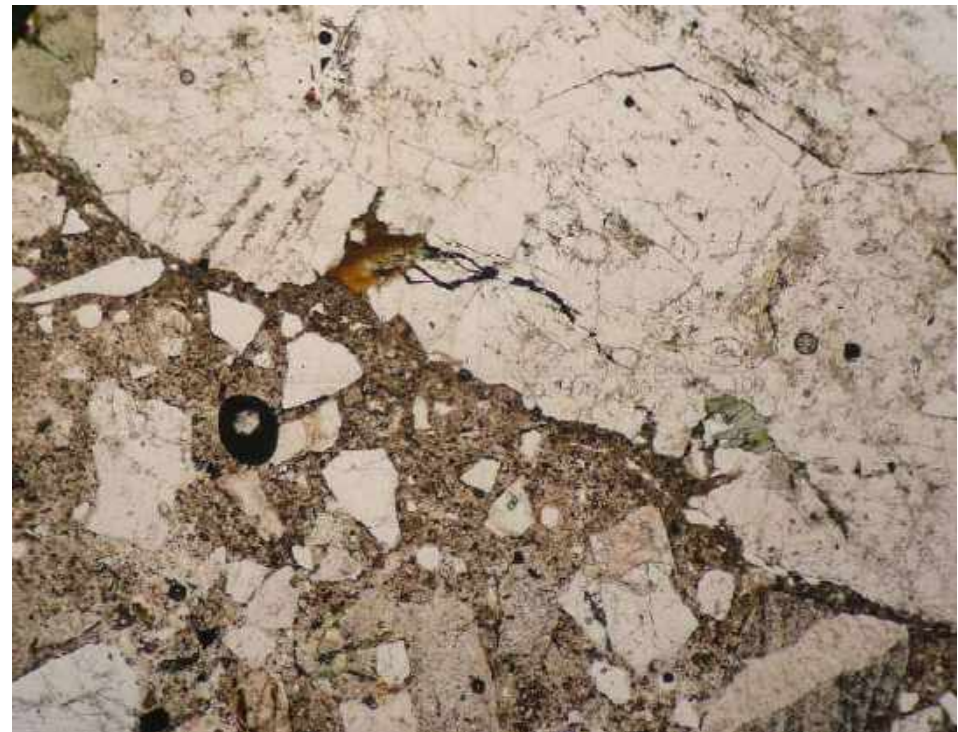
8. A crack is seen passing alongside an aggregate particle in this thin-section view, in plane polarized light. Magnification 50x, field of view is 3.3 mm.

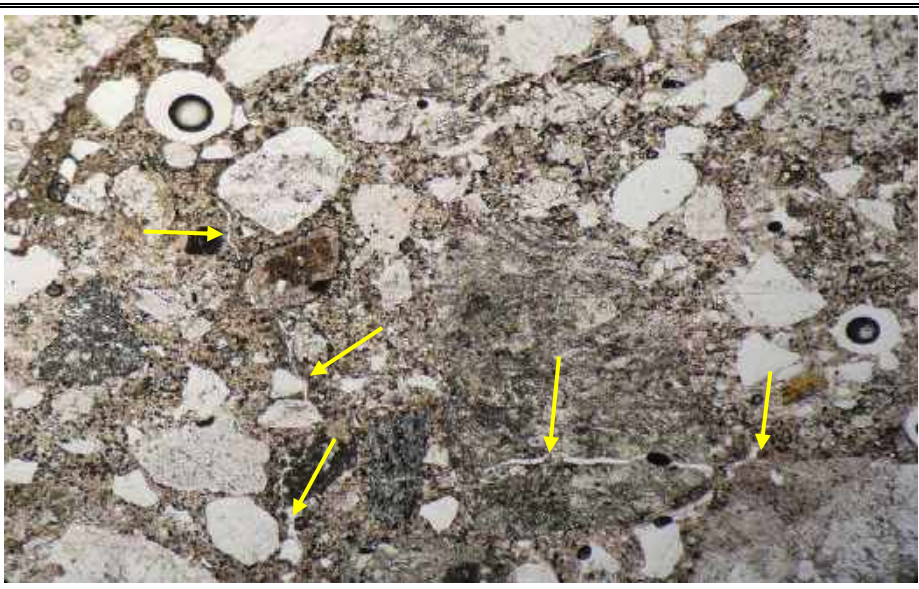
9. View in thin-section, plane polarized light, showing a crack that extends through a reactive volcanic particle and passes through the surrounding paste. Magnification 50x, fov 3.3 mm.

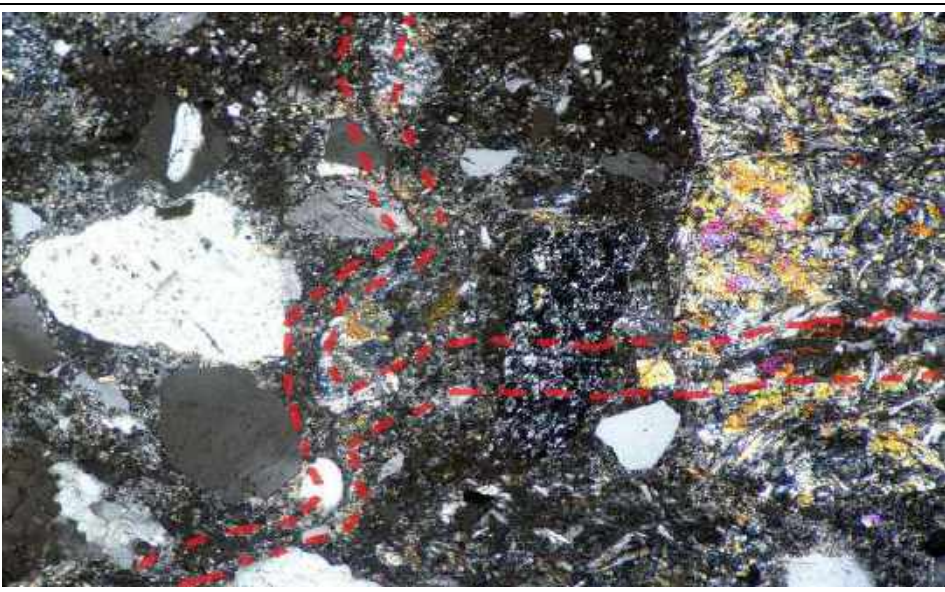
10. Detail of previous view, seen in cross-polarized light, and viewed at a magnification of 100x (field of view 1.75 mm). Cracks are outlined with dashes.

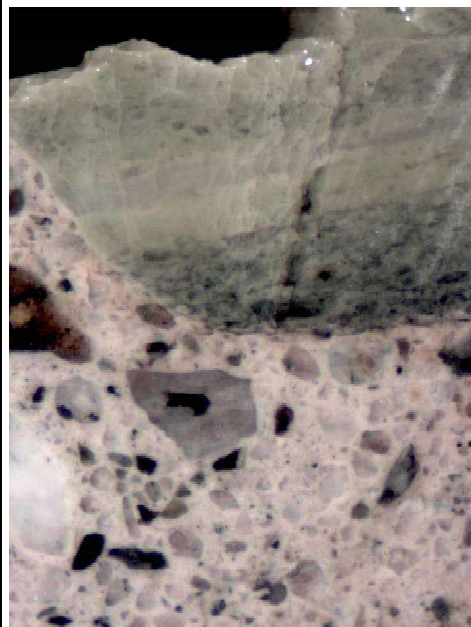
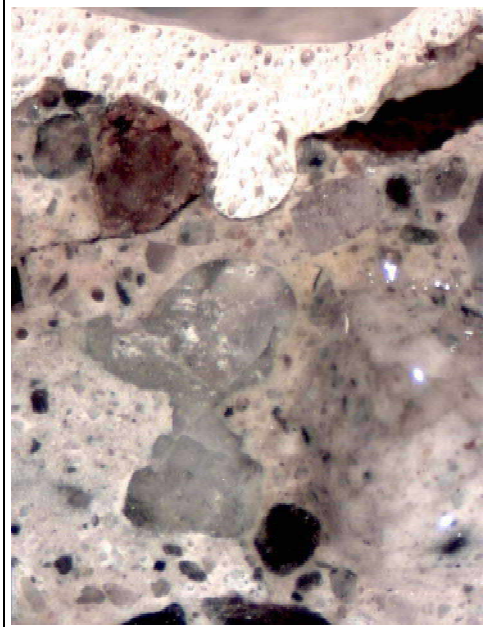
3a. Shattered aggregate at surface of core; it does not appear to have exerted significant force on the surrounding paste. Mag. 10x, field of view is 8.7 mm long.
3b. White porous coating at top of core is seen adjacent a crack expression at the surface. Mag. 10x, fov = 8.7 mm.

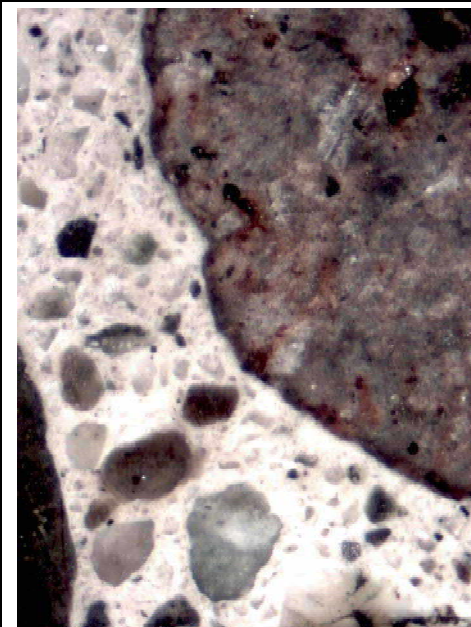
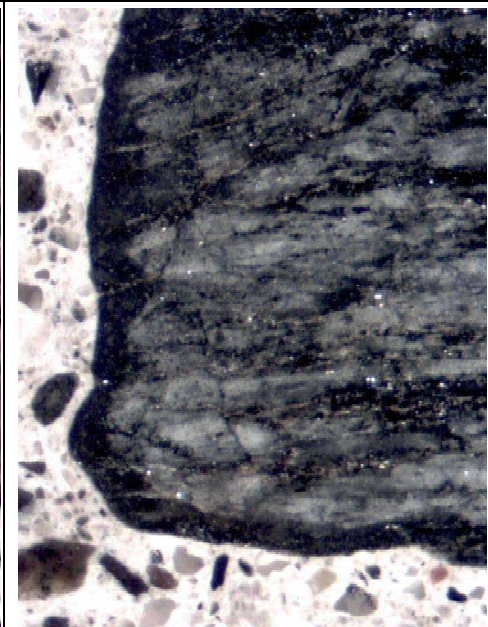
4. Reaction rims on a volcanic aggregate particle (left view) and gneissic particle (right view). Both views are at a magnification of 10x, with a field of view of 8.7 mm long.

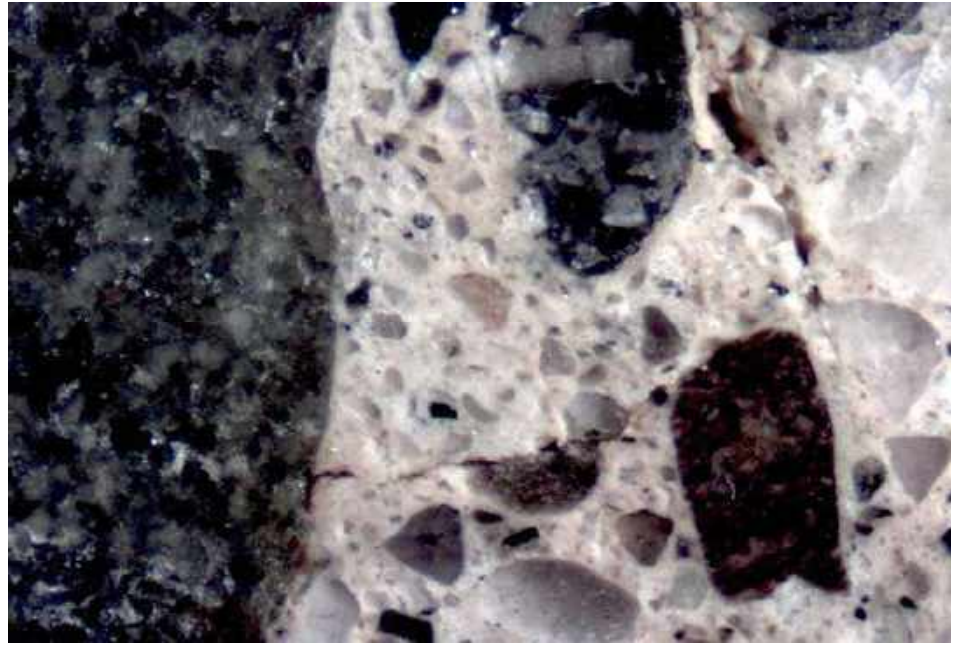
5. Crack in the paste extends from coarse aggregate particle through paste and exits at the surface. Mag. 50x, fov = 3 mm long.

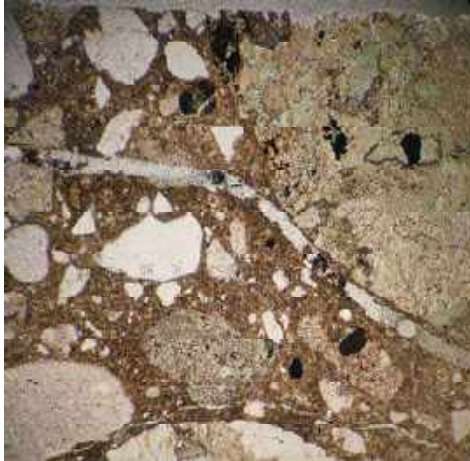
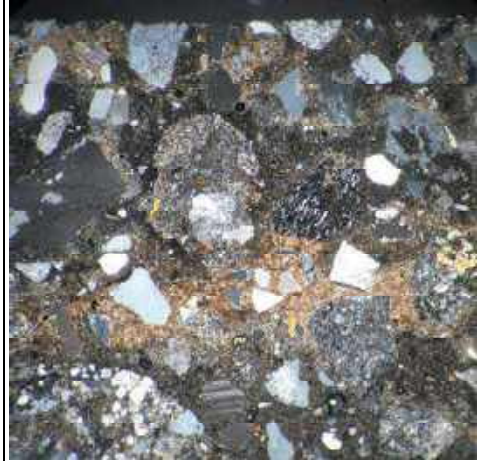
6. Plane-polarized light view showing large crack in the paste; surface of core is at top. Mag. 50x, fov 3 mm.

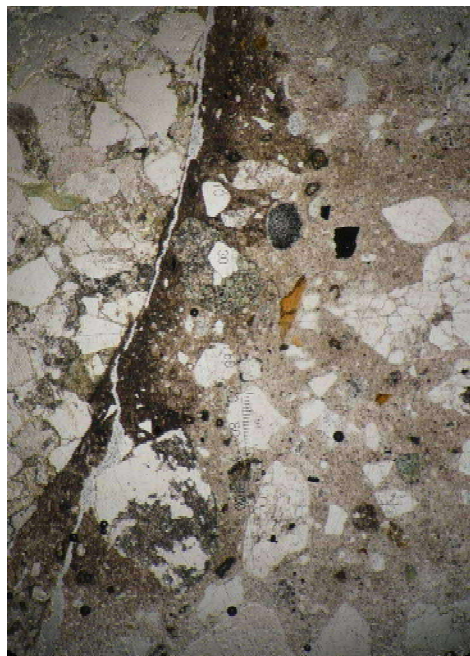
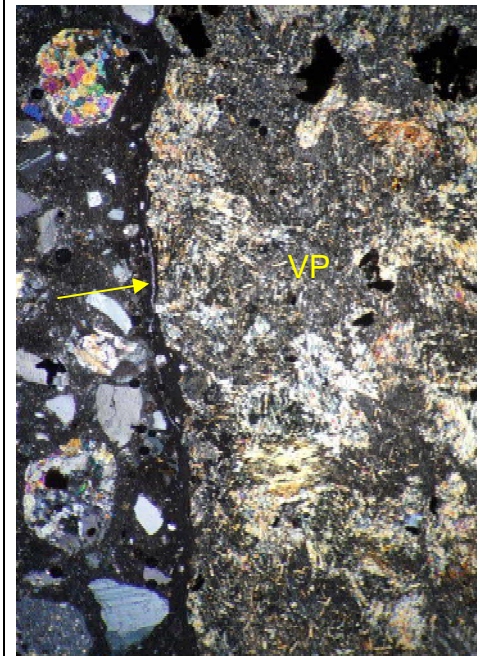
7. Cross-polarized light view showing discoloured (probably carbonated) patch of paste, with fine cracks. Surface of core is at top. Magnification is 50x, fov 3 mm.

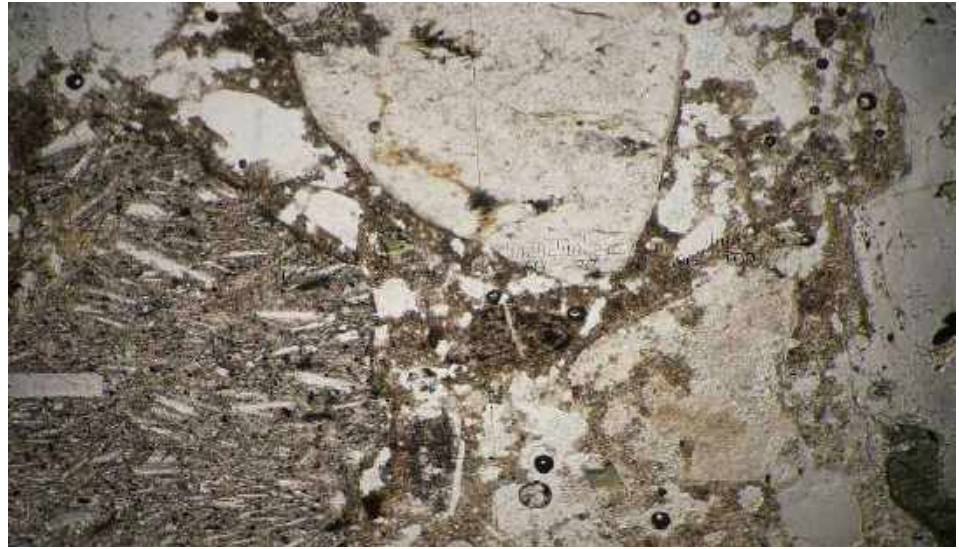
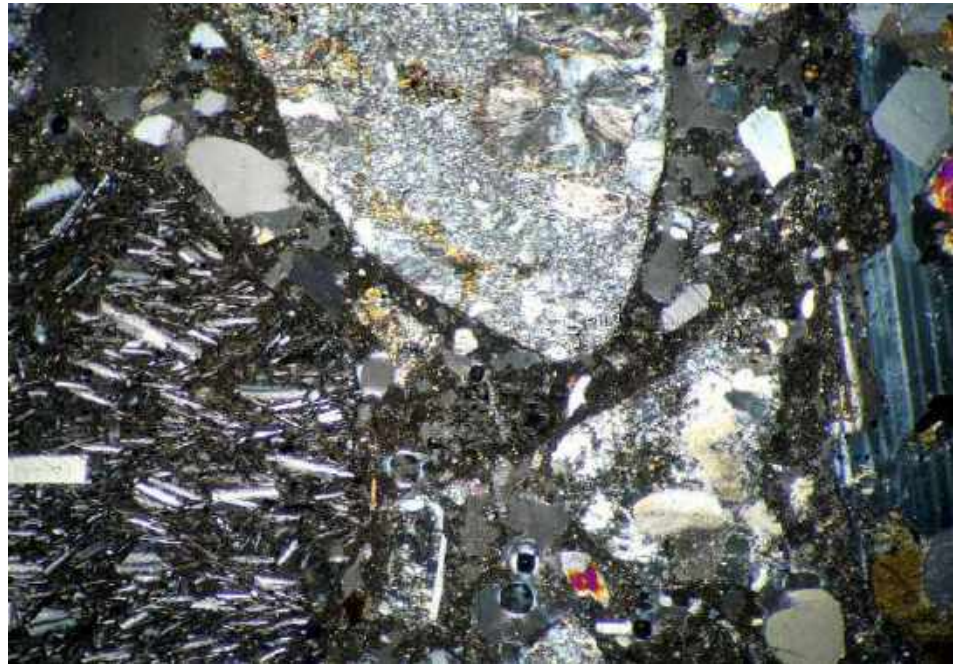
9a, b. Views seen in plane-polarized light (upper) and cross-polarized light (lower) showing dense paste that encloses aggregate particles. Both views mag. 50x, fov = 3 mm.

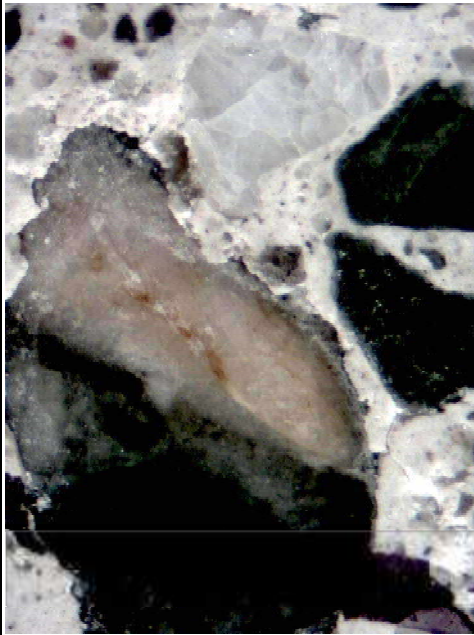
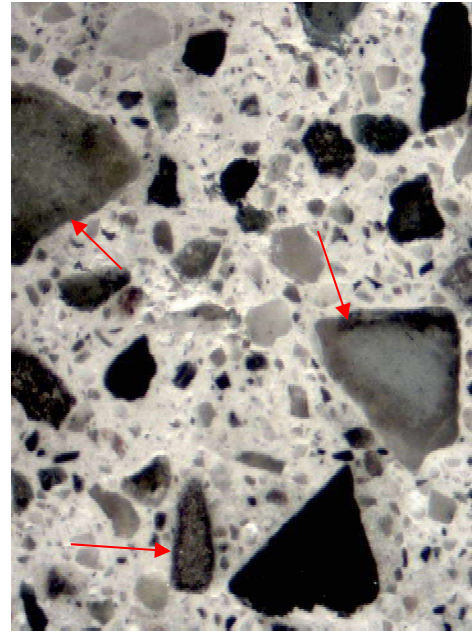
3a. Debonded aggregate particle: soft and porous paste encloses the aggregate.
Magn. 10x, field of view is 8.7 mm.
3b. Reaction rims on siliceous aggregates (chert, volcanic rock).
Mag. 10x, fov = 8.7 mm.

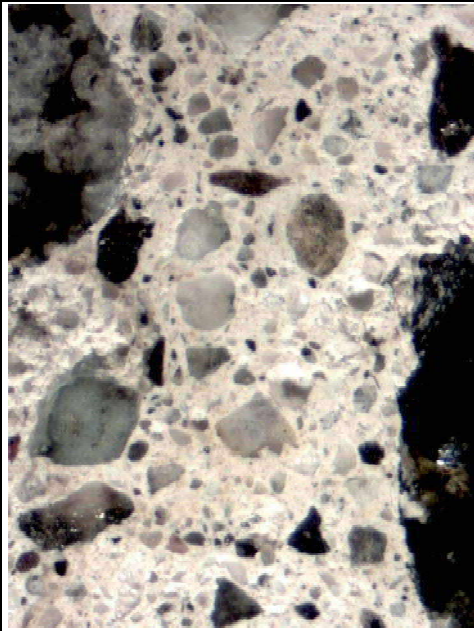
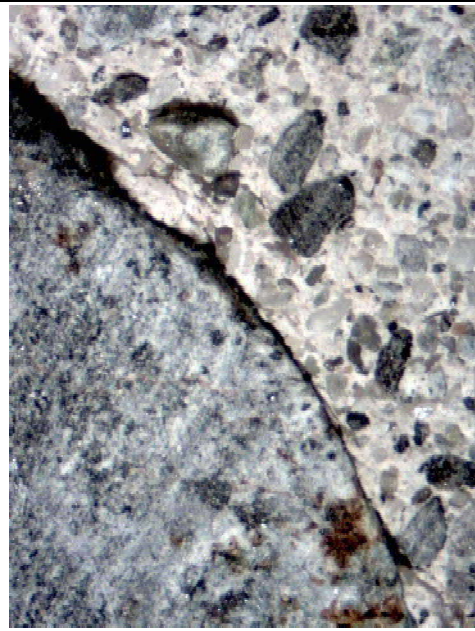
4a. Soft paste in the sample is absorbent and easily disturbed. Mag. 10x, fov = 8.7 mm.
4b. Debonded aggregate particle.
Mag. 10x, fov = 8.7 mm.

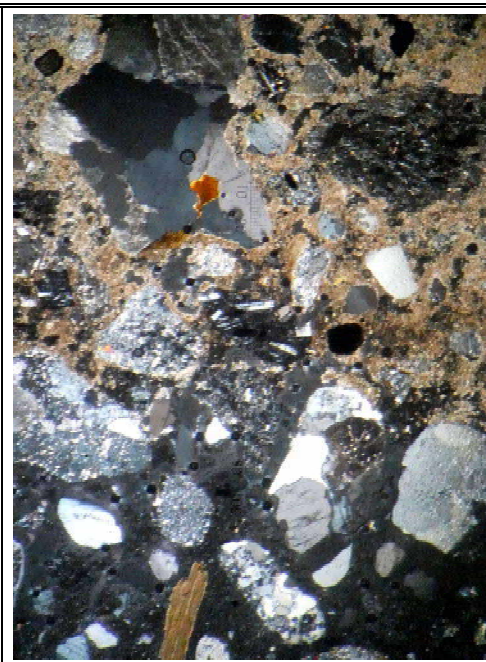
<p>5a. Carbonated paste appears as brown in this cross-polarized light view of a thin-section. Mag. 50x, fov = 3 mm long.</p> <p>5b. A crack extends through a volcanic aggregate particle (upper portion of view) and passes through paste in the lower portion of the view. Mag. 50x, fov = 3 mm long.</p>

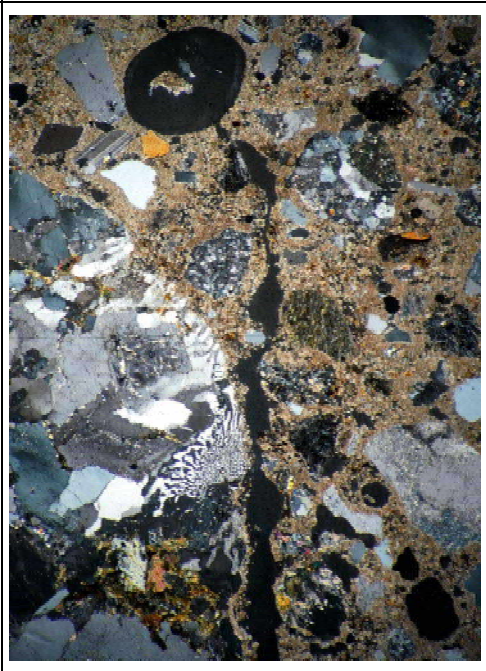
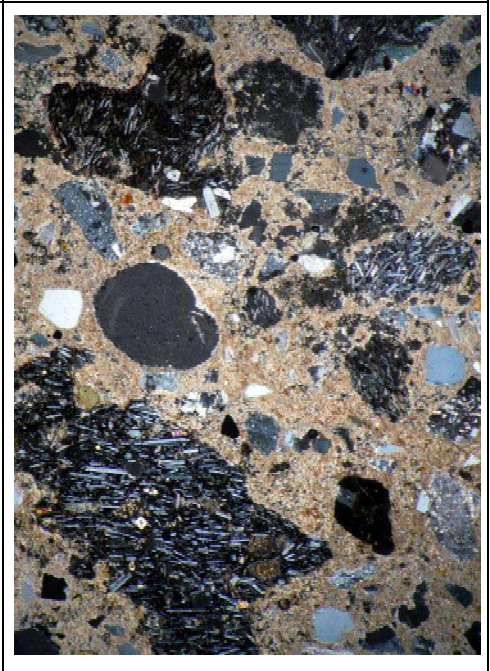
<p>6. Cross-polarized light view showing large ASR gel-filled crack in the paste. Mag. 50x, fov 3 mm.</p> <p>7. Cross-polarized light view showing several volcanic aggregate particles enclosed by paste. Magnification is 50x, fov 3 mm.</p>

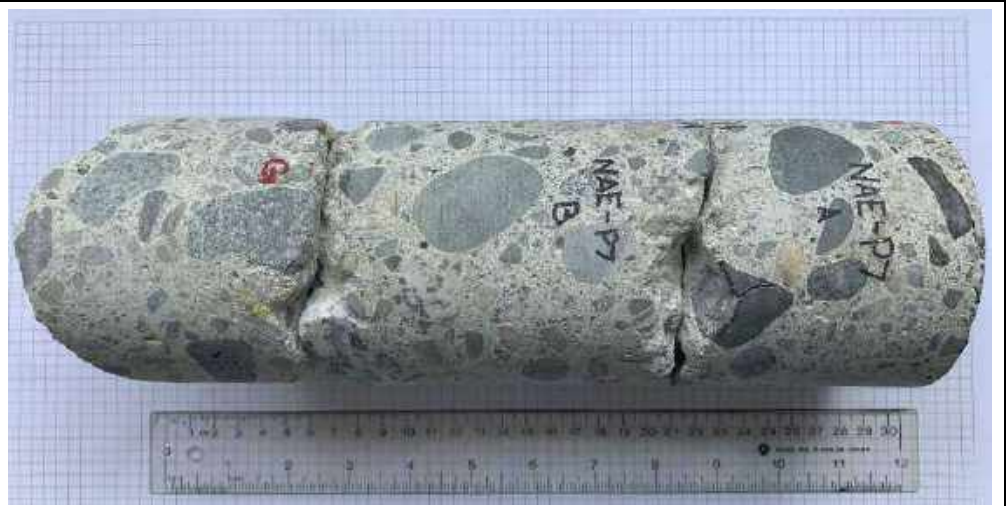
1. View of the sample prior to sawcutting and polishing.

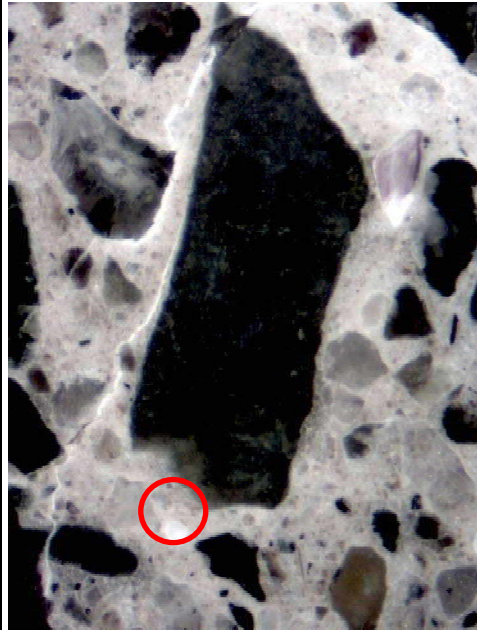
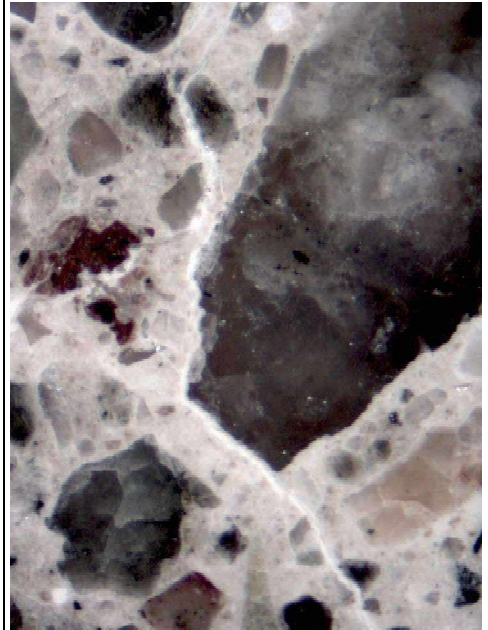
3a. ASR-gel-filled cracks passing through paste along a volcanic aggregate particle. Note also a gel-filled air void located below the large aggregate particle. Magn. 10x, field of view is 8.7 mm.

3b. ASR-gel-filled cracks pass through paste in various orientations. Mag. 15x, fov = 6.3 mm.

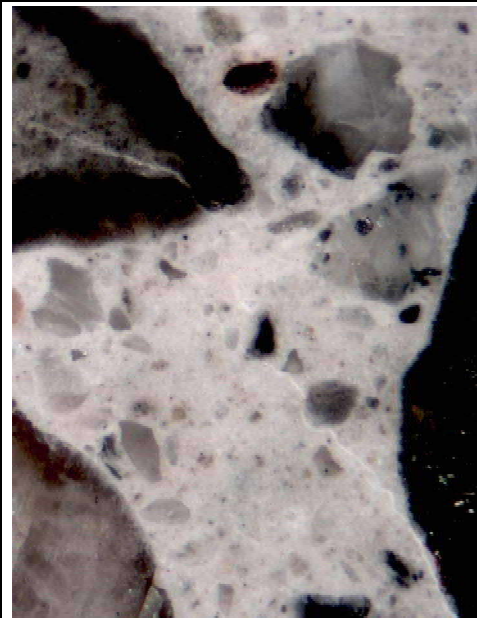
4a. Reaction rim on volcanic particle with ASR-gel-filled internal crack that extends out into paste (arrows). Mag. 20x, fov = 5.0 mm.

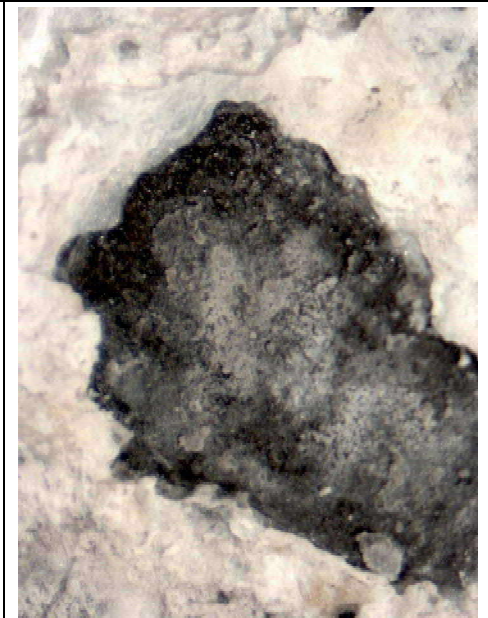
4b. Reaction rim and crusty dried ASR gel on reacted volcanic aggregate particle. Mag. 10x, fov – 8.7 mm.

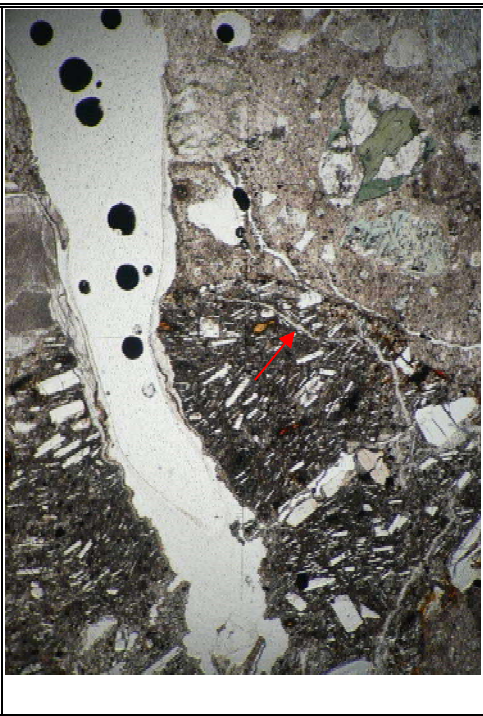
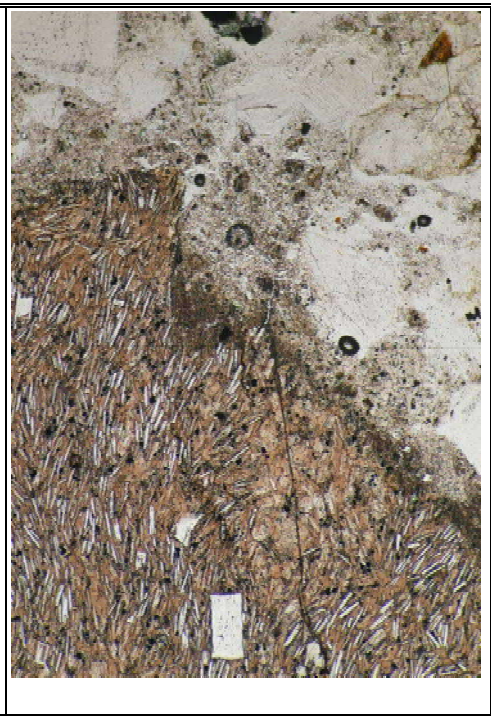
<p>5a. A relatively large (≤ 1 mm wide) open crack is seen in thin-section, lined with old ASR gel and carbonate material, passing through a volcanic aggregate particle, through which a number of finer cracks pass, these filled with ASR gel. Mag. 50x, fov = 3 mm long.</p> <p>5b. A volcanic aggregate particle dominates the lower left of this thin-section view, with a darkened reaction rim, and an internal crack that extends into the paste. Mag. 100x, fov = 1.5 mm long.</p>

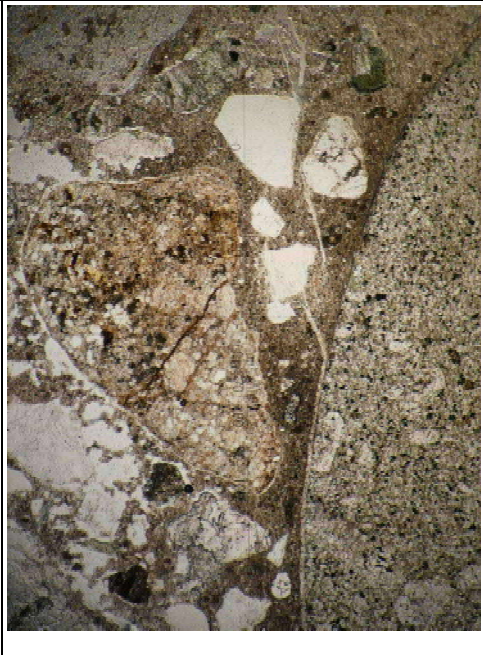
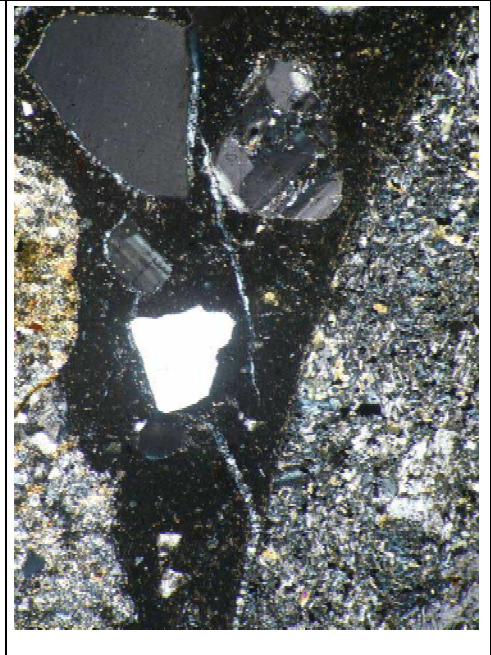
<p>6. Views of ASR-gel-filled cracks seen in thin-section (left is plane polarized light, right in cross-polarized light). Left mag. 50x, fov 3 mm; right is 100x, fov 1.5 mm.</p>

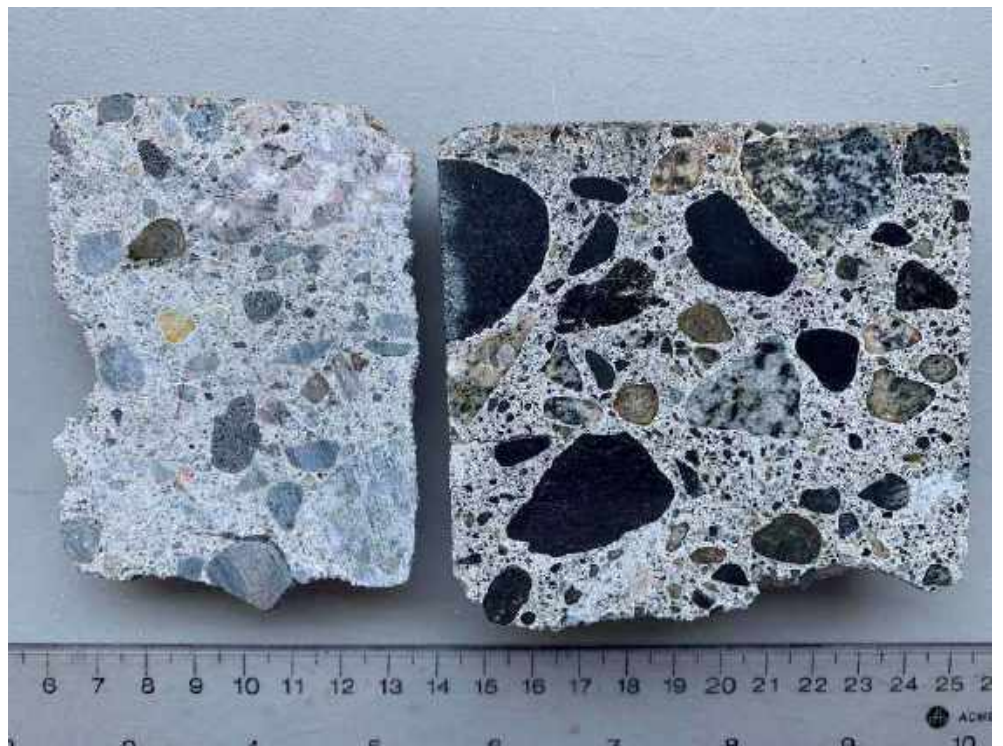
1. View of the sample after sawcutting and polishing.

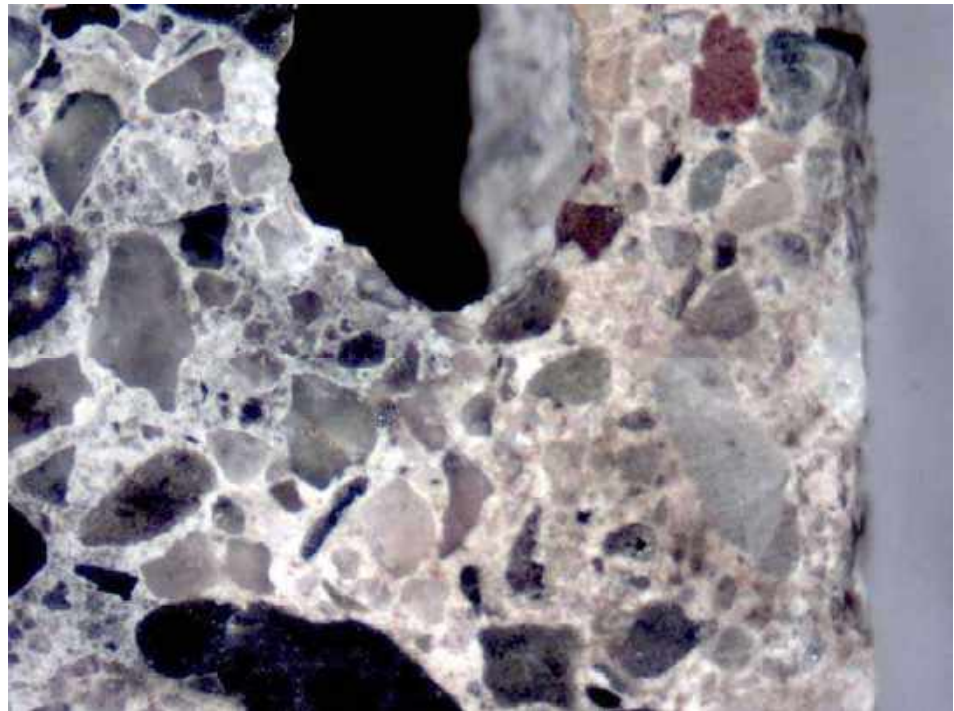
2. Detail of polished sample illustrating carbonated paste extending into core from the surface to a depth of about 6 mm. Magnification 10x, field of view is 8.7 mm across.

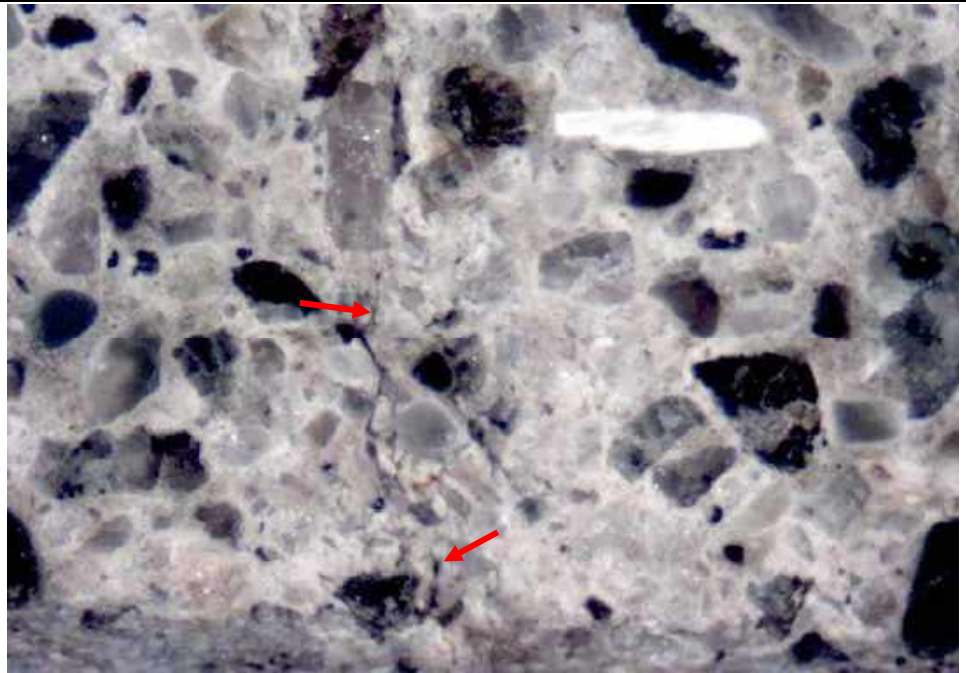
3. A crack is shown extending horizontally through the paste at a depth of about 5.8 cm below the core's surface. Magnification of 10x, field of view 8.7 mm long.

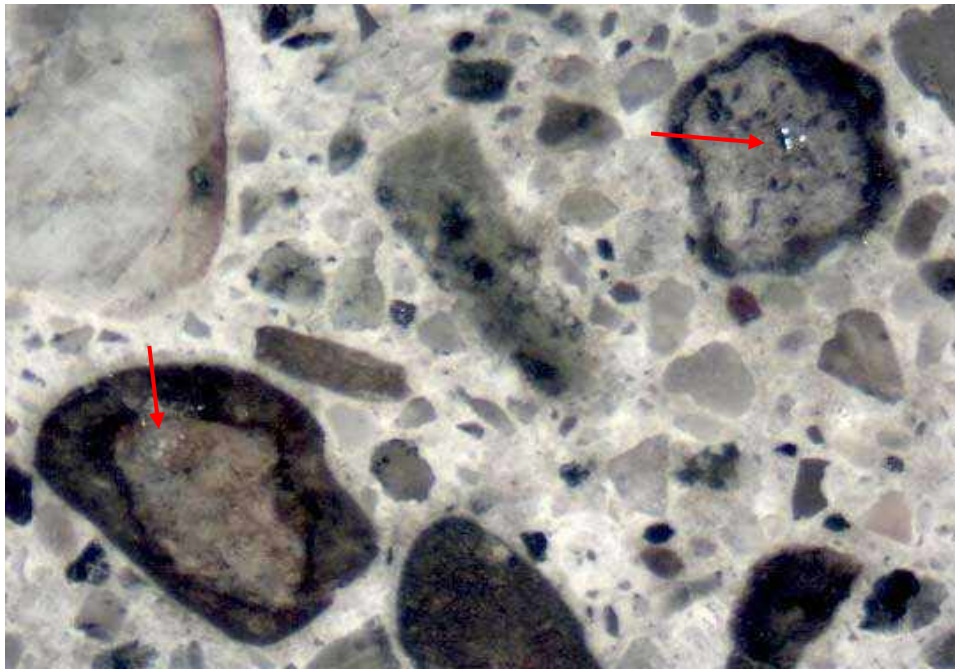
4. Two felsic volcanic rocks with prominent reaction rims and fresh ASR gel (arrows) exuded since cut-polish preparation (i.e., about four days' time). Magnification 10x, FOV is 8.7 mm length.

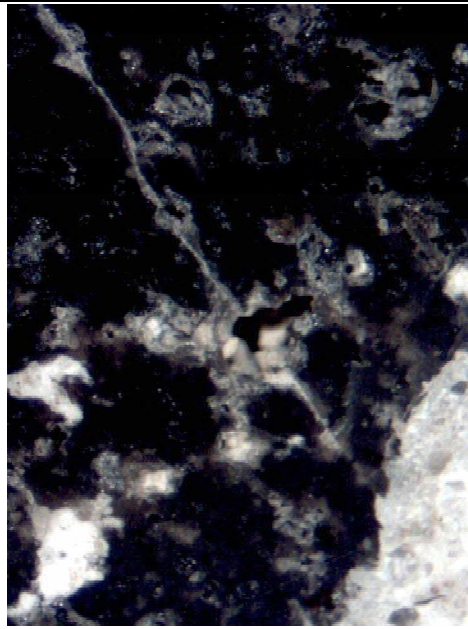
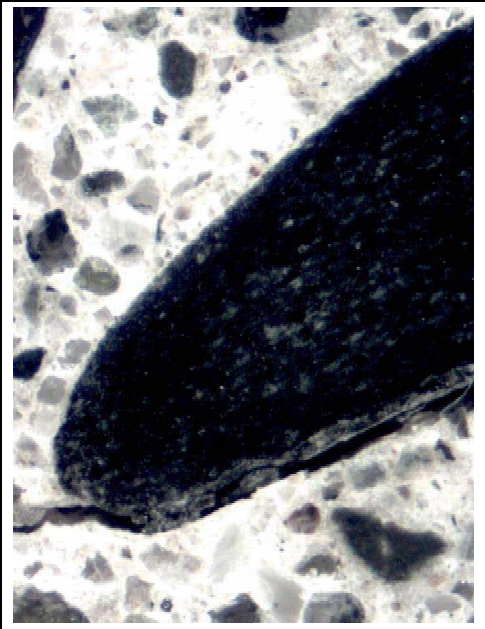
5a. An ASR-gel-filled crack is observed passing through a volcanic aggregate particle.
5b. Debonded aggregate. Both views are at a magnification of 10x, FOV is about 8.7 mm long.

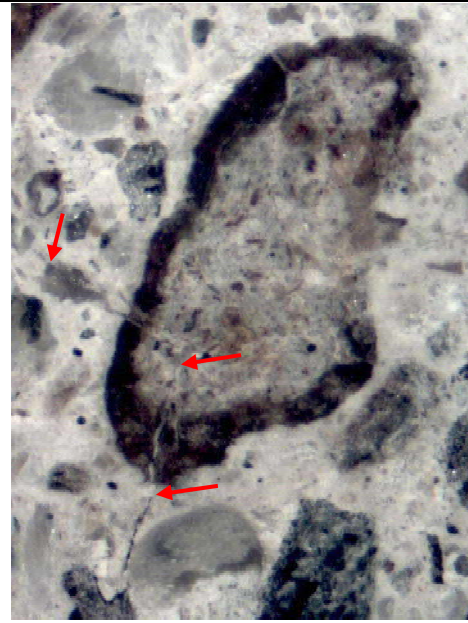
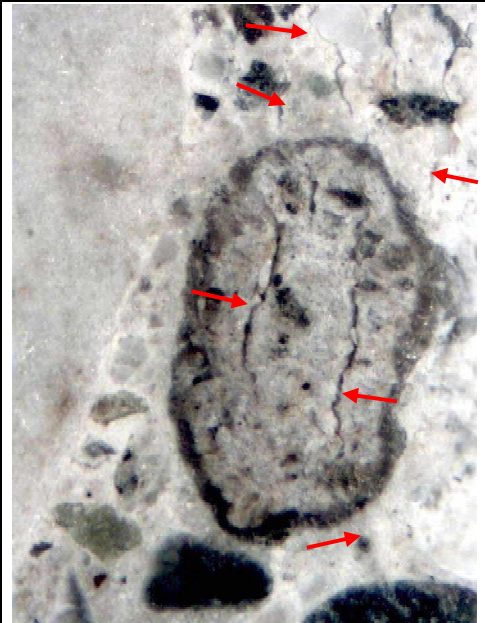
6a, b. Two volcanic aggregate particles exhibiting pronounced reaction rims with ASR-gel-filled cracks passing through and extending into the surrounding paste. Left view magnification 15x, fov 6.3 mm and right view 20x, fov 5.0 mm in length.

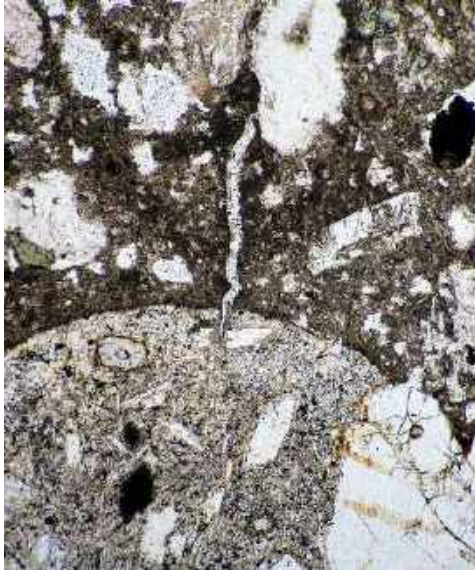
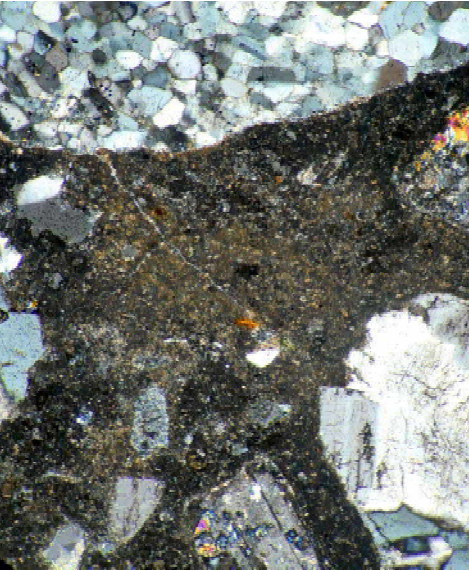
<p>7a, b. Thin-section views of cracks in the paste that extend from reacting aggregate particles. Left view, seen in plane polarized light, shows an ASR gel-lined crack that extends from a volcanic aggregate, while the right view, seen in cross-polarized light, shows a crack extending from an aggregate particle that contains strained quartz. Both views 100x magnification with a field of view (lengthwise) of 1.5 mm.</p>

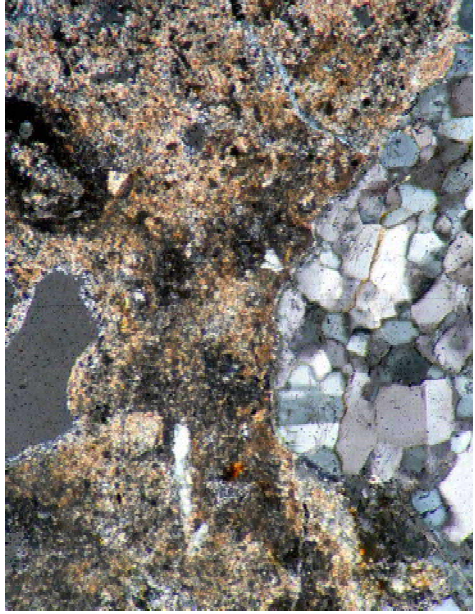
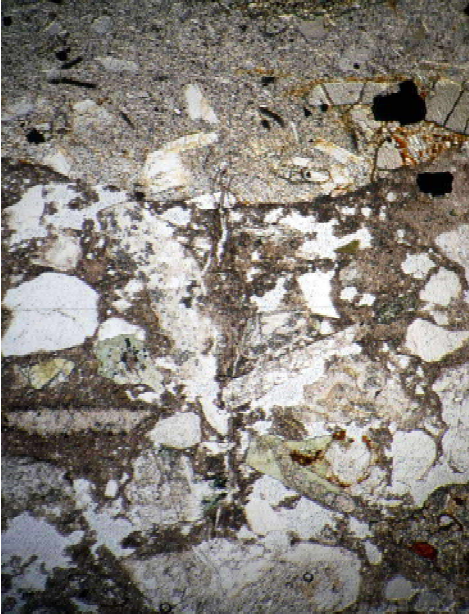
<p>8a. Cross-polarized view of thin-section showing ASR gel-filled crack passing from siliceous aggregate; 100x mag. FOV = 1.5 mm length. 8b. Plane-polarized light view of thin-section showing ASR gel-filled crack issuing from volcanic particle at top of view. 50x mag. FOV 3 mm.</p>
